GROUP	MODEL
Product Improvement	2024-2026MY EV9 (MV1, MV1a)
NUMBER	DATE
PI2601A	April 2026

TECHNICAL SERVICE BULLETIN

SUBJECT: **PASSENGER SIDE WIPER ARM REPLACEMENT (PI2601A)**

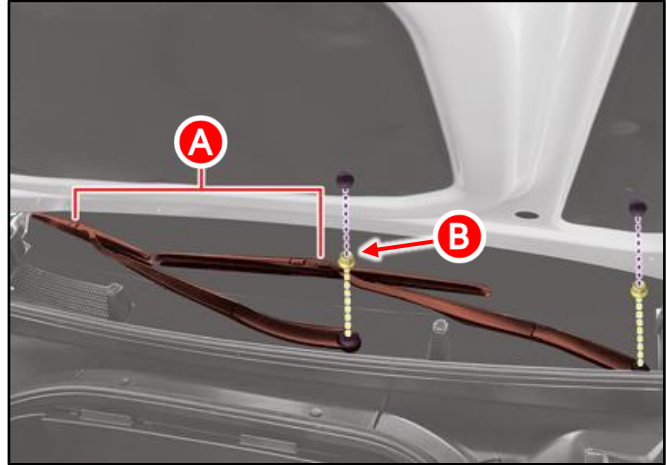
1. Remove the passenger-side (RH) windshield wiper arm (A) by referring to "Body (Interior / Exterior / Electrical) → Exterior Green House → Wiper Arm → Removal and Installation" in the applicable Shop Manual on KGIS.

Tightening torque for nut (B):
6.5 - 9.4 lb.ft (8.8 - 12.7 N.m)

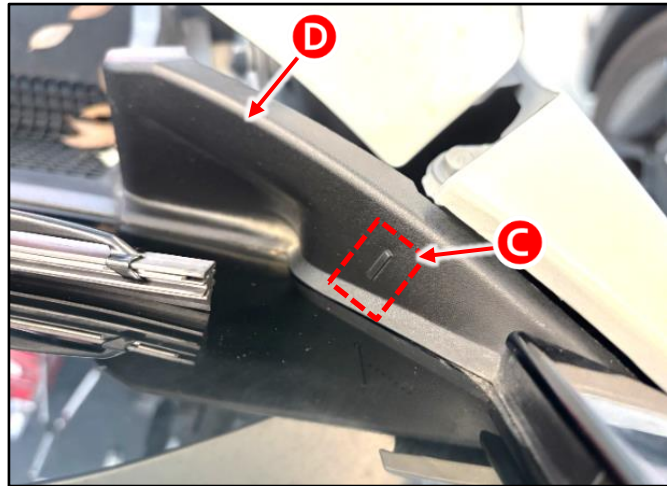
2. Locate the installation mark (C) stamped on the passenger (RH) A pillar garnish (D).

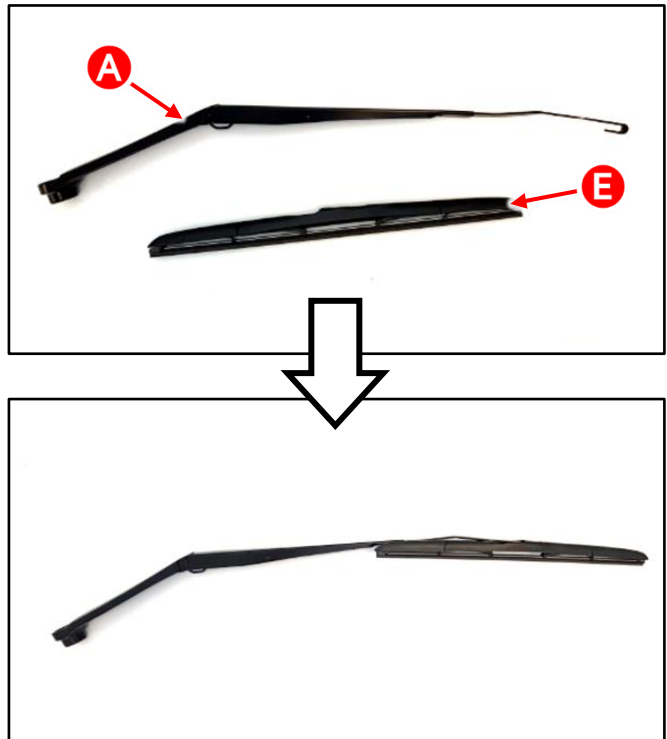
3. Install the wiper blade (E) onto the wiper arm (A).

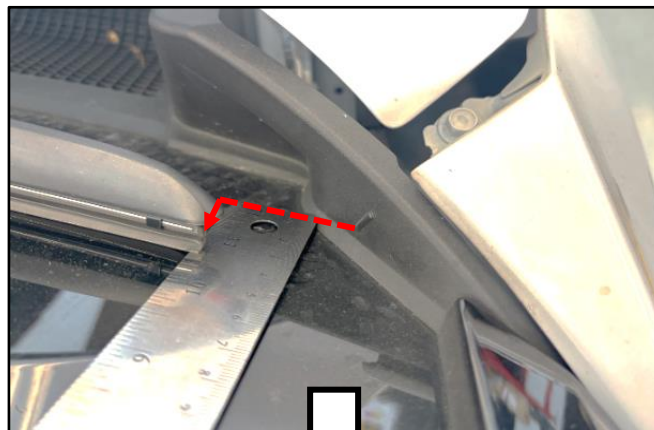
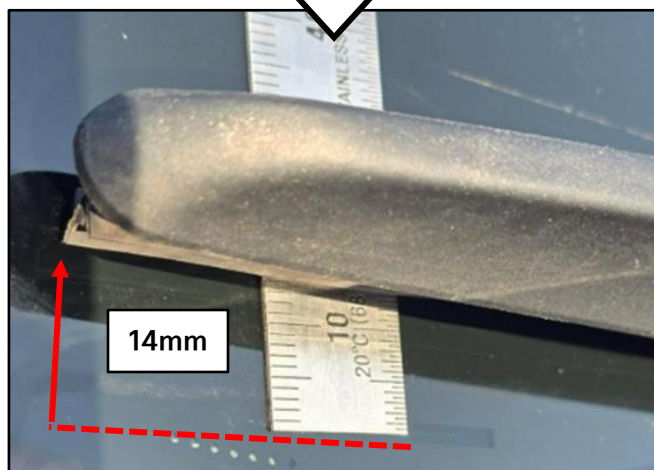
- 4a. Install the **new** wiper arm (A) and wiper blade (E) but **DO NOT INSTALL THE NUT (B)**.
- 4b. Align the tip of the wiper blade (E) rubber 14 mm **HIGHER** than the existing installation mark.

The wiper arm **MUST** be installed at the specified height.

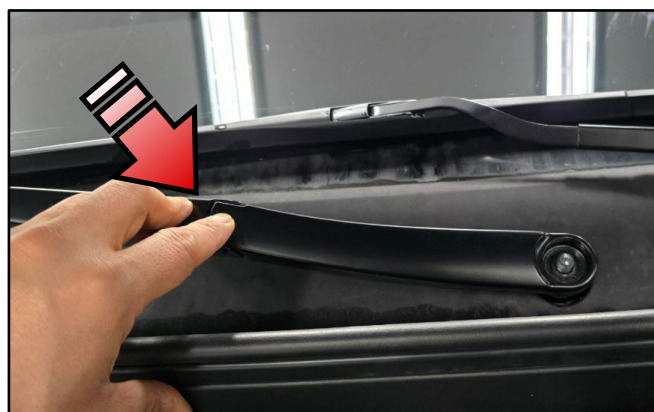
- 5a. Install the nut (B).
- 5b. Apply light downward pressure on the wiper arm (A) at the spring when tightening nut (B). This prevents the wiper arm from popping up, which could cause interference between the wiper arm and the hood.
6. Reinstall all removed parts in reverse order or removal.
7. Confirm normal wiper operation.

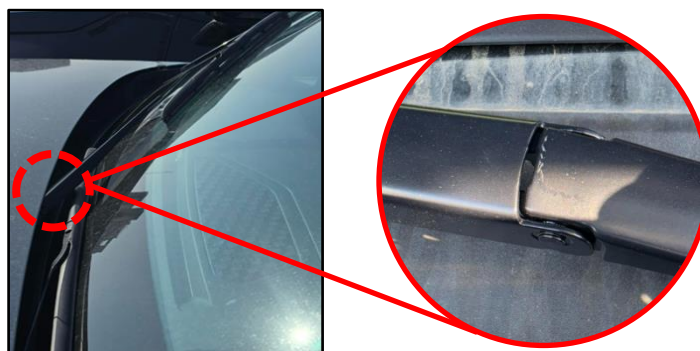
Improper seating of the wiper arm on the linkage may cause hood interference and result in component damage. Ensure the wiper arm is correctly installed.
