SIB 65 05 26

SERVICE ACTION: REPLACE PSDI-X DRIVER'S AIR BAG MODULE

2026-04-30

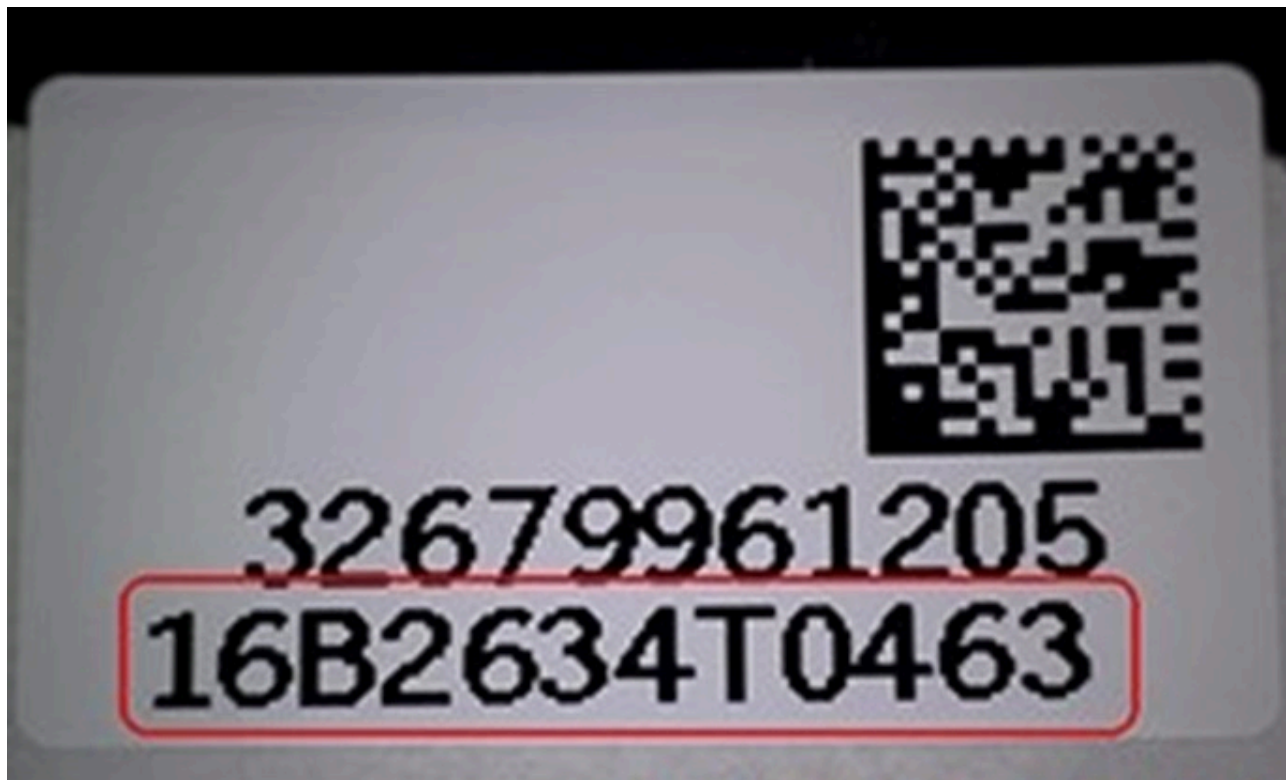
Before installing the replacement part, the new air bag module's serial number (circled above) must be documented by the technician on the repair order so it can also be entered into the warranty claim's comment section.
