## SIB 61 02 26

009CBB - SHORT CIRCUIT IN THE FOOTWELL MODULE (FRM)

2026-04-30

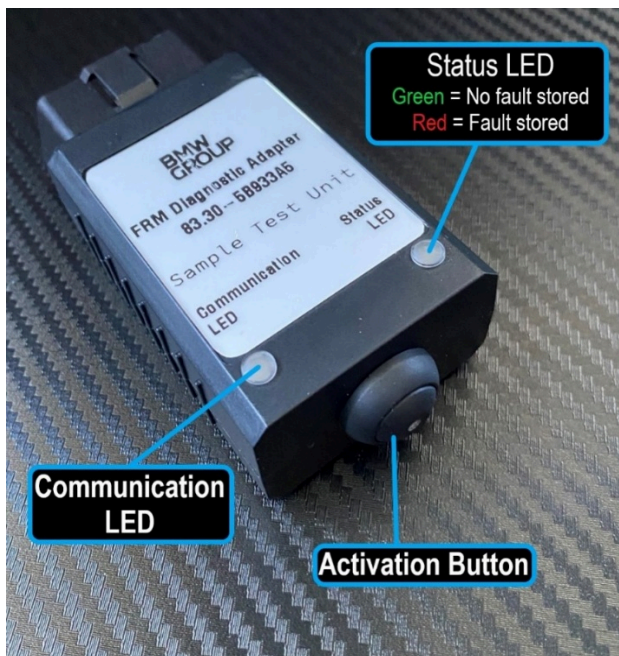
1. Exit the test plan.
2. Disconnect the ICOM from the Connection Manager and remove the (OBD-II) On-board Diagnostics connector from the vehicle.
3. Insert the FRM dongle (**5B933A5**) into the vehicle's OBD-II port.
  - The Communication LED will light solid "**blue**".
4. Activate Terminal 15 by inserting the vehicle key and turning the ignition ON.
  - The Communication LED will begin flashing slowly "**blue**".

If the **blue** "Communication LED" stays solid and **does not flash** after Terminal 15 activation, please refer to the troubleshooting section below.

5. The dongle automatically queries the status of the short-circuit counters in the FRM module.

**Observe the Status LED indicator:**

**Green:** No fault stored / All short-circuit counters are at zero; no FRM reset needed.

**Red:** Fault code 9CBB is stored / One or more short-circuit counters are greater than zero; FRM reset is required.
