Fuel Level Unchanged After Refueling

Topic number	LI47.00-N-069565
Version	4
Function group	47.00 - General
Date	4/29/26
Validity	MODEL 907 with OM654, OM651, or OM642
Reason for change	Remedy Update

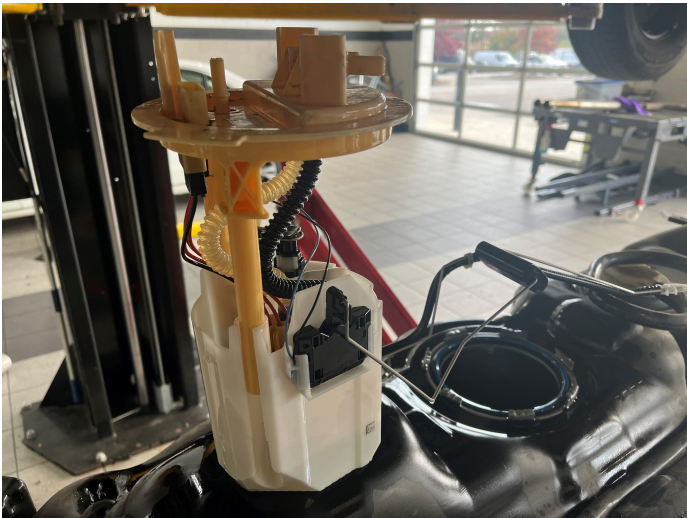
- A. The Fuel Supply Control Unit (FSCU) fails to detect a refueling event.
- B. The Fuel Level Sensor provides incorrect readings.

Attachments	
File	Description
Stuck Level Sensor.jpg	Level Sensor Stuck on Pickup Tube

1. Remove the fuel tank.
2. Carefully remove the low-pressure fuel pump lock ring for inspection.
3. Examine the fuel level sensor for signs of sticking, interference, a bent pickup tube, misrouted wiring, or hoses. Refer to attachments for examples.

4. Adjustment only. No parts replacement on the first visit.
 - Only if the fuel level sensor is found to be stuck on fuel lines, wiring, or the pickup tube, correct routing as needed, adjust the sensor position, and reinstall.

- When installing the low-pressure fuel pump module, ensure the pickup tube does not become stuck on the bottom of the fuel tank. If the pickup tube is forced against the bottom of the tank, the level sensor arm or float can bind and cause an incorrect fuel level reading.
