OM651 Exhaust Bracket Cracking

Topic number	LI49.10-N-060969
Version	7
Function group	49.10 - Exhaust pipes, mufflers
Date	4/17/26
Validity	Sprinter with engine OM651
Reason for change	Validity Update

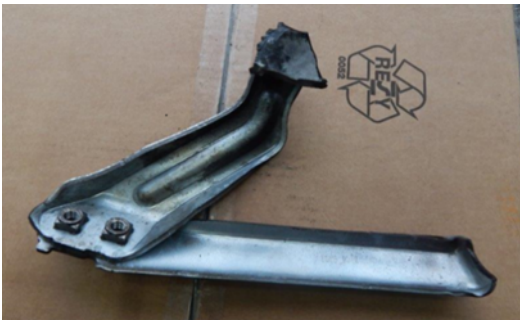
Attachments	
File	Description
Pic 1.jpg

1. The exhaust bracket from the DPF to the transmission is cracked or broken.
 - See Pic. 1 for an example of a broken bracket.

Broken exhaust bracket to transmission
Pic 2.JPG	Transmission bell housing cracked

1. Inspect the exhaust bracket from the DPF to the transmission.
 - Check the bracket for cracks or complete separation.
 - See Pic. 1 for a failed example.

- See EPC OM651 #550 and Pic. 3 for bracket location.
 - If damaged, replace the bracket.
 - See Pic. 4, Pic. 5, and Pic. 6 for the updated bracket design and identification.

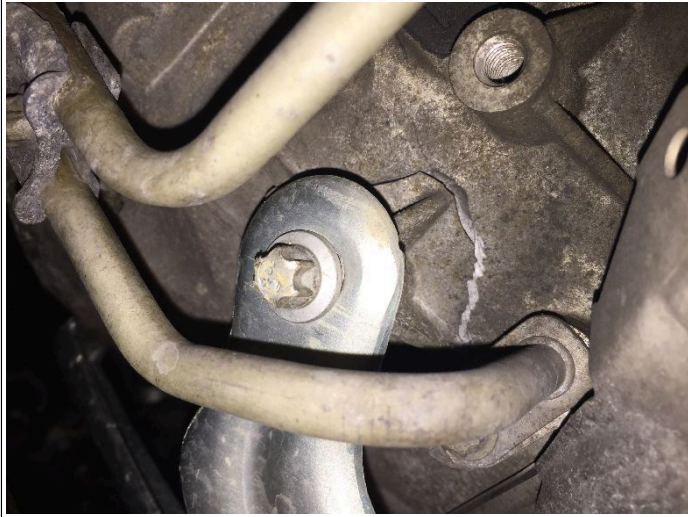
2. Transmission bell housing cracked or broken at the exhaust mounting area.
 - See Pic. 2 for an example of bell housing damage.

2. Inspect the transmission bell housing.
 - Inspect the bell housing at the exhaust mounting point for cracks or structural damage.
 - See Pic. 2 for an example of bell housing damage.

- Replace the transmission if damage is confirmed.
3. Inspect the exhaust bracket from the DPF to the engine (cylinder crankcase).
 - Inspect the bracket for cracks or broken mounting points.

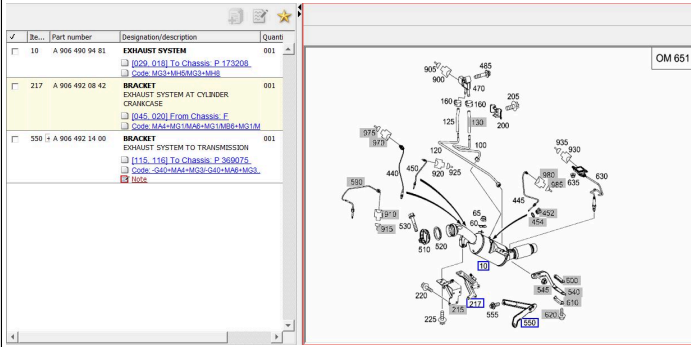
Attachments	
File	Description
EPC OM651 exhaust.JPG

EPC parts description
Pic 3.jpg

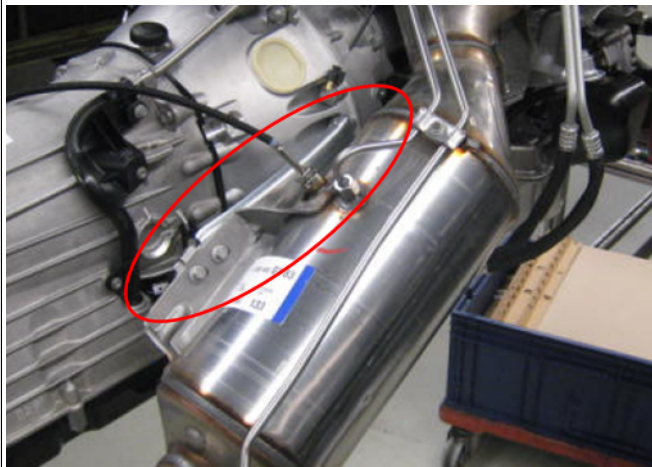
Location of DPF to Transmission bracket
Pic 4.JPG	DPF bracket to transmission has extra hole for mounting

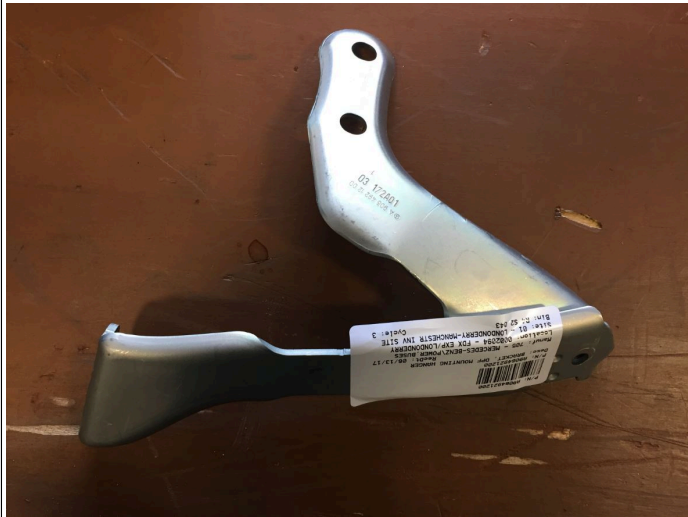
Pic 5.JPG

DPF bracket to transmission has extra hole for mounting see part number

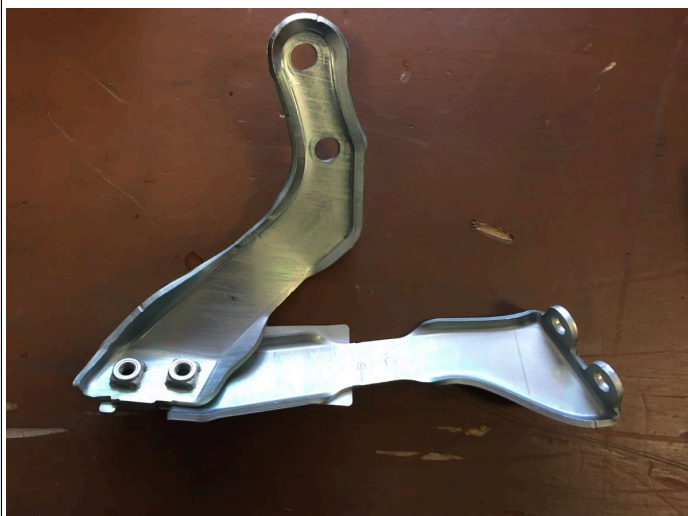
Pic 6.JPG

DPF bracket to transmission rear view

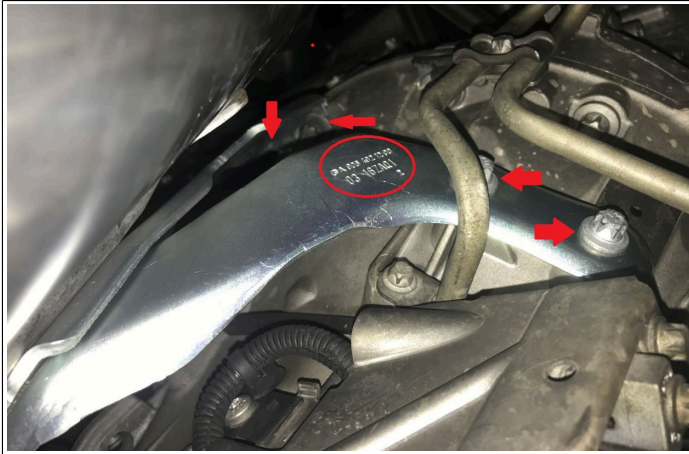
Pic 7.JPG

Location of mounting screws

1. Tighten the exhaust system in the correct sequence.
 - Tighten engine mounting bolts to 25 Nm.
 - Tighten V-mount bolts to 25 Nm.
 - Tighten exhaust bracket bolts to 15 Nm.
 - See “Tightening sequence of the exhaust system” image.
2. Verify mounting bolt locations.
 - Confirm correct mounting screw positions at the transmission bracket.
 - See Pic. 7 and Pic. 8 for mounting screw locations.

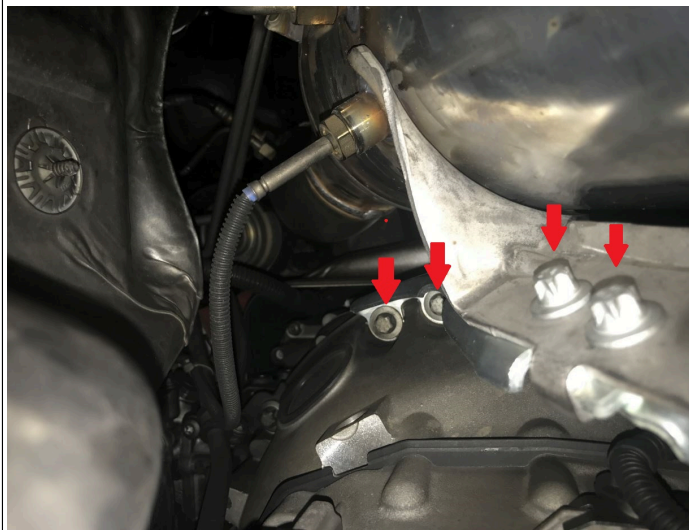
Pic 8.JPG

Location of mounting screws view 2
