# Solenoid Failures

# Solenoid Hi/Pi Coils - Prol. Pow. App. (O/H Coils-Ext. Abut.)

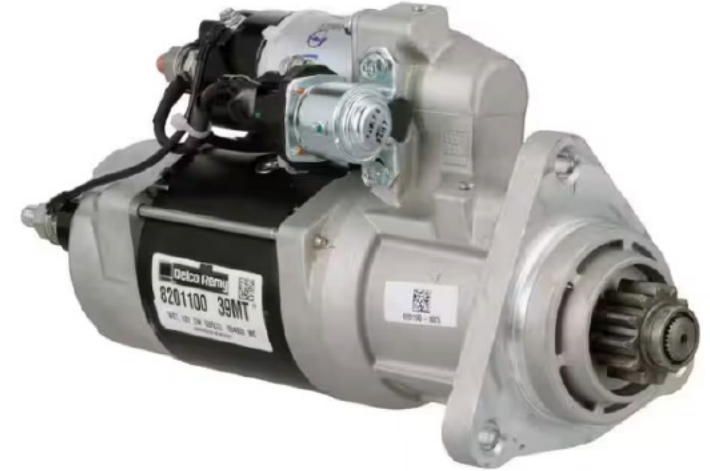
- Solenoid Hi/Pi Coils - Prol. Pow. App. (O/H Coils-Ext. Abut.) 25%
  - Sharp spike in failures, exceeding 51 cases/month at its highest.
  - Post- Nov 2023: Fluctuates at lower levels (~7–12 cases/month).
- Solenoid B+ Terminal - Loose (Customer) 11 %
  - Sharp spike in failures, exceeding 18 cases/month at its highest.
- System/OE - Out Of Warranty 10%
  - Irregular pattern (~5–35 cases/month) of warranty returns that exceed the product's time or mileage limits.
- System/OE - System Issue 6%,
- System/OE - Trouble Not Found 4%,
- CE Ground Terminal - Customer Nut Loose 2 %
- System/OE - External Circuit Control 1%

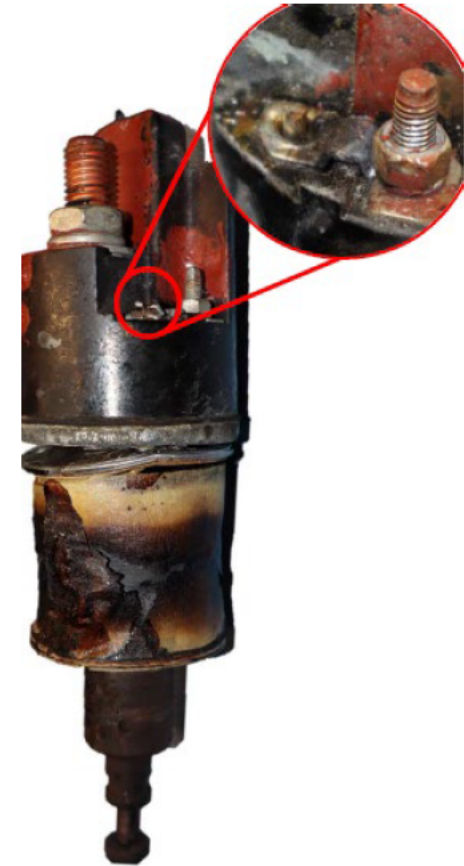
- The solenoid failed a resistance test due to overheating.
- Prolonged energization caused thermal damage to the pull-in and hold-in coils, including solder reflow at the S-terminal.
- A teardown showed no issues with drive pack components.
- Physical signs such as discoloration and reflowed solder confirm the overheating.

- Internal investigation at PHINIA. Application analysis of DD engines  
Collaboration with Freightliner to assess this failure mode as part of the truck application.
- A detailed teardown analysis, supported by laboratory testing, will be conducted to understand this failure mode at application level.
