Top Routing and Clipping Defects - A/C Harness

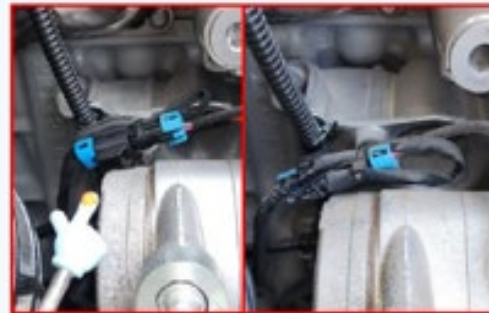
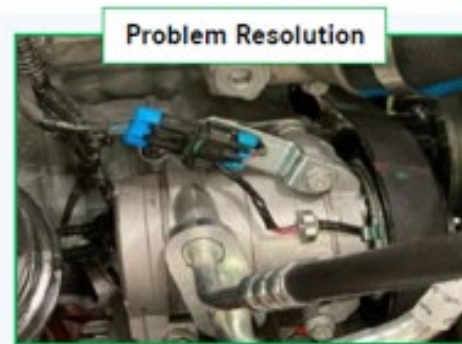
- A/C harness rubbing on compressor

- The connector was rubbing against the compressor due to missing support for wiring routing.

- Shopcall was created to add a new routing with a bracket and zip tie to secure the connector and prevent chafing.
