SS 3124 - FTL Legacy M2 Bulkhead Module (BHM) Replacement and DiagnosticLink Issues

Legacy M2 Business Class, 108SD, 114SD using a Bulkhead Module (BHM) and Chassis Module (CHM) for power distribution and control.

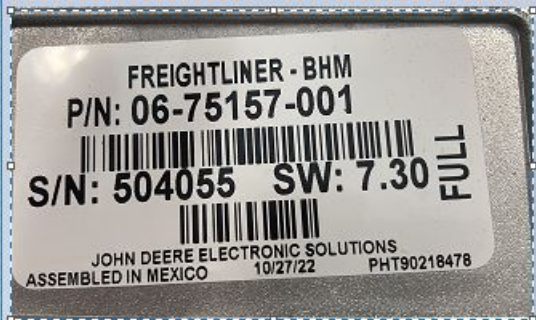
Figure 1

If an incorrect part is used, and then the correct part is installed, DiagnosticLink may program an incorrect software version to the module. See the attached screen shot, which shows the DiagnosticLink Professional view of a BHM with part number 06-75157-001 (originally loaded with 7.30 application software) that was reflashed to 7.45 application software and has a blank VIN.

Flashing to a different software version than supported by the module may render a BHM inoperative. The example noted above resulted in a module that would only communicate on a 500kbps J1939 network, where the truck had a Natural Gas engine that only supported a 250kbps J1939 network.

1. DiagnosticLink Professional will not flash the per-serial configuration to the module, as noted above.
2. As a result of the failure to flash the per-serial configuration, the VIN in the BHM will remain at "ABCDEFGHJKLMN0P1".
3. DiagnosticLink will attempt to migrate the vehicle data to an (incorrect) software version.
4. Without further intervention by the DTNA CAC, further attempts to install a BHM will also fail.
5. Even if the correct BHM part is subsequently installed, DiagnosticLink professional will reprogram the application software, rendering the BHM unusable except on newer M2 chassis.

Before using DiagnosticLink, ensure that the correct BHM part number, as called out in Excelerator, is installed on the truck. Excelerator has correct part number information for the BHM (module 32A).

If a module has been replaced, and it is determined that the module was flashed with incorrect software, DiagnosticLink has initiated a data migration. A ticket must be logged with the Customer Assistance Center in SalesForce, specifically requesting BHM migration rollback.
