## SS 3146 - FTL M2, 108SD, 114SD - Unable to Program Replacement Bulkhead Module - Certain Model Years

**Vehicles Affected:** Legacy M2 Business class, 108SD and 114SD

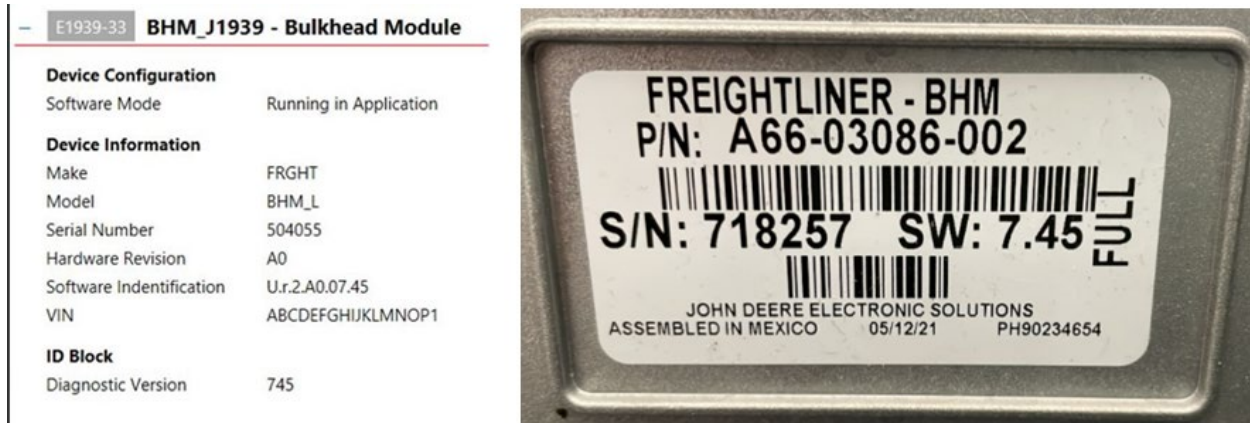
**Figure 1**

If replacing a Bulkhead Module, refer to Excelerator for the latest hardware displayed in module 32A. If the BHM was replaced in a truck *without* first confirming the correct part with Excelerator, DiagnosticLink may not be able to program the replacement BHM.

This is *especially* important if a truck is being rebuilt with a sales cab. Sales cabs *may not* have the correct BHM for the original vehicle. *Use the serial number of the original vehicle when confirming the correct BHM part number.*
