# Technical Service Bulletin

<b>Subject:</b>  <b>RATTLE NOISE FROM ENGINE COMPARTMENT AND OIL LEAKAGE FROM DRIVE BELT AUTO TENSIONER</b>	<b>Bulletin No.: 01-008/26</b>
	<b>Last Issued : 04/30/2026</b>

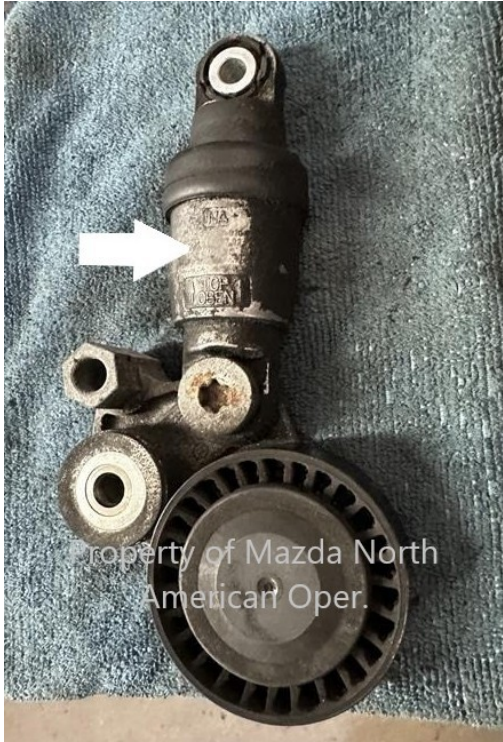
Dry / Normal Dirt Accumulation

- If the tensioner is found to be **"Good"** after completing the Drive Belt Auto Tensioner Inspection, do not replace the tensioner.

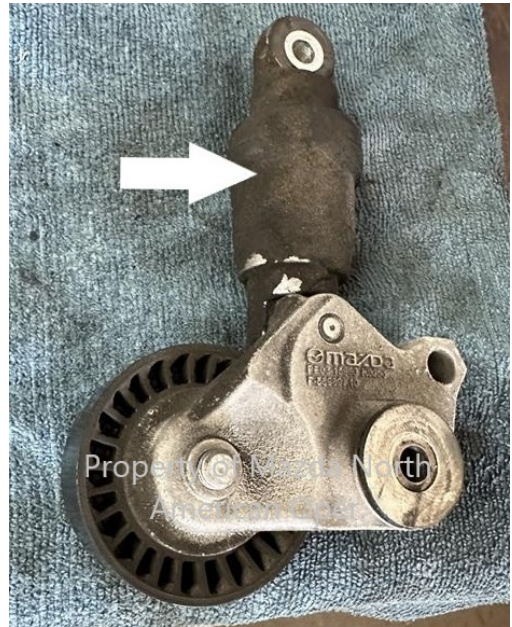
Dry / Normal Dirt Accumulation

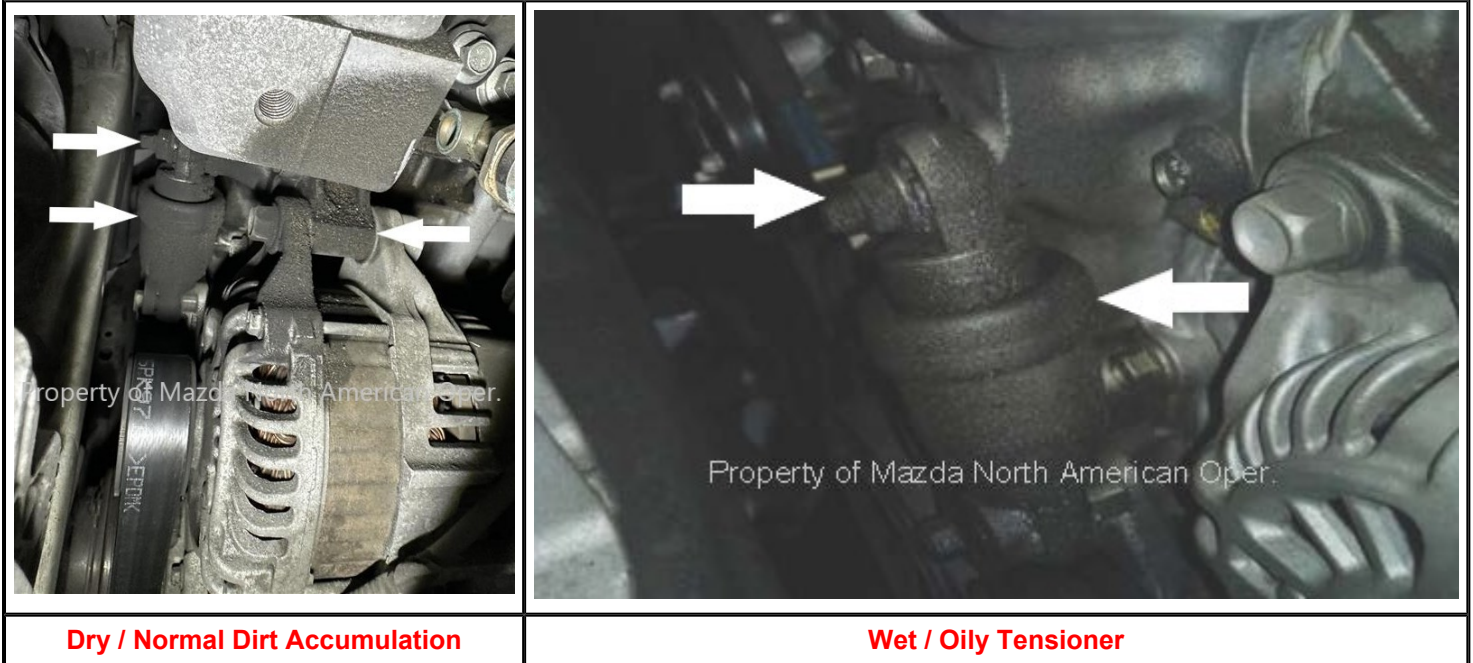
Some vehicles may exhibit rattling noises from the engine compartment and oil leakage from the drive belt auto tensioner. This may be caused by insufficient sealing at the drive belt auto tensioner damper when the auto tensioner fully operates under both high ambient temperature and high load conditions.

**Dry / Normal Dirt Accumulation****Wet / Oily Tensioner**

- If the tensioner is found to be **"No Good"** after completing the Drive Belt Auto Tensioner Inspection, replace it with a modified part according to the instructions on MGSS online:
