<b>Subject:</b>  <b>ABNORMAL NOISE FROM THE FRONT SUSPENSION WHEN DRIVING ON ROUGH ROADS OR GOING OVER SPEED BUMPS</b>	<b>Bulletin No.:</b> 02-001/26
	<b>Last Issued :</b> 04/29/2026

2024-2026 CX-90 (H3T inline 6) with VINS lower than JM3KK\*\*\*\*\*385285 (produced before February 18, 2026)

2025-2026 CX-70 (H3T inline 6) with VINS lower than JM3KJ\*\*\*\*\*207154 (produced before February 18, 2026)

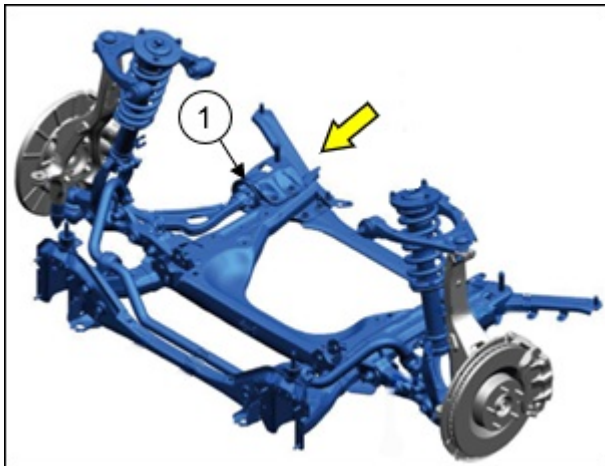
Front Lower Arm (Rear) (1)

Some customers may complain that an abnormal noise is heard from the front suspension when driving on rough road surfaces or when passing over speed bumps. This is caused by insufficient heat resistance of the bushing material under specific operating conditions, resulting in cracking and fluid leakage in the front lower arm bushing.

- The bushing material has been changed to a heat-resistant material.
- The bushing shape has been modified to reduce deformation.
- The damping characteristics of the front lower arm bushing have been modified.

- If noise is detected, replace the front lower arm (rear side) according to the instructions in MGSS.
  - CX-90 (FRONT LOWER ARM REMOVAL/INSTALLATION)
  - CX-70 (FRONT LOWER ARM REMOVAL/INSTALLATION)
- If NO noise is detected, this TSB is NOT applicable.

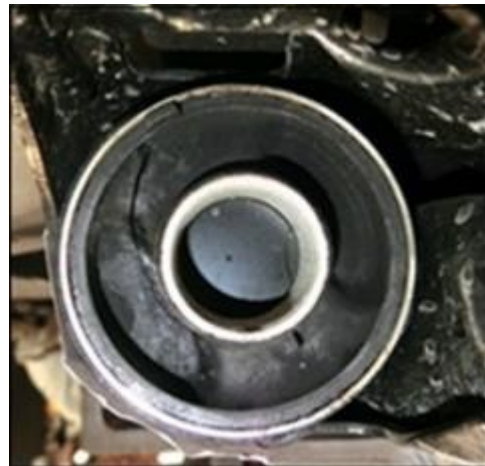
View of Yellow Arrow showing cracked bushing
