Technical Service Bulletin

Subject: INTERMITTENT BATTERY DISCHARGE CAUSED BY C-22/C-23 CONNECTOR CORROSION FROM WATER	Bulletin No.: 09-014/26
	Last Issued : 04/29/2026

2023-2026 CX-50 (All)

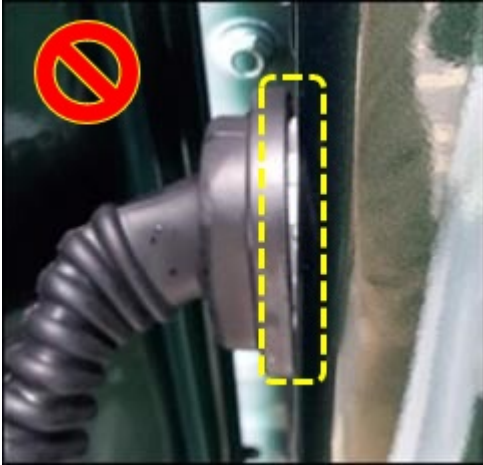
Some vehicles may experience intermittent battery discharge. This may be caused by improperly installed door boots allowing water to enter into the central connectors C-22/C-23 (located near the A-pillar at the base of the left and right front doors), leading to corrosion in the connector.

The boots are lifted off (improperly installed)
Figure 1

3. Replace the rear harness and the affected door harness with new ones, making sure to properly install the door boots. Then go to next step.
4. Verify the repair, then charge the battery and return the vehicle to the customer.

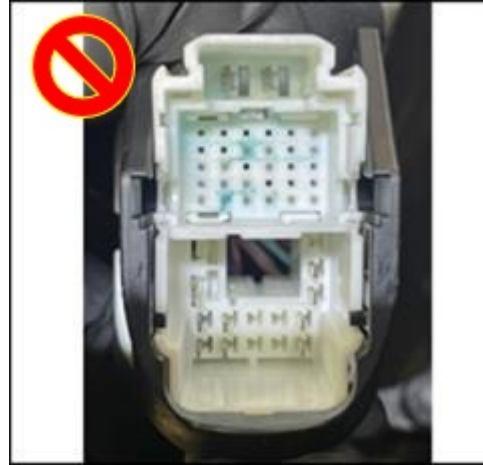
Figure 2

I. Are the door boots installed properly? NOTE: Refer to Figure 1 (improperly installed door boot).	YES: This TSB does not apply. Look for other issues causing battery discharge.
	NO: Go to next step (II).
II. Is there any corrosion or moisture on connector C-22 or C-23? NOTE: Refer to Figure 2.	YES: Go to Step 3.
	NO: Go to next step (III).
III. Is the parasitic draw (dark current) within 60 mA? Refer to Back-up Current Inspection in BATTERY INSPECTION.	YES: Go to Step 4.
	NO: Look for other issues causing excessive parasitic draw.
