Subject: <p style="text-align: center; font-weight: bold;">REAR BUMPER DISTORTED</p>	<p style="font-weight: bold;">Service Alert No.: SA-008/26</p> <hr/> <p style="font-weight: bold;">Last Issued : 04/20/2026</p>
--	---

2023-2026 CX-50 (All)

DESCRIPTION

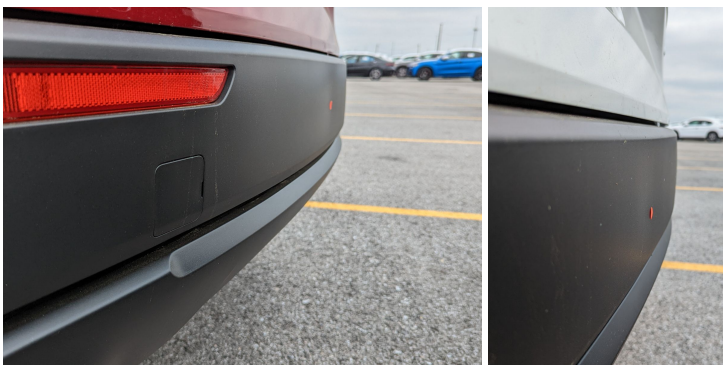
During PDI, an indentation in the rear bumper may be noticed, or in some cases, the customer may return after delivery to report the indentation. Follow the steps below to repair the concern.

1. Check the rear bumper for an indentation.

Is the indentation in the same location (red dot) on the bumper as in the examples shown below?

- **YES** - Continue to the next step.
- **NO** - This Service Alert does not apply; please contact the Mazda Technical Hotline for assistance.
