<b>Subject:</b> "TCU MALFUNCTION. HAVE THE VEHICLE INSPECTED." MESSAGE AND DTC B1252:87 OR U0198:00 STORED	Service Alert No.: SA-012/26
	Last Issued : 04/17/2026

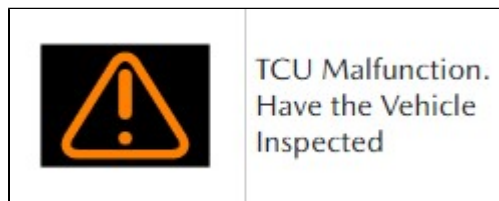
Some customers may experience a message "TCU Malfunction. Have the Vehicle Inspected" in the instrument cluster.

- B1252:87-8B:TCU - COMMUNICATION ERROR WITH CONNECTIVITY MASTER UNIT (CMU)
- U0198:00-03:CMU - COMMUNICATION ERROR WITH EMERGENCY CALL UNIT/TELEMATICS COMMUNICATION UNIT

1. Verify the concern.
2. Check if any of the following DTCs are stored:
  - B1252:87-8B:TCU - COMMUNICATION ERROR WITH CONNECTIVITY MASTER UNIT (CMU)
  - U0198:00-03:CMU - COMMUNICATION ERROR WITH EMERGENCY CALL UNIT/TELEMATICS COMMUNICATION UNIT

3. Check for electrical devices in the vehicle such as a device connected to USB hub, Dash Cam, Insurance Device, FasTrak.....ect.

4. Clear the DTC's

- Inform the customer that Mazda is aware of the condition and is working on a resolution.
- Vehicle driving operation is not affected during these conditions.
- NO repairs or component replacements should be attempted at this time.
- Vehicle may be released to the customer.
