Subject: INFOTAINMENT CENTER DISPLAY AND CONNECTED VEHICLE IMPROPER OPERATION	Service Alert No.: SA-015/26
	Last Issued : 04/09/2026

2026 CX-5 (KM)

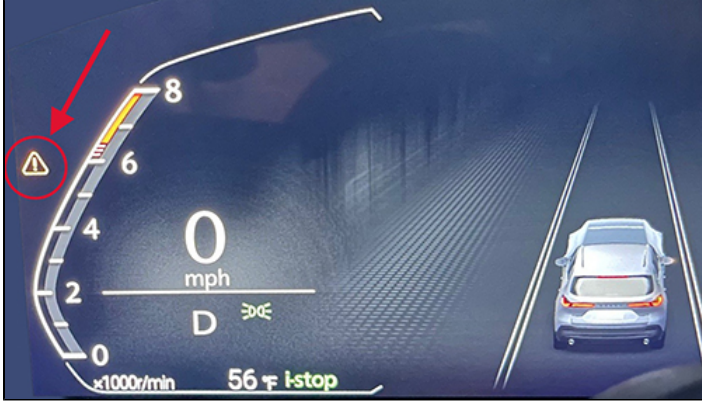
3. Instrument Cluster Master Warning Light may be illuminated

- Emergency Call Unit Malfunction Notification
 - Center Display Home screen --> All Apps --> Maintenance --> Notifications
- This condition is related to Item 1 above. Advise the customer that Mazda is aware of the condition and is currently working on a resolution. As soon as a resolution becomes available, this Service Alert will be promptly updated and re-released.

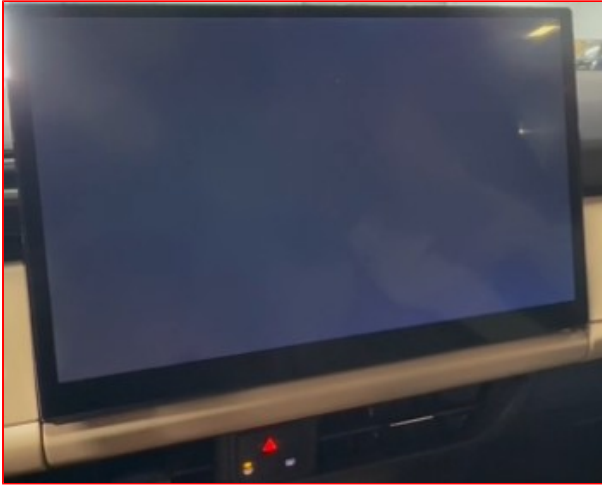
4. The center display screen is blank

- This condition is related to Item 1 above. Advise the customer that Mazda is aware of the condition and is currently working on a resolution. As soon as a resolution becomes available, this Service Alert will be promptly updated and re-released.

NOTE: The rear view camera display while in “Reverse” remains operational during this condition.

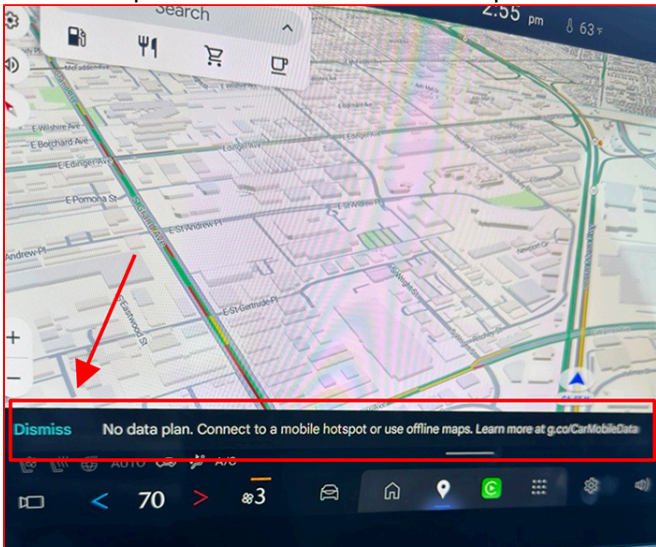
5. No data plan. Connect to a mobile hotspot or use offline maps. learn more at g.co/CarMobileData message

- This message is incorrect.
- It does not affect system operation.
- Dismissing the message may temporarily clear it.
- Please ignore this message at this time.
- This condition is related to Item 1 above. Advise the customer that Mazda is aware of the condition and is currently working on a resolution. As soon as a resolution becomes available, this Service Alert will be promptly updated and re-released.

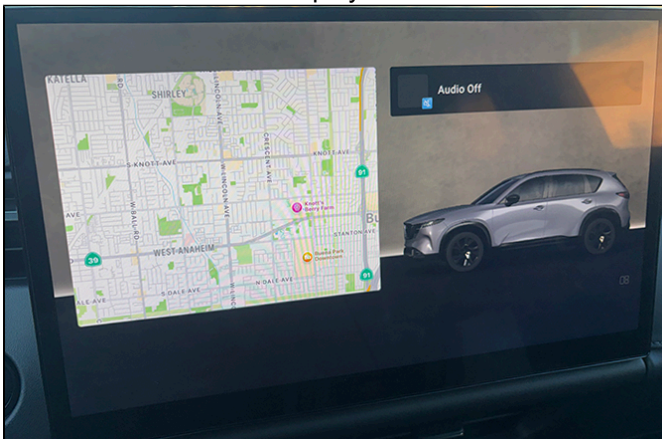
7. Infotainment Center Display Home Screen Partial Boot Up

- Top icons are not displayed.
- Bottom climate controls are not displayed.
- Google Voice is inoperative.
- Advise the customer that Mazda is aware of the condition and is currently working on a resolution. As soon as a resolution becomes available, this Service Alert will be promptly updated and re-released.

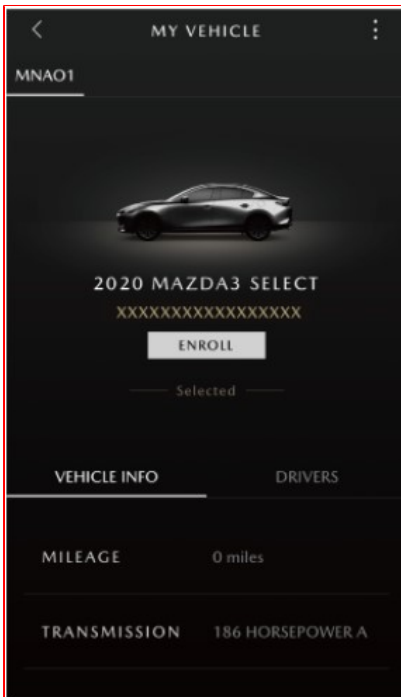
8. No Connected Vehicle One-Time Passcode (OTP)

- The MyMazda App OTP request is sent; however, the vehicle's center display does not display the OTP.
- This condition is related to Item 1 above. Advise the customer that Mazda is aware of this condition and is currently working on a resolution. Once a resolution becomes available, this Service Alert will be promptly updated and re-released.
