<b>Subject:</b> INFOTAINMENT CENTER DISPLAY AND CONNECTED VEHICLE IMPROPER OPERATION	Service Alert No.: SA-015/26
	Last Issued : 04/20/2026

2026 CX-5

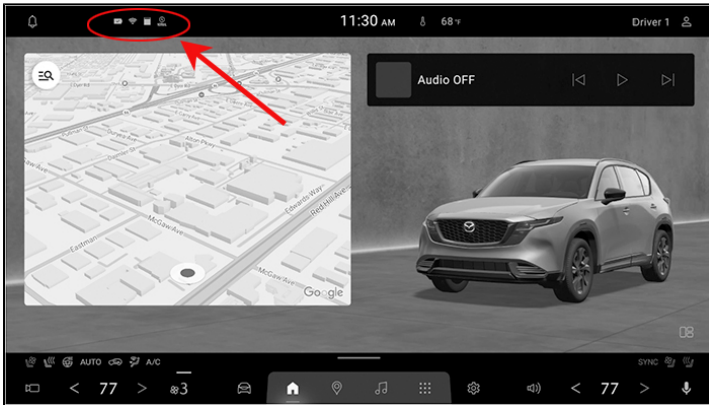
1. Intermittent Globe with a slash icon.

- The Globe with Slash icon indicates that communication between the Cockpit Domain Controller (CDC) and the Data Communication Module (DCM) has not yet been completed.
  - This communication may take up to 90 seconds to complete. During this time, some Mazda Connect 3 functions, such as Google Assistant, will not be available.
  - Once communication is complete, the Globe with Slash icon will be replaced by the reception icon, as shown below.

- If communication between the CDC and DCM does not complete within 90 seconds, the system has experienced an interruption. Advise the customer that Mazda is aware of the condition and is currently working on a resolution. As soon as a resolution becomes available, this Service Alert will be promptly updated and re-released.

**Recovery - Turn off the vehicle and allow it to fully power down to sleep mode**

- Turn off, exit, and lock the vehicle, let it sit for 5+ mins

If the Recovery procedure above does not resolve the issue, perform the following:

- Disconnect the 12V battery negative cable.
- Wait 10+ minutes.
- Reconnect the 12V battery and retest.

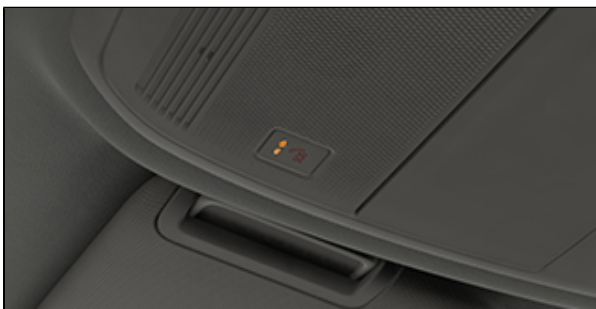
## 2. Beep sound near the SOS button and SOS button amber or red LED.

- This condition is related to Item 1 above. Advise the customer that Mazda is aware of the condition and is currently working on a resolution. As soon as a resolution becomes available, this Service Alert will be promptly updated and re-released.

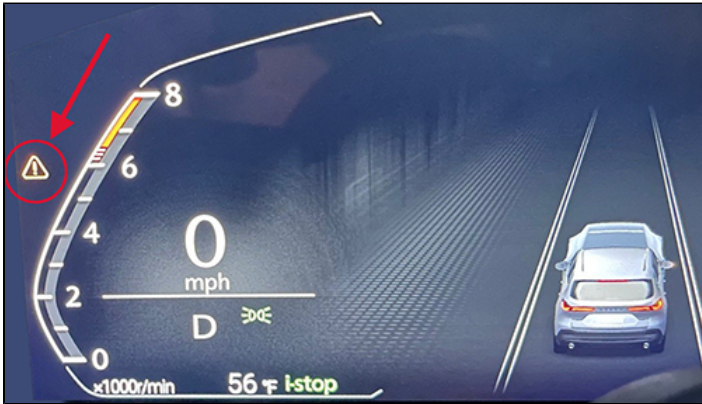
## 3. Instrument Cluster Master Warning Light may be illuminated.

- Emergency Call Unit Malfunction Notification.
  - Center Display Home screen --> All Apps --> Maintenance --> Notifications
- This condition is related to Item 1 above. Advise the customer that Mazda is aware of the condition and is currently working on a resolution. As soon as a resolution becomes available, this Service Alert will be promptly updated and re-released.

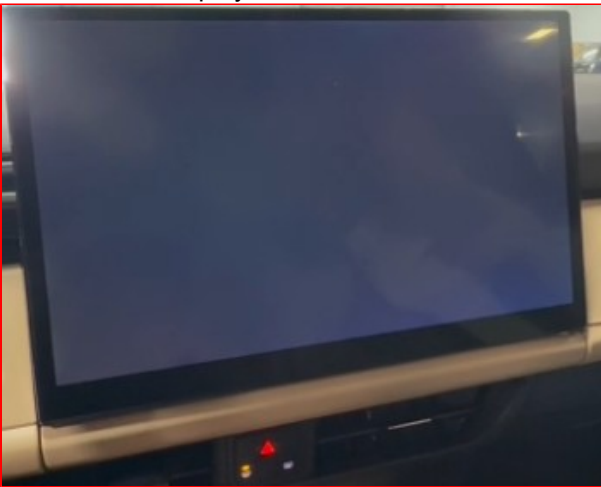
## 4. The center display screen is blank.

- This condition is related to Item 1 above. Advise the customer that Mazda is aware of the condition and is currently working on a resolution. As soon as a resolution becomes available, this Service Alert will be promptly updated and re-released.

**NOTE:** The rear view camera display while in "Reverse" remains operational during this condition.

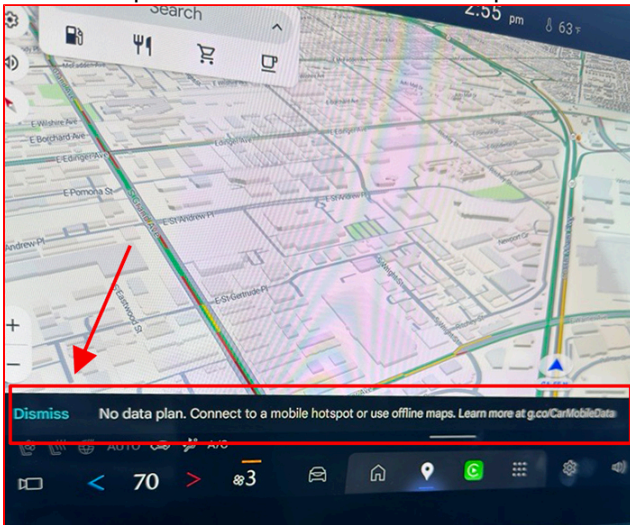
5. No data plan. Connect to a mobile hotspot or use offline maps. Learn more at [g.co/CarMobileData](https://g.co/CarMobileData) message.

- This message is incorrect.
- It does not affect system operation.
- Dismissing the message may temporarily clear it.
- Please ignore this message at this time.
- This condition is related to Item 1 above. Advise the customer that Mazda is aware of the condition and is currently working on a resolution. As soon as a resolution becomes available, this Service Alert will be promptly updated and re-released.

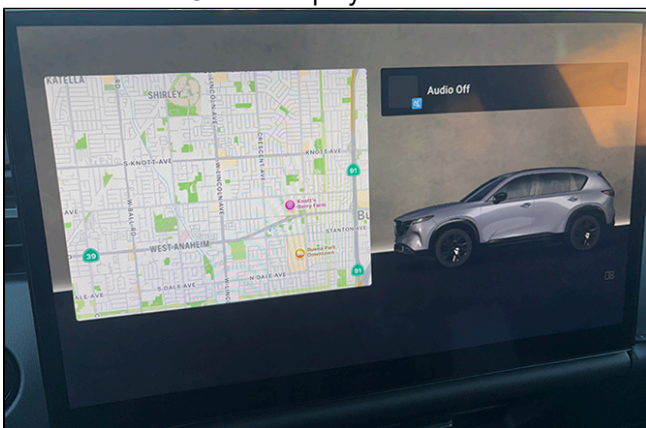
7. Infotainment Center Display Home Screen Partial Boot Up.

- Top icons are not displayed.
- Bottom climate controls are not displayed.
- Google Voice is inoperative.
- Advise the customer that Mazda is aware of the condition and is currently working on a resolution. As soon as a resolution becomes available, this Service Alert will be promptly updated and re-released.

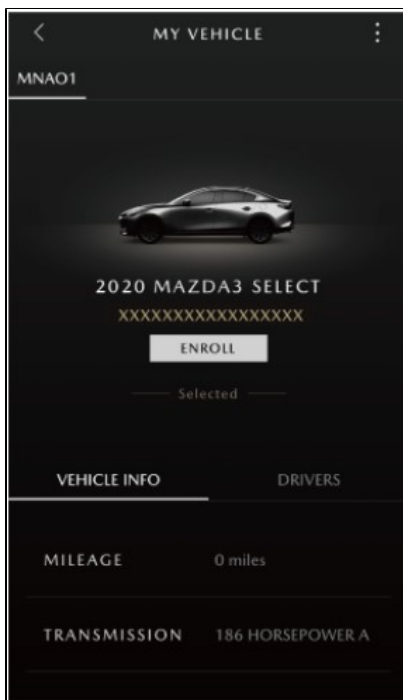
#### 8. No Connected Vehicle One-Time Passcode (OTP).

- The MyMazda App OTP request is sent; however, the vehicle's center display does not display the OTP.
- This condition is related to Item 1 above. Advise the customer that Mazda is aware of this condition and is currently working on a resolution. Once a resolution becomes available, this Service Alert will be promptly updated and re-released.

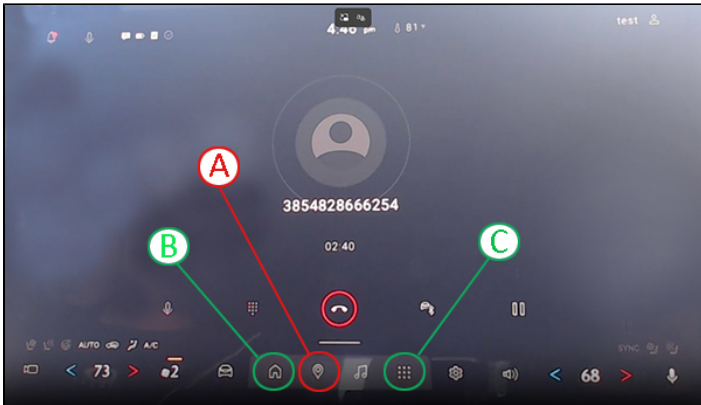
#### 9. During a Bluetooth® phone call, tapping the navigation icon (A) does not launch Google Maps.

- This is normal system operation.
  - Google Maps is available during a Bluetooth® phone call:
    - Tap the [HOME] button (B) on the navigation bar, then tap the [Map Widget].
    - Tap the [All Apps] button (C) on the navigation bar, then select [Google Maps].

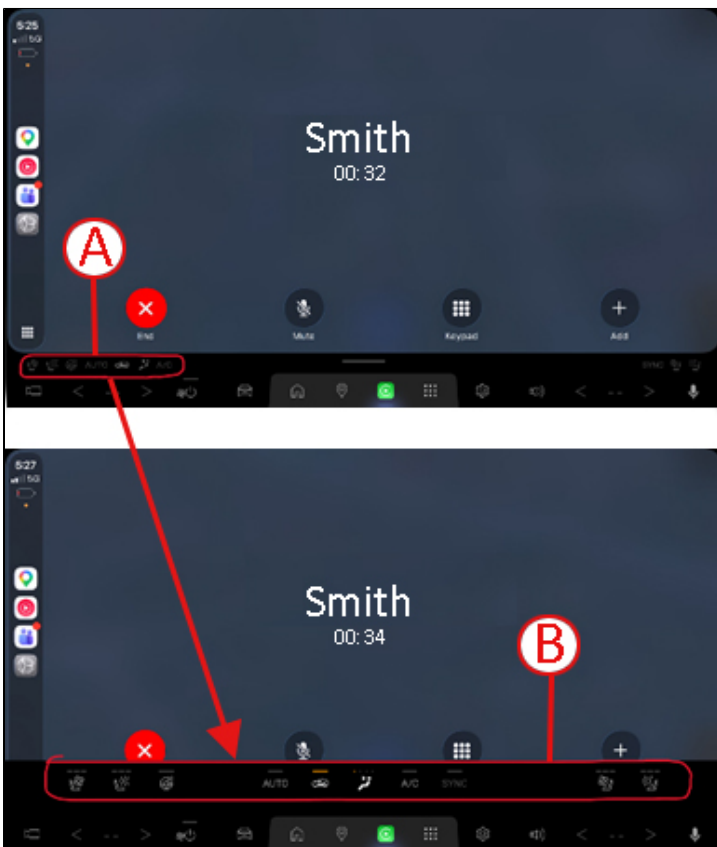
10. During an Apple CarPlay phone call, the Climate Control full screen menu cannot be accessed. This is normal system operation.

- The Climate Control is available during a Apple Carplay phone call by selecting the area above the menu bar (A), then the Climate Control quick menu (B) will be displayed.

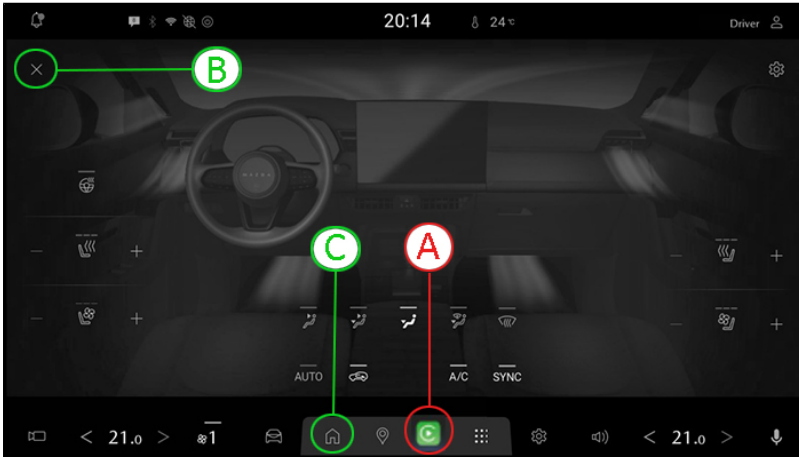
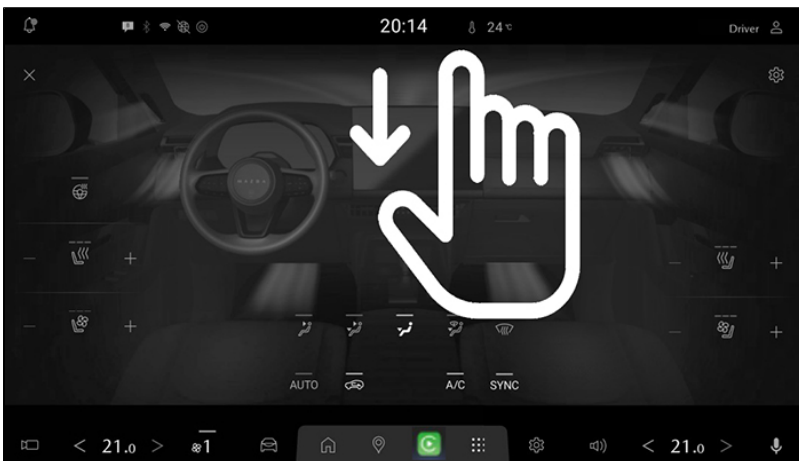
11. While the Climate Control screen is displayed in full screen, tapping the Apple CarPlay icon (A) does not launch Apple CarPlay.

- Because the screen priority is set to “Climate Control screen,” it is not possible to switch directly to the CarPlay screen from the navigation bar.
- Use one of the following methods to return to the CarPlay screen:
  - Tap the “x” button (B) in the upper-left corner of the screen.
  - Tap the HOME button (C) on the navigation bar, then tap the CarPlay button on the navigation bar.

- Swipe downward on the screen.
