<b>Subject:</b>  <b>CLICKING OR KNOCKING NOISE FROM EITHER FRONT DRIVE SHAFT OUTER CV JOINT WHEN TURNING AND ACCELERATING</b>	<b>Service Alert No.: SA-028/26</b>
	<b>Last Issued : 04/16/2026</b>

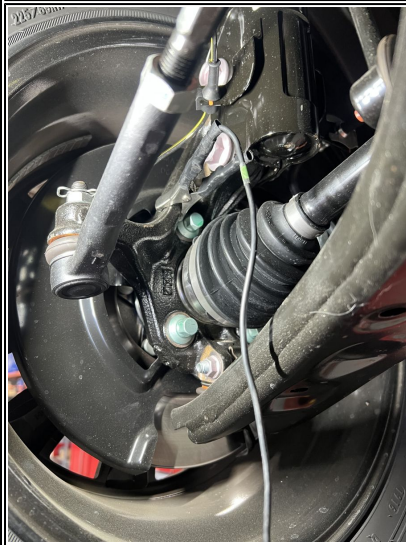
Sensor on the knuckle.

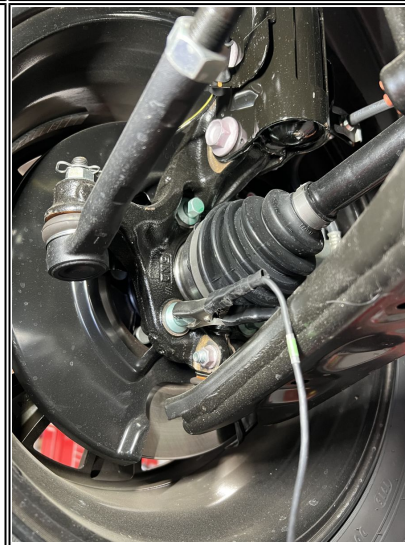
Sensor on wheel bearing bolt.
