SERVICE PROGRAM BULLETIN

APPLICABILITY: 2025 Solterra **NUMBER:** WRF-25R
SUBJECT: Solterra Power Distribution Box Replacement **DATE:** 05/01/25
Revised: 04/02/26

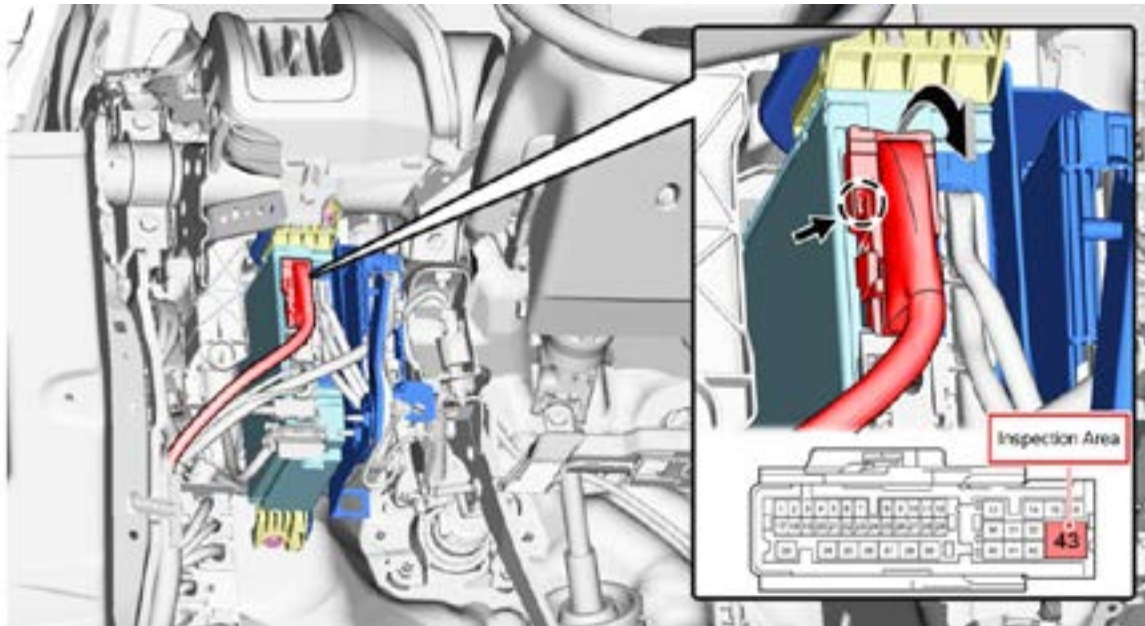
Step 3: Inspect connector No. K123, terminal 43, for any signs of damage. Minor rounding of the corner is acceptable - refer to the image below for examples.

OK	<p>No Melt Damage (minor rounding of corners is acceptable)</p>  	<p>Continue with replacing the power distribution box assembly with a new one.</p>
NG	<p>Melt Damage Present (With visible burn marks)</p>  	<p>Contact Techline via TechShare. Refer to the TechTIP Special Edition: <i>Techline Case Submission Now Through TechShare</i> for additional instructions. Select the case type as Electrical and complete the WRF-25 worksheet, ensure to attach a picture of the damaged terminal.</p>

If no damage is found, continue to Step 4. If terminal 43 is damaged, contact Techline via TechShare. Refer to the TechTIP Special Edition: *Techline Case Submission Now Through TechShare* for additional instructions. Select the case type as **Body Electrical** and complete the **WRF-25** worksheet, ensure to attach clear pictures that clearly show the condition of the connector, terminal, and wiring harness.
