SERVICE PROGRAM BULLETIN

APPLICABILITY: 2023-2024MY Legacy & Outback **NUMBER:** WRB-26
SUBJECT: Incorrect FOTA Distribution for Data Communication Modules **DATE:** 02/11/26
REVISED: 04/09/26

The subject vehicles were incorrectly linked with their corresponding software versions during a FOTA distribution, which may have caused telematics service functions to become unavailable.

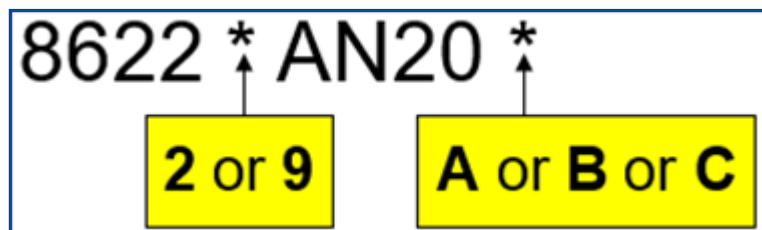
Fifth Digit: 2 indicates the DCM was installed by the factory. 9 indicates the DCM is a replacement part.

Tenth Digit: A,B, and C indicates the DCM version.

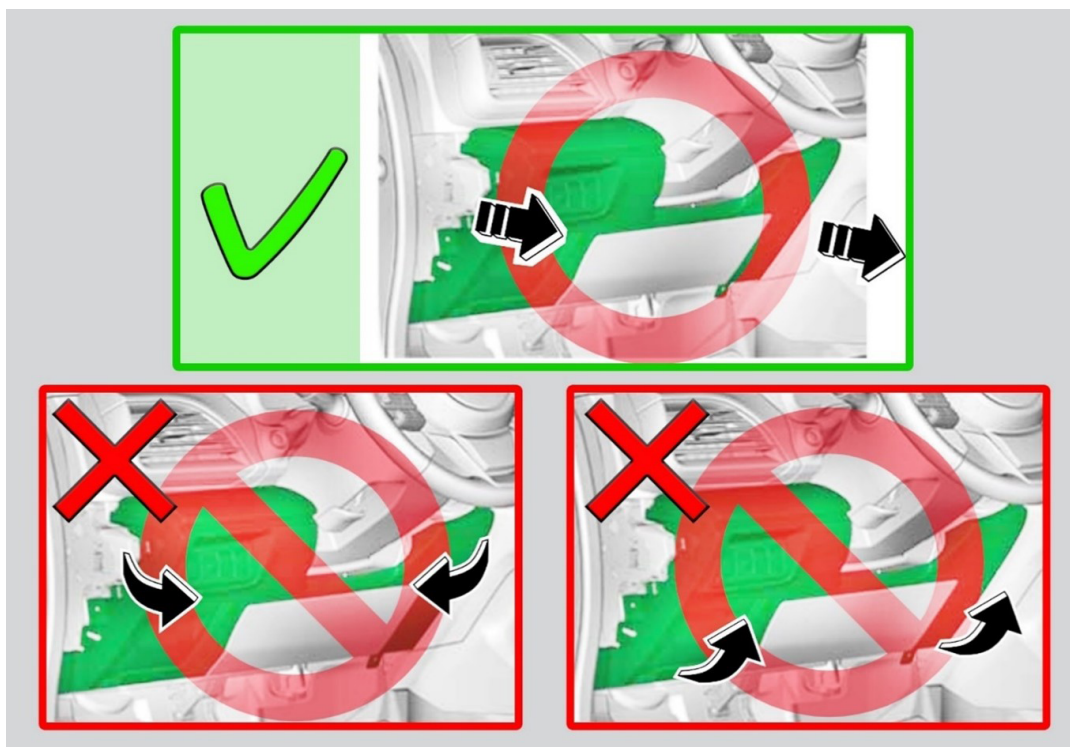
CAUTION: When removing the lower driver cover, **ALWAYS** pull the cover in a straight direction. Pulling in a lateral or upward direction may cause damage to the lower driver cover.

CAREFULLY disconnect all electrical connections. Remove the lower driver cover.

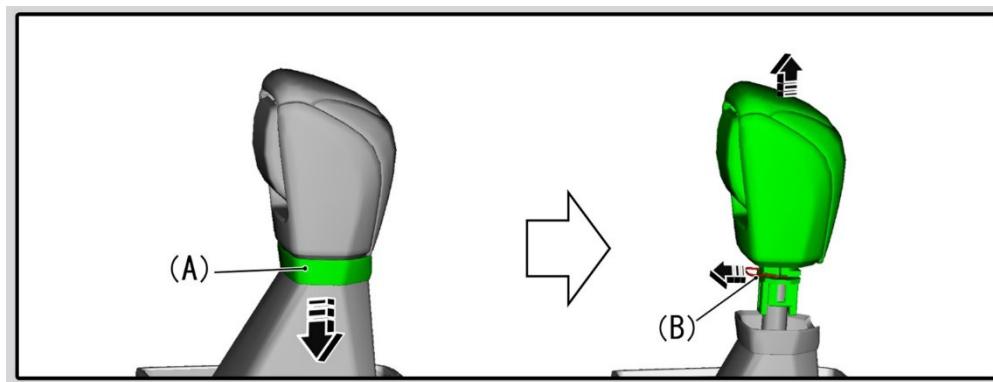
CAUTION: Be careful not to lose the clip.

STEP 9: Detach clamp (A) from the shift knob. Release clip (B) from the shift knob and remove the knob from the lever. ALWAYS maintain proper shift rod alignment when reinstalling (detailed information can be found in the September 2021 TechTIPS article).

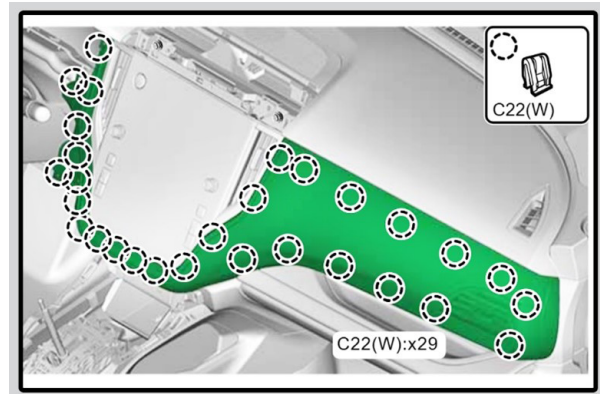
NOTE: Vehicles equipped with push button start will require the push button ignition switch to be disconnected prior to removal.

STEP 11: Release the mid passenger ornament panel mounting clips and remove the panel.

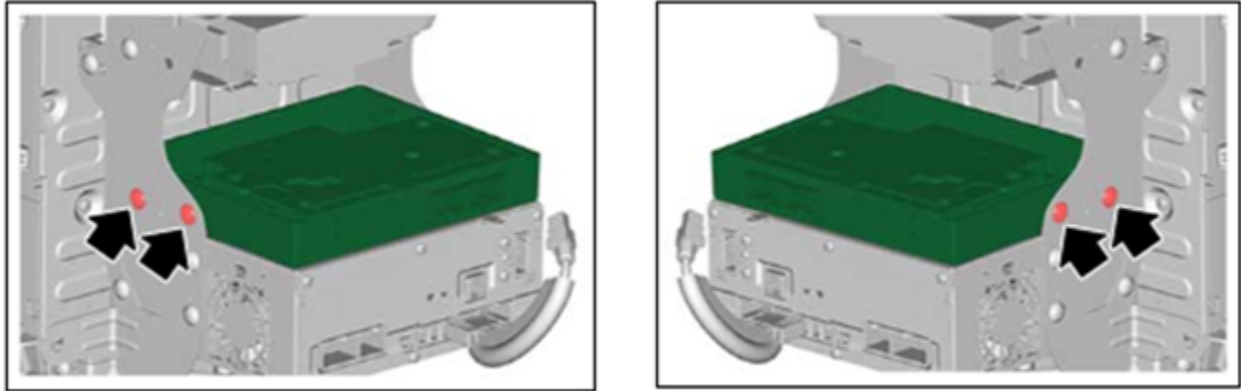
CAUTION: DO NOT apply any impact to the CID assembly or DCM during this process.

STEP 14: Remove the four DCM mounting screws located on the left and right side. The DCM can then be removed.

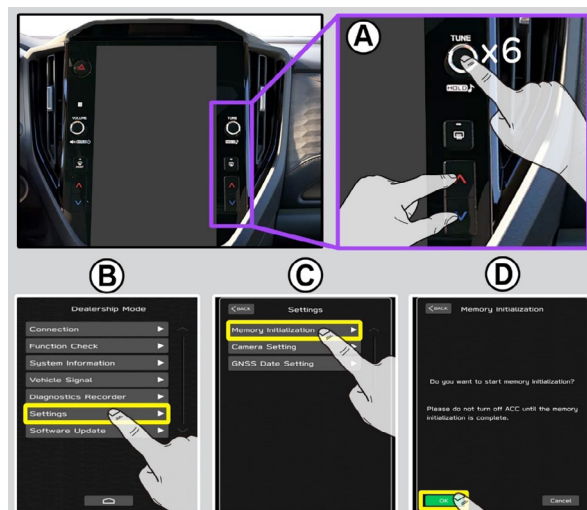
NOTE: Initializing the memory will reset the internal memory to its default state and erase all custom settings. Please record any necessary settings beforehand.

STEP 17: To restore CID assembly to its normal operating state, please perform a memory initialization by following the steps below.

- With the ignition on or the engine running, **Press and Hold** both the upper and lower temperature control buttons on the **Right** side, and simultaneously press the tuning/scroll knob **Six Times**. Then release all buttons to display the dealer mode menu.
- Select “**Settings**”.
- Select “**Memory Initialization**”.
- Select “**OK**” to complete the memory initialization.
