## SERVICE BULLETIN

**APPLICABILITY:** 2025-26MY Forester

**NUMBER:** 12-278-26

**SUBJECT:** Loose Fitting Roof Dome Lamp

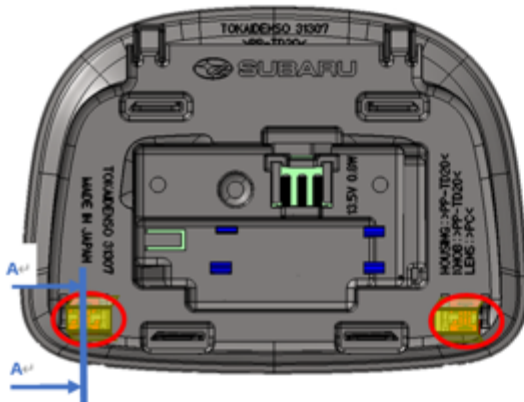
Top View

This bulletin announces the repair procures to be followed when encountering cases of loose fitment of the interior dome lamp. A customer may report cases of the interior dome lamp having movement when operating the light switch. If this situation is reported by a customer, follow the service procedures outline in this bulletin.

**STEP 3:** Apply the non-woven tape to the dome lamp clips. Confirm the tape covers the clips.
