Preview Solution CBR-983-7

Volvo Chassis - Model VHD - Splash Shield Rubbing Lower Cowl - Model Year 2018 - Current

Valid for
Volvo VHD Model Year 2018 to Current

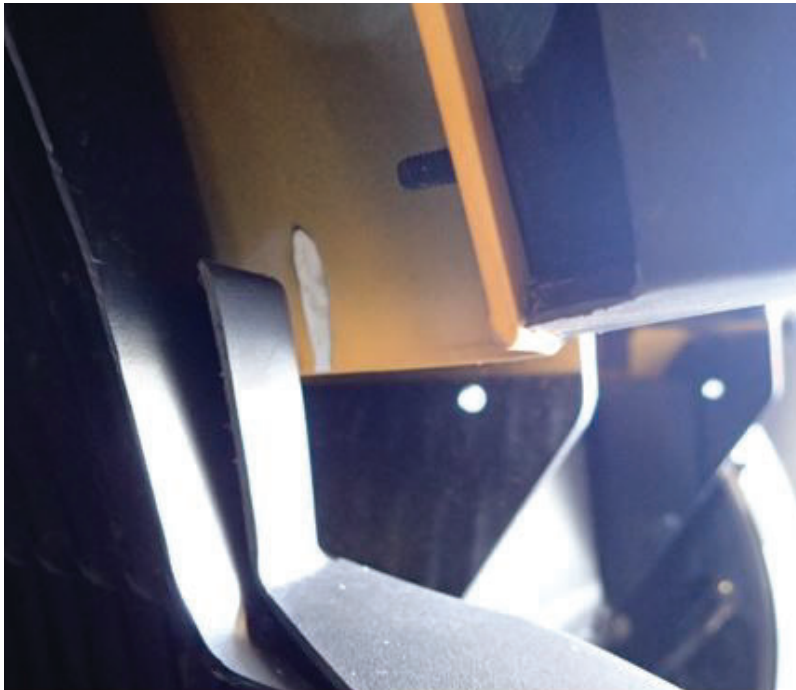
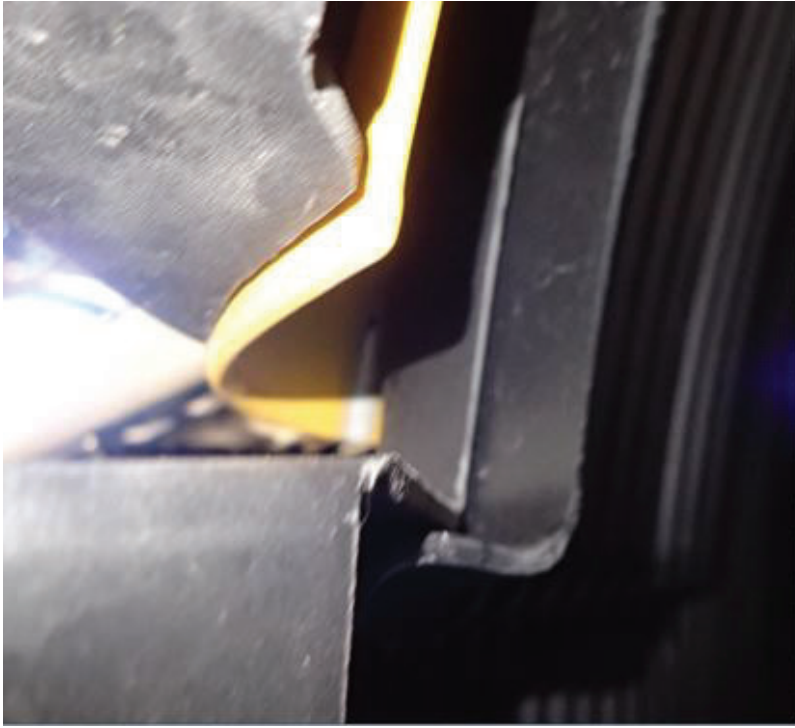
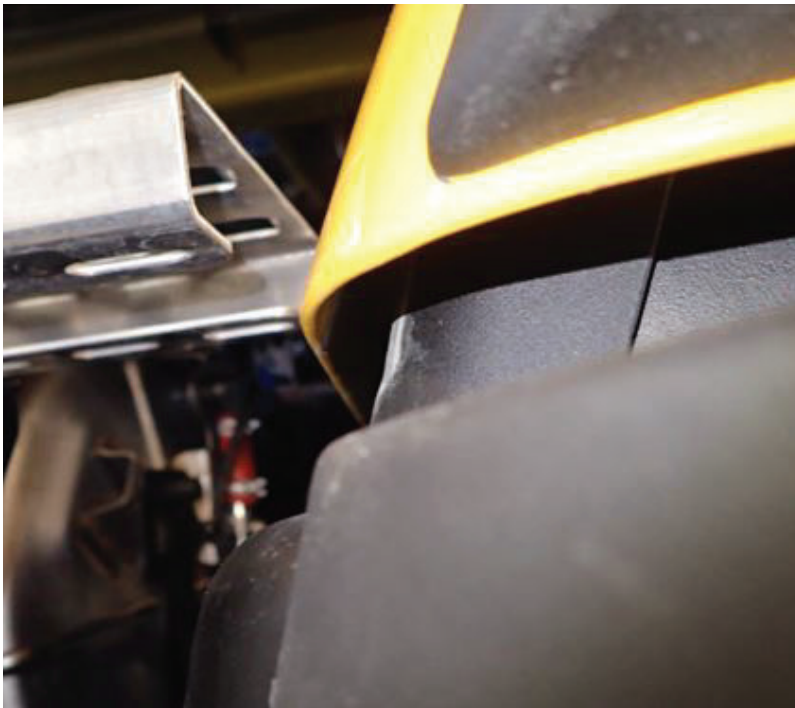
If the splash shields are rubbing the lower part of the cowl as seen here:

To gain the correct air gap (22mm) the splash shield will have to be loosened and retightened in the correct sequence. See images below.
