Subject: MULTIPLE ELECTRICAL MALFUNCTIONS AFTER BODY REPAIR	Service Alert No.: SA-021/26
	Last Issued : 04/03/2026

2013-2025 CX-5	2014-2021 Mazda6	2016-2026 Mazda2 (Puerto Rico/Mexico spec)
2014-2018 Mazda3	2016-2022 CX-3	2023-2026 CX-50

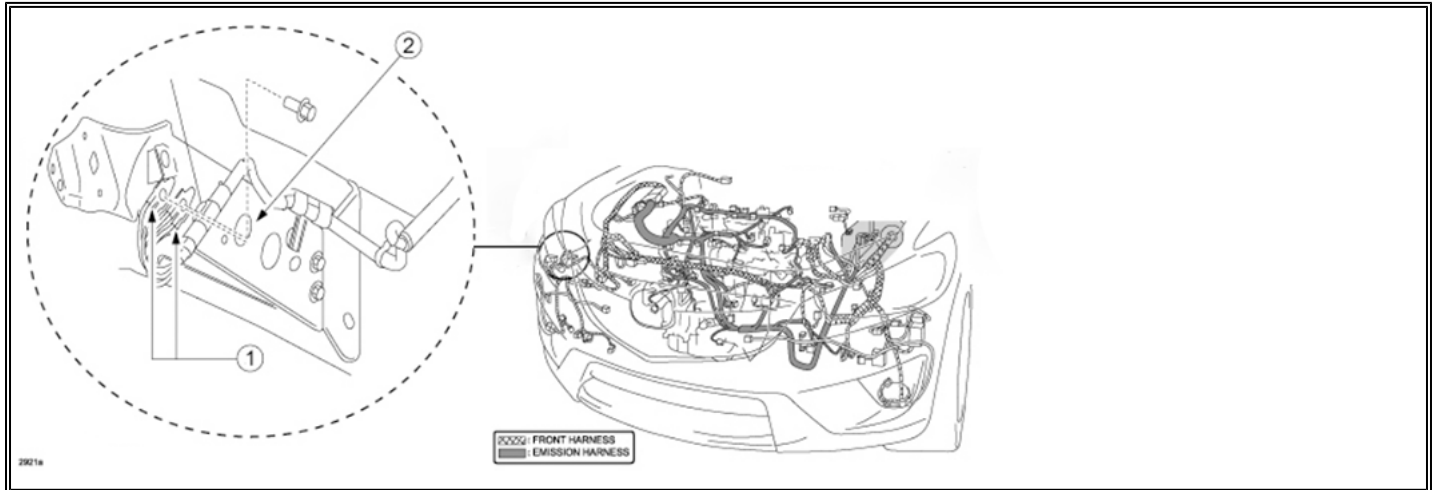
CX-5 shown

Some customers may experience one or more electrical malfunctions after a vehicle body repair. A newly painted fender stay (2) may be causing a poor front harness (1) ground connection.

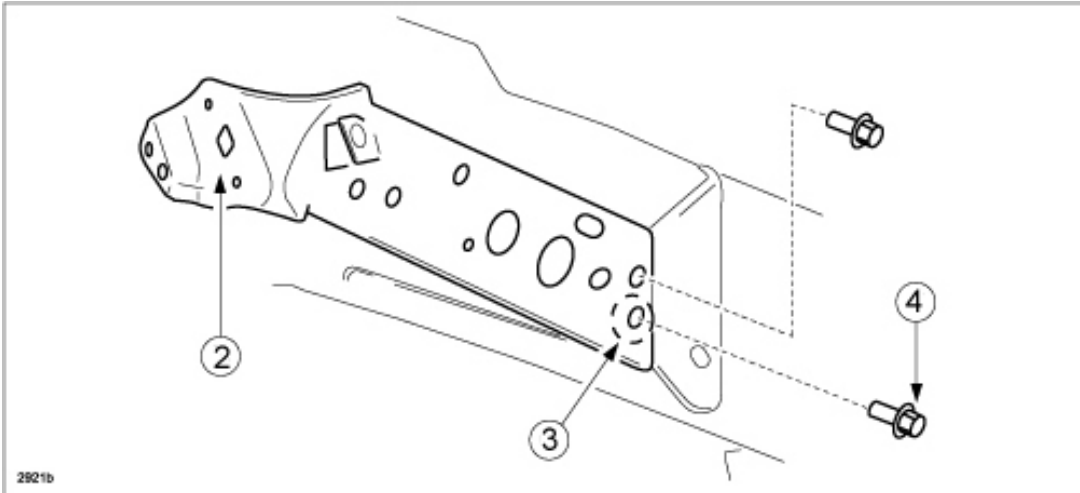
CX-5 shown

The front fender stay (2) newly painted surface at ground point (3), where attachment bolt (4) is seated, may create a poor front harness ground connection.

NOTE: DO NOT paint ground point (3) attachment bolt (4) is seated.

Customer concern can be resolved by sanding off paint at ground point (3) where attachment bolt (4) is seated. After installing the bolt (4), apply touch-up paint to the exposed base material area of the front fender stay.

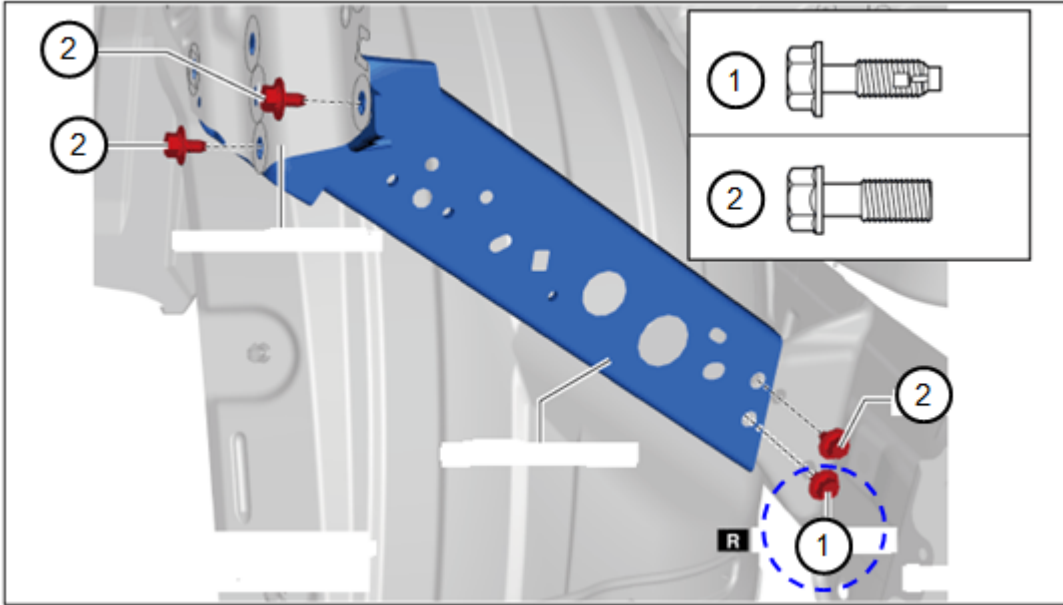
Ground bolt (1)

Mounting bolt (2)

- After installing the bolt (4), apply touch-up paint to the exposed base material area of the front fender stay.
- Always replace the ground bolt (1) if the Workshop Manual or Bodyshop Manual instructs to use the ground bolt for proper grounding.
