Condition

Model(s)	Year(s)	VIN Range	Vehicle Specific Equipment
A8	2019 – 2021	All	V8 TFSI
S8	2020 – 2025

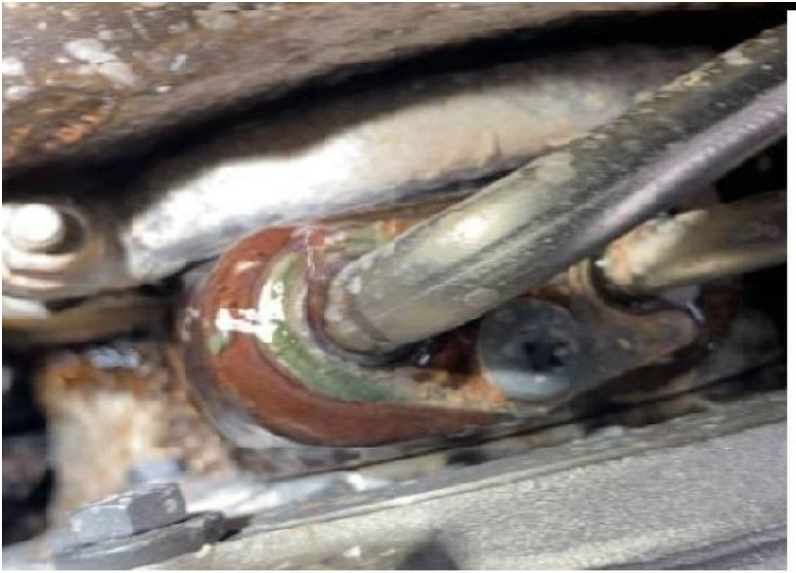
A coolant leak is identified at the return lines to the turbocharger (Figure 1).

Figure 1. Coolant leak at the return lines to the turbocharger.

In some model years, After-Run Coolant Pump (V51) start with a slight delay. This can lead to unintended additional heat at O-rings at the return connected to the turbochargers.

- Replace the O-rings at the coolant return lines at the Turbocharger (refer to Figures 2 and 3 or SSP **920493**).
- **Please remove and install the coolant return line according to workshop manual (ELSA) and replace O-rings on the coolant at the crankcase side (Figure 3).**

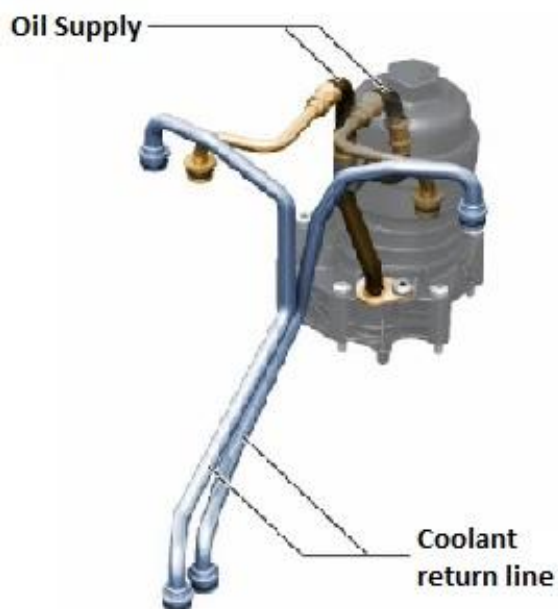
Figure 2: Coolant return lines are marked.

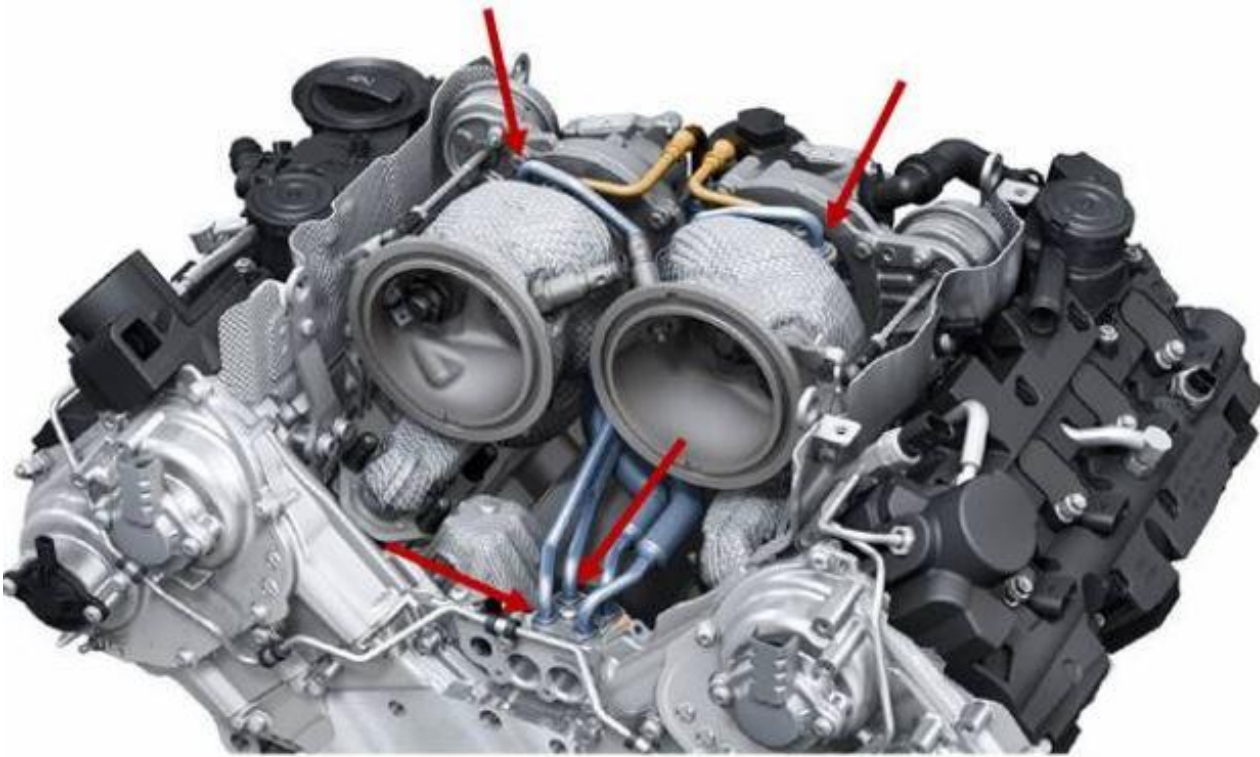
Figure 3: Location of the O-rings.
