Condition

Model(s)	Year(s)	VIN Range	Vehicle Specific Equipment
Q7	2017 – 2026	All	Not applicable
Q8	2019 – 2026		
SQ7, SQ8, and RS Q8	2020 – 2026

Technical Background

On vehicles manufactured within a specific period, wire insulation in the area around the plenum chamber may have been damaged under the wrappings in unfavorable conditions.

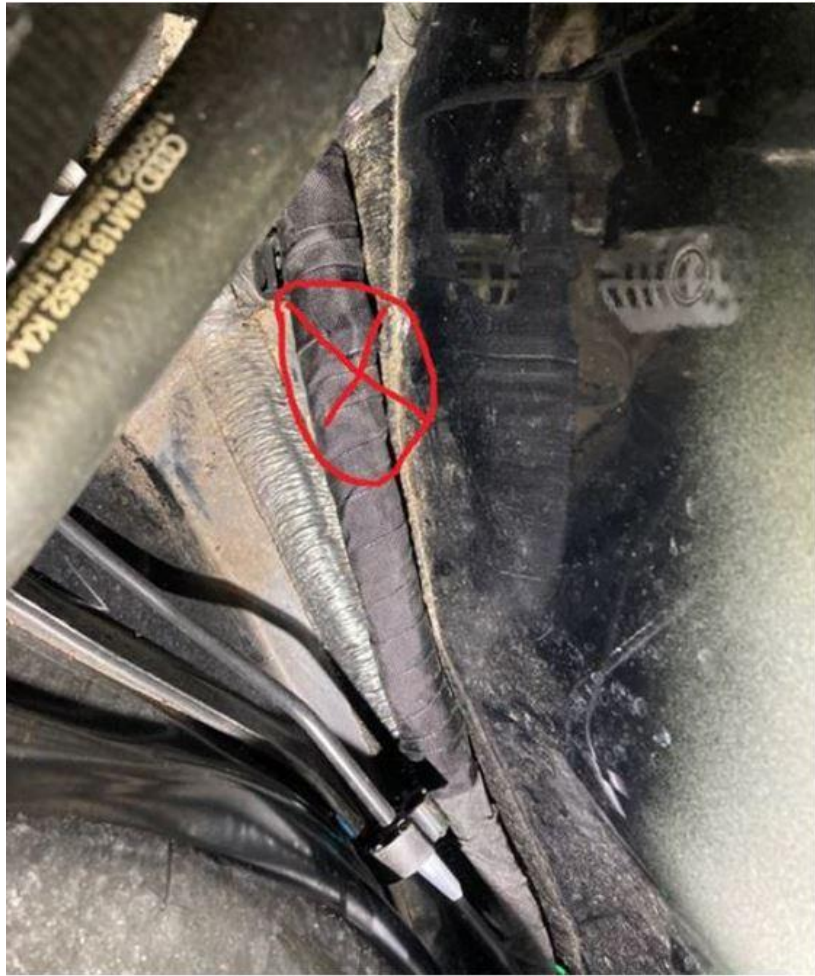
Figure 1. No external damage to the wiring harness can be seen.

3. Repair affected wires using wiring harness repair set **VAS1978 B / C**.

4. Wrap the repaired wiring harness using fabric adhesive tape **N 10592002**.

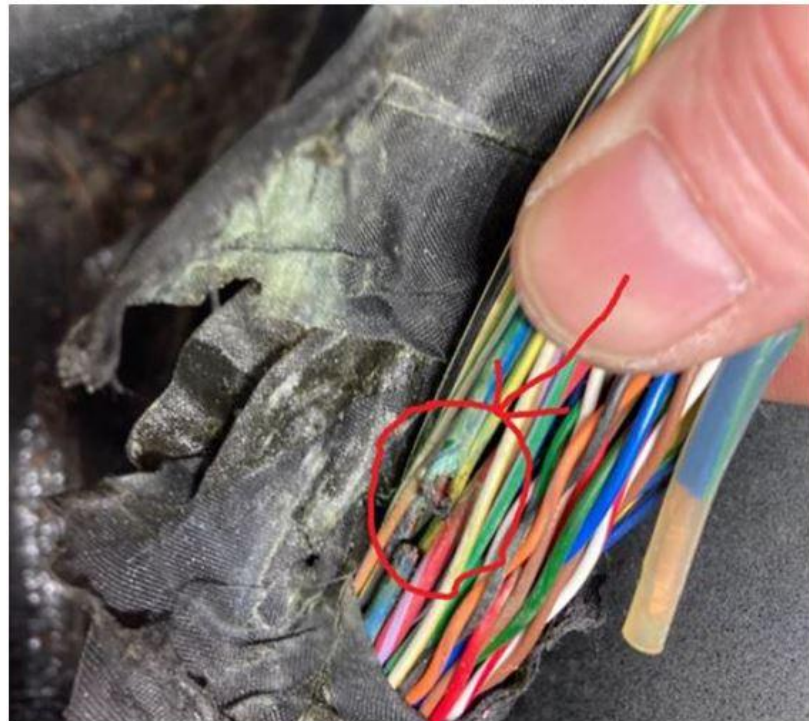
Figure 2. The damaged wire is only visible once the wrapping has been removed.

If the wire strands are not clean and shining, the wire **MUST** be cut back and lengthened as needed.
