Condition

Model(s)	Year(s)	VIN Range	Vehicle Specific Equipment
A8	2019 – 2021	All	4.0 ltr. V8 TFSI
S8, SQ7, and SQ8	2020 – 2025		
RS Q8	2020 – 2023 2025		
RS6 Avant, and RS 7	2021 - 2025

Remove and install valve N649	1984 19xx	See SRT with associated operations
	Remove and install coolant pump (if necessary)	1950 19xx	See SRT with associated operations
	Charge battery	2706 8950	See SRT with associated operations
	GFF	0150 0060	Labor according to the diagnostic log
Claim Comment:	As per TSB 2074303/11

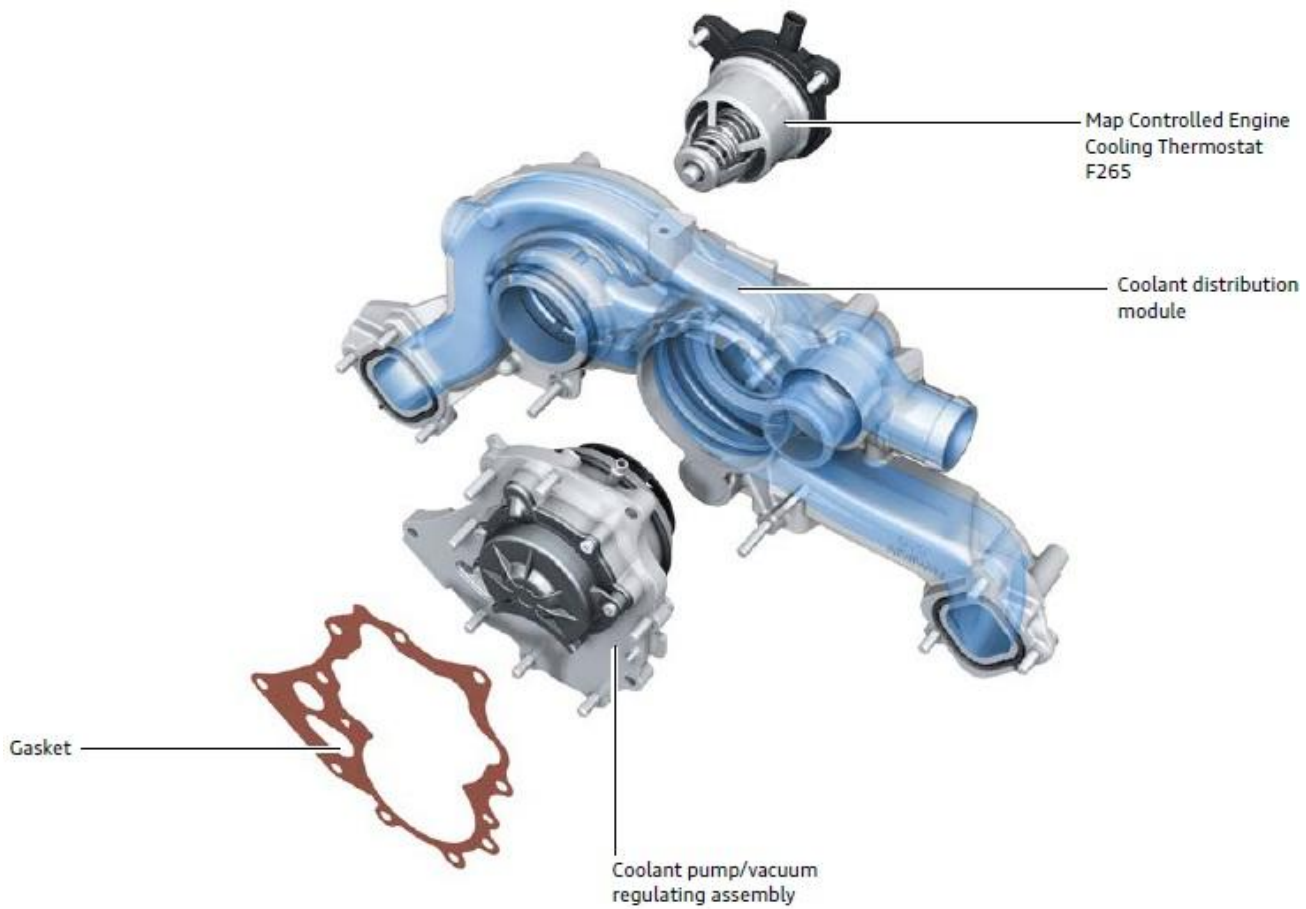
Figure 1. Coolant distribution

A fresh coolant leak around the mechanical coolant pump can take the form of fresh drops on the underside of the coolant distributor or the leakage reservoir (See figures 1 and 2 or attachment "Overview of coolant distributors"). If necessary, perform a pressure test of the cooling system according to ELSA.

If a fresh leak is detected, please note that it is not necessary to replace the coolant distributor. Replacing the mechanical coolant pump as per the Workshop Manual is sufficient in this case.

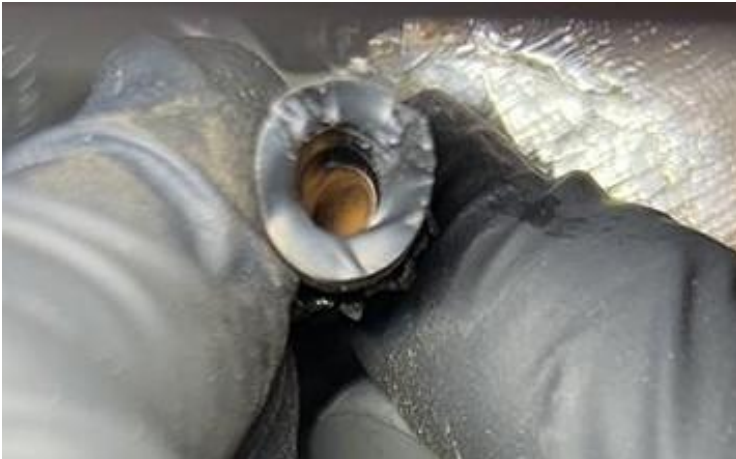
A slight coating (brown/red) on the inside of the vacuum lines is not a clear indication that coolant has entered. Also compare with the following example:

If it cannot be determined that coolant has entered, it is important to always perform a function check on the switch valve for mechanical coolant pump N649 using ODIS.

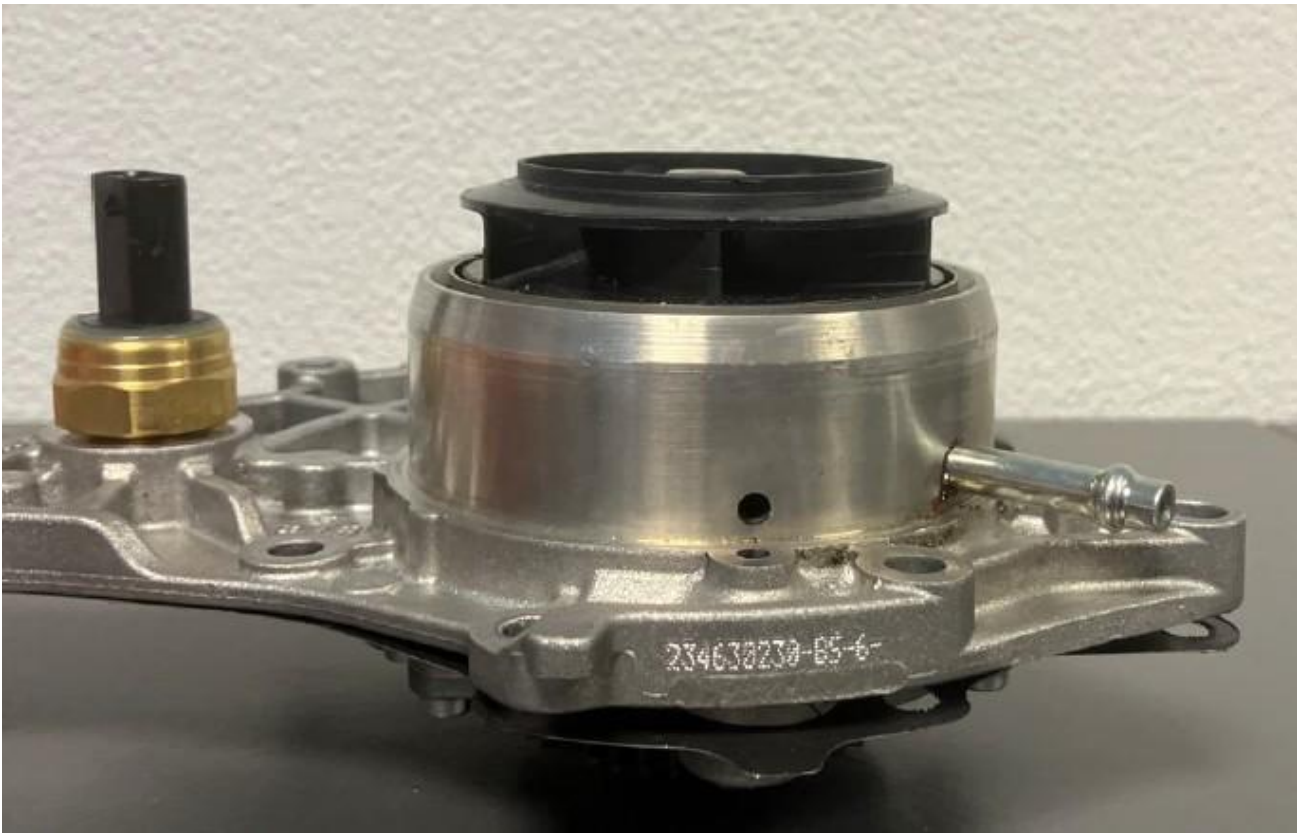
- If there is no vacuum applied to the vacuum connection of the mechanical coolant pump, the modulating piston (orifice panel) must be fully retracted into the pump housing.

Figure 3. *Modulating piston moved back correctly (starting position, not actuated)*

If the end positions are not reached correctly, replace the mechanical coolant pump.

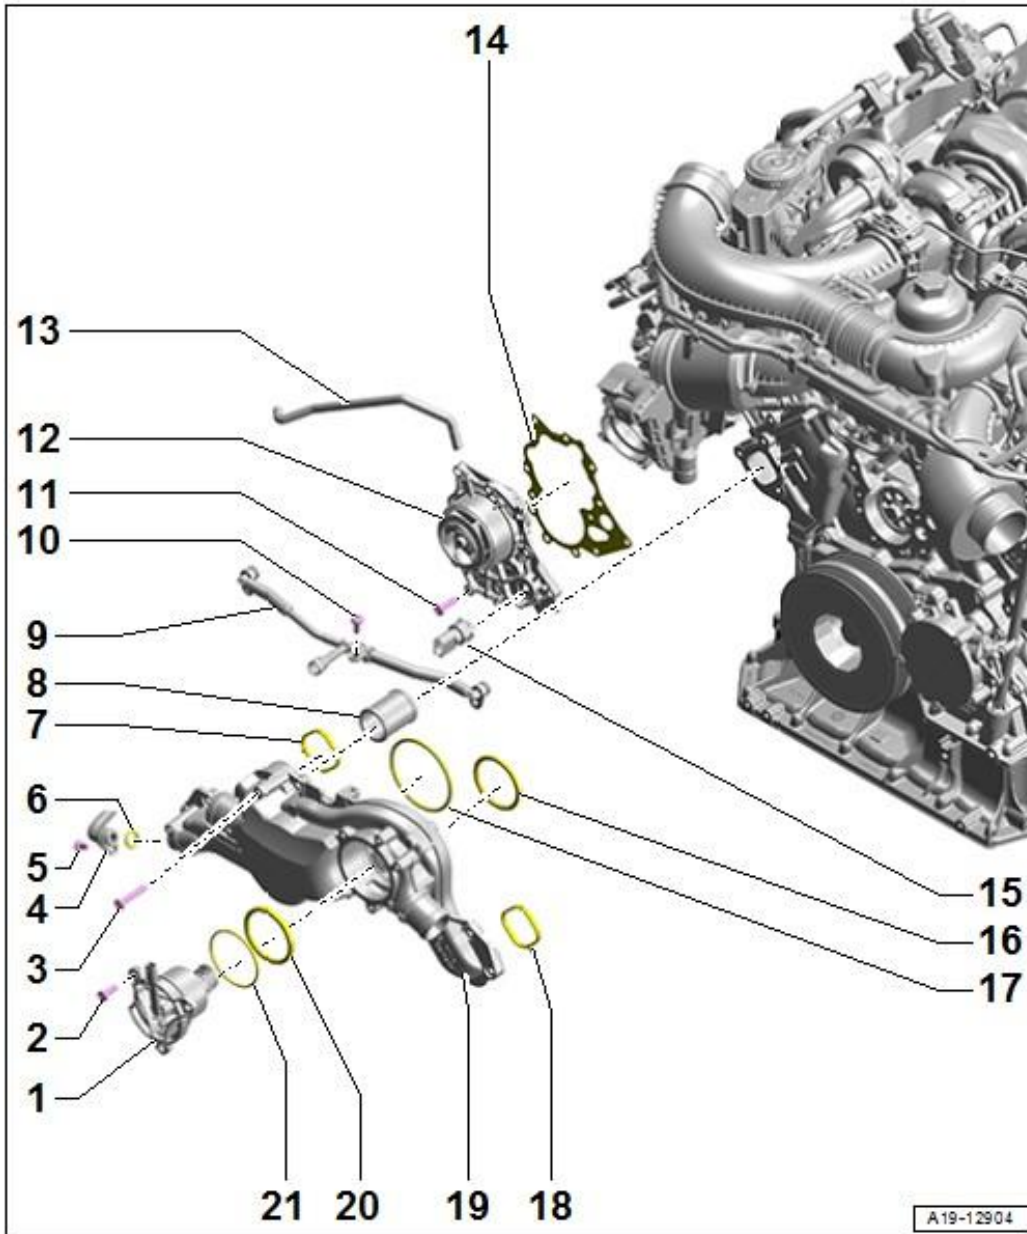
Figure 5. Assembly overview – coolant pump/thermostat incl. switchable mechanical coolant pump, number 12.
