Condition

Model(s)	Year(s)	VIN Range	Vehicle Specific Equipment
A8	2019 – 2021	All	4.0 ltr. V8 TFSI
S8, SQ7, SQ8, and RS Q8	2020 – 2025		
RS6 Avant, and RS 7	2021 - 2025

Technical Background

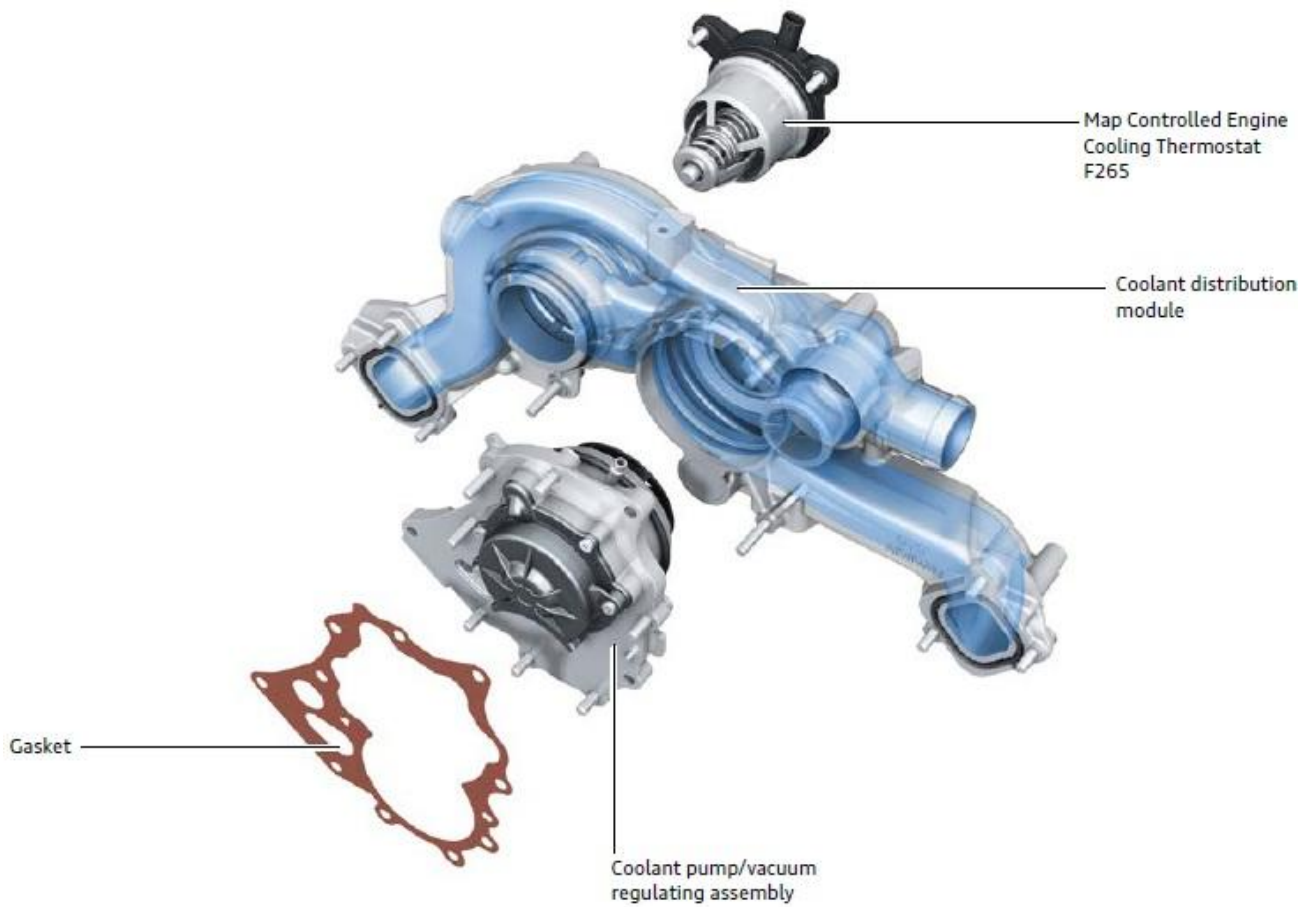
Figure 1. Coolant distribution

Note: The mechanical coolant pump on the EA825 V8 TFSI engine is behind the coolant distributor. Please refer to the attachment “Overview of coolant distributors” and the following two images.

A fresh coolant leak around the mechanical coolant pump can take the form of fresh drops on the underside of the coolant distributor or the leakage reservoir (See figures 1 and 2 or attachment "Overview of coolant distributors"). If necessary, perform a pressure test of the cooling system according to ELSA.

If a fresh leak is detected, please note that it is not necessary to replace the coolant distributor. Replacing the mechanical coolant pump as per the Workshop Manual is sufficient in this case.

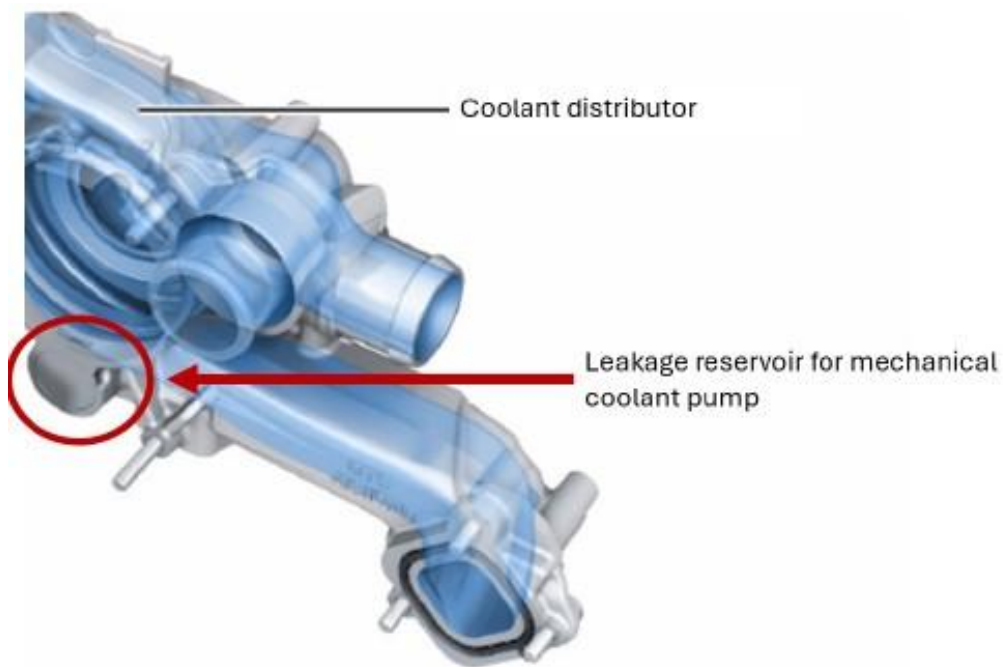
Figure 2. Coolant distributor and leakage reservoir

If no fresh coolant is visible from the mechanical coolant pump or the coolant distributor, it may be what is known as a “cosmetic leak” from the mechanical coolant pump. Replacing the mechanical coolant pump is therefore not intended for this reason.

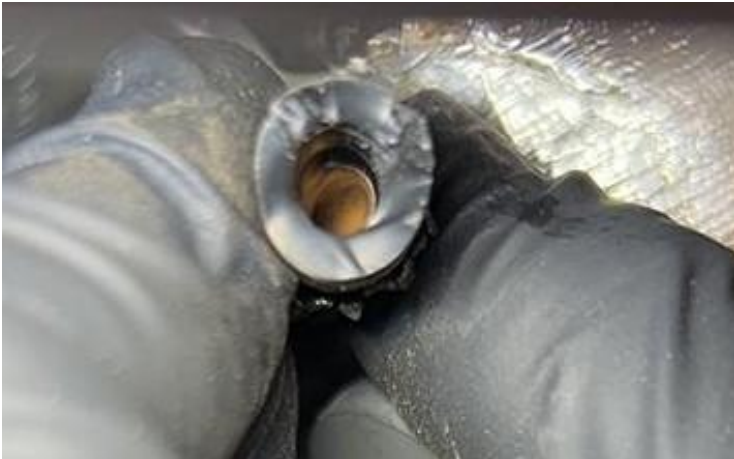
Check whether a coolant leak has occurred at the vacuum connection of the mechanical coolant pump in the direction of N649. If there is any coolant in the vacuum connection of the valve or in the vacuum hose between the mechanical coolant pump and N649, replace N649, the mechanical coolant pump, and the vacuum connection.

A slight coating (brown/red) on the inside of the vacuum lines is not a clear indication that coolant has entered. Also compare with the following example:

If it cannot be determined that coolant has entered, it is important to always perform a function check on the switch valve for mechanical coolant pump N649 using ODIS.

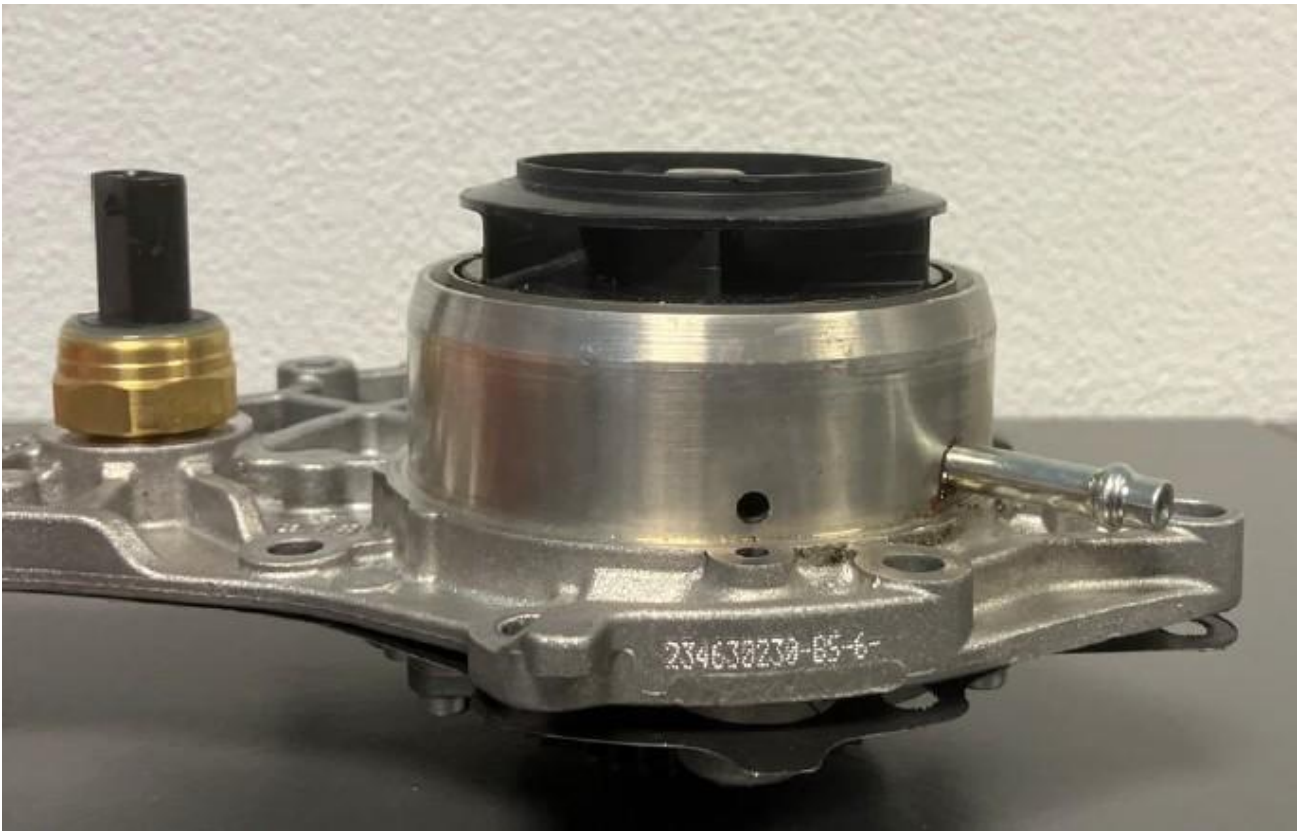
- If there is no vacuum applied to the vacuum connection of the mechanical coolant pump, the modulating piston (orifice panel) must be fully retracted into the pump housing.

Figure 3. Modulating piston moved back correctly (starting position, not actuated)

If the end positions are not reached correctly, replace the mechanical coolant pump.

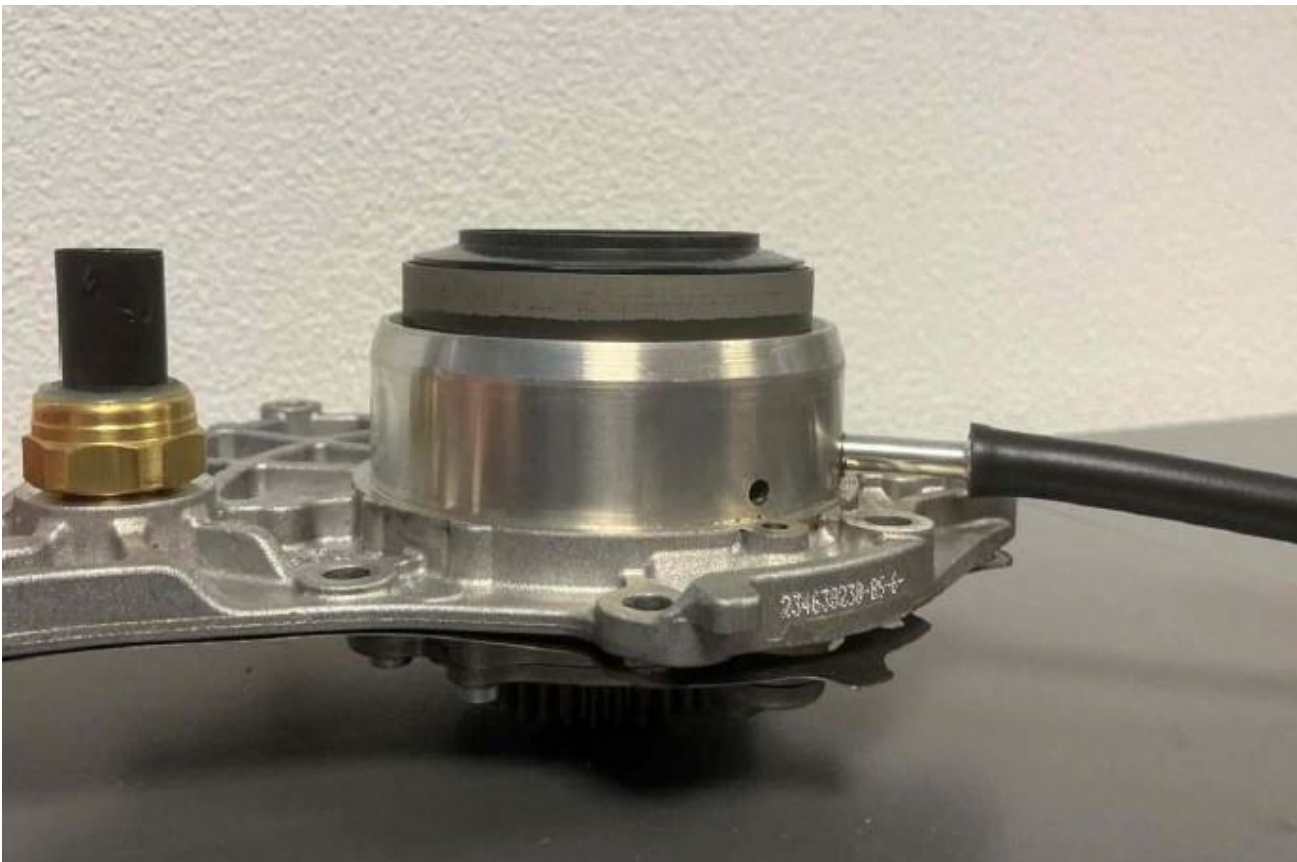
- The modulating piston (orifice panel) must completely cover the pump impeller when a vacuum (maximum: ~600mbar) is applied at the vacuum connection of the mechanical coolant pump. The vacuum must be maintained throughout the functional test.

Figure 4. Modulating piston correctly deployed (end position, actuated)

Note: The modulating piston tilting while it is moving out is not a reason for complaint if the end positions (as pictured above) are reached correctly.
