Model(s)	Year(s)	VIN Range	Vehicle Specific Equipment
A6 Sportback e-tron, S6 Sportback e-tron, Q6 e-tron, Q6 Sportback e-tron, SQ6 e-tron, and SQ6 Sportback e-tron	2025	All	00A5 – Front sensor for driver assistance systems: Software: 0250 0295

REVISION HISTORY		
Revision	Date	Purpose
6	-	Revised Condition (Added Fault code)
5	02/12/2026	Revised <i>Warranty</i> (Added claiming instructions)
4	01/22/2026	Revised <i>Service</i> (Updated instructions) Revised <i>Warranty</i> (Added claiming instructions)

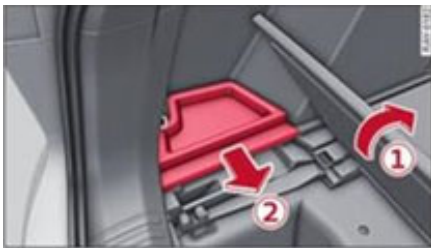
1. Switch off the ignition
2. Remove fuse F39 (activation of charging flap and charging socket no.1) or F43 (activation of charging flap and charging socket no.2) for at least 10 seconds. The fuse is in the luggage compartment (see Figures 1 and 2).
3. Reinsert the fuse in its position.

Figure 1: Fuse carrier installation location: luggage compartment on left, open cover.

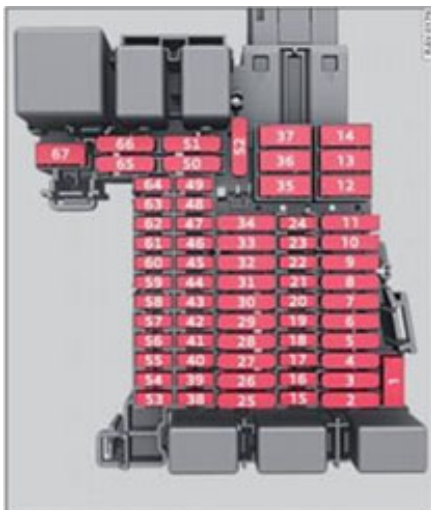
Figure 2: Fuse carrier.
