Technical Service Bulletin

Transaction No.: **2078134/4**

93 Q4 e-tron - electric drive system warning lamp lights up / event memory entry:
P0BBD00 in 008C

Release date: Apr 9, 2026

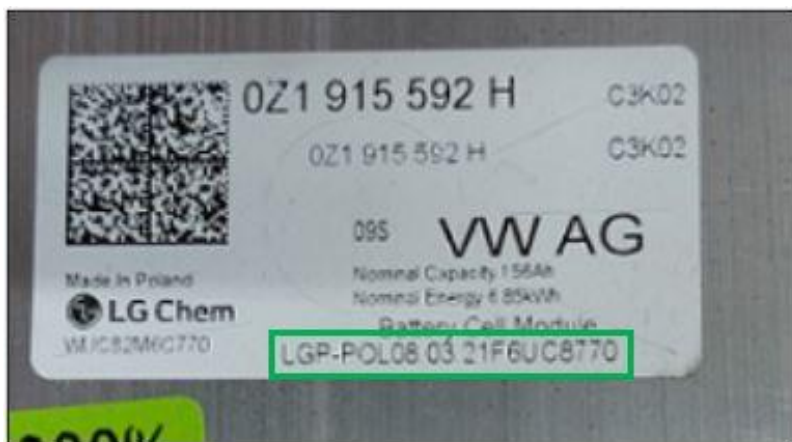
- Remove and open the high-voltage battery as per the Workshop Manual.
- Check the manufacturing date on type plate of the battery module to be renewed (see Figure 1):

- The consecutive production number (see Figure 1, highlighted in green) also includes the manufacturing date of the battery module. The manufacturing date of the battery module from the example (see image 1, highlighted green): LGP-POL **08.03.21** F6CUC8770 would therefore be **03/08/2021**.

Figure 1. Example image of a battery module type plate with production date: 08 03 21 (= 08.03.2021).

- If the battery module that must be replaced has a manufacturing date **prior to 12/04/2023 and** has one of the following part numbers: 0Z1.915.592.G, 0Z1.915.592.H, 0Z1.915.592.J, 0Z1.915.599.G, 0Z1.915.599.H, 0Z1.915.599.J, 0Z1.915.599.P, the battery module must be replaced according to the Workshop Manual/parts catalogue.

- If a battery module with a manufacturing date **from 12/04/2023 onwards** is installed, a *technical repair query* must be created.
