Condition

Model(s)	Year(s)	VIN Range	Vehicle Specific Equipment
All Audi vehicles	2025 – 2026	All	Not applicable

Instructions for combined baseline updates (SVM)

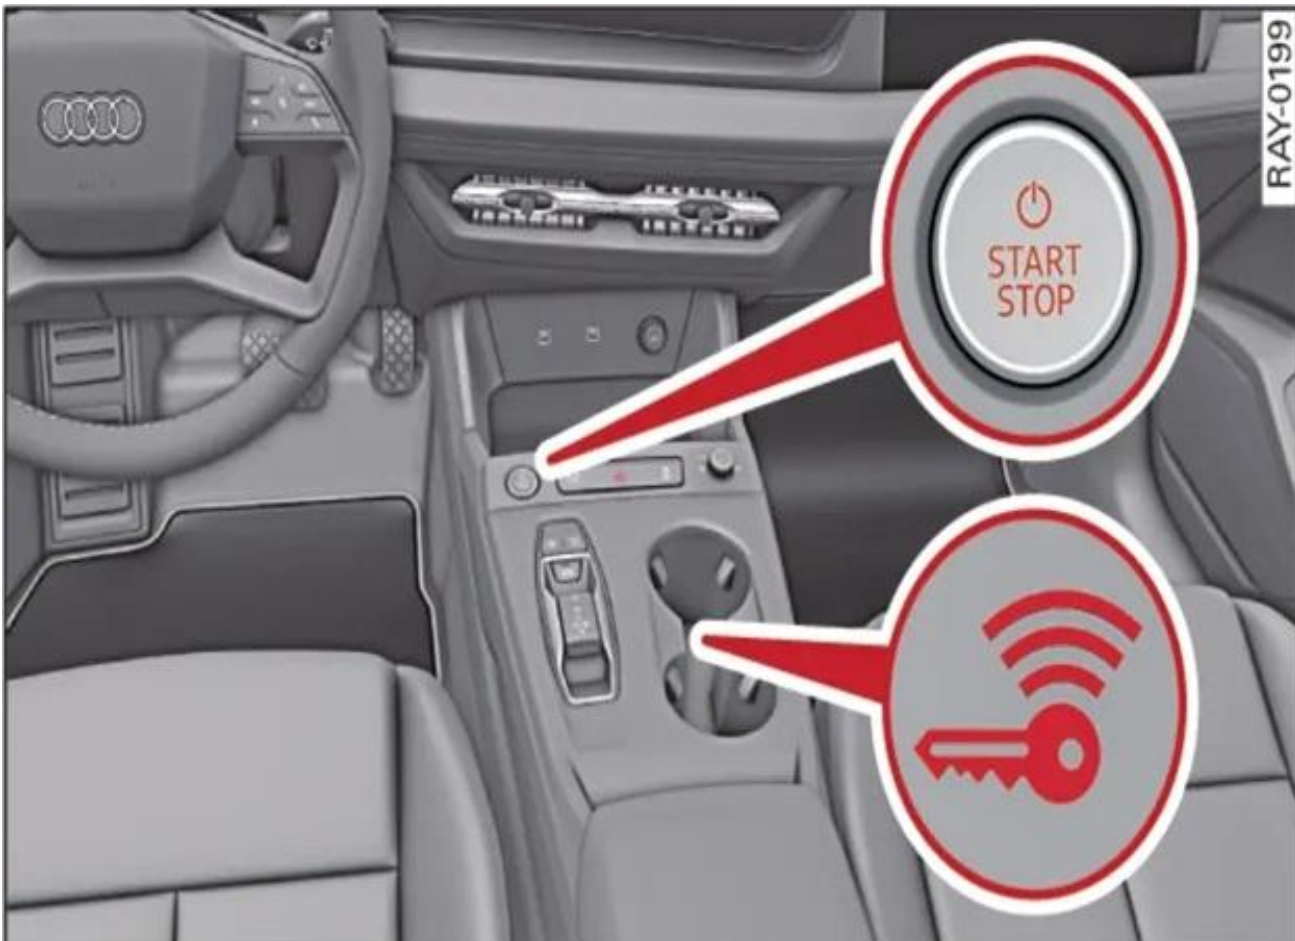
Figure 2. The reader coil is in the cupholder.

- Charge level (SOC) >80% / system voltage at least 12.5V.
- 12V battery charger connected.
- Do not charge the high-voltage system during the update.
- Place the ignition key directly on the reader coil. (refer to the Owner's Manual for the correct position).

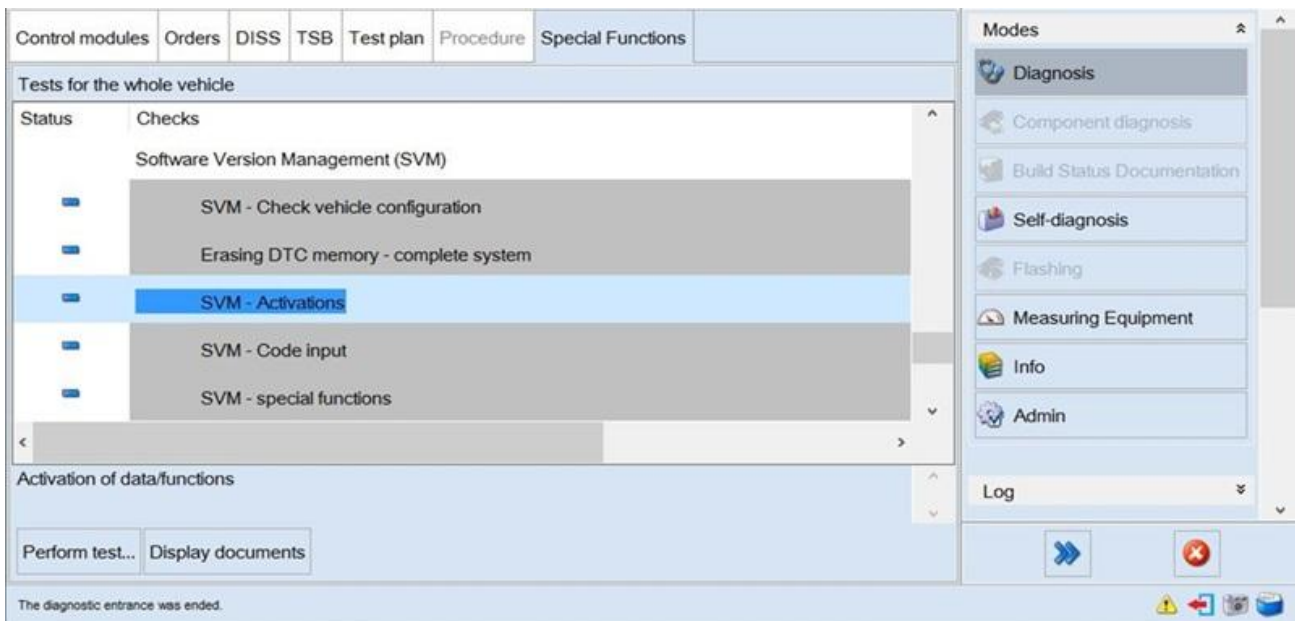
Figure 3. ODIS screen.

- Select "Special functions" => "SVM activations".

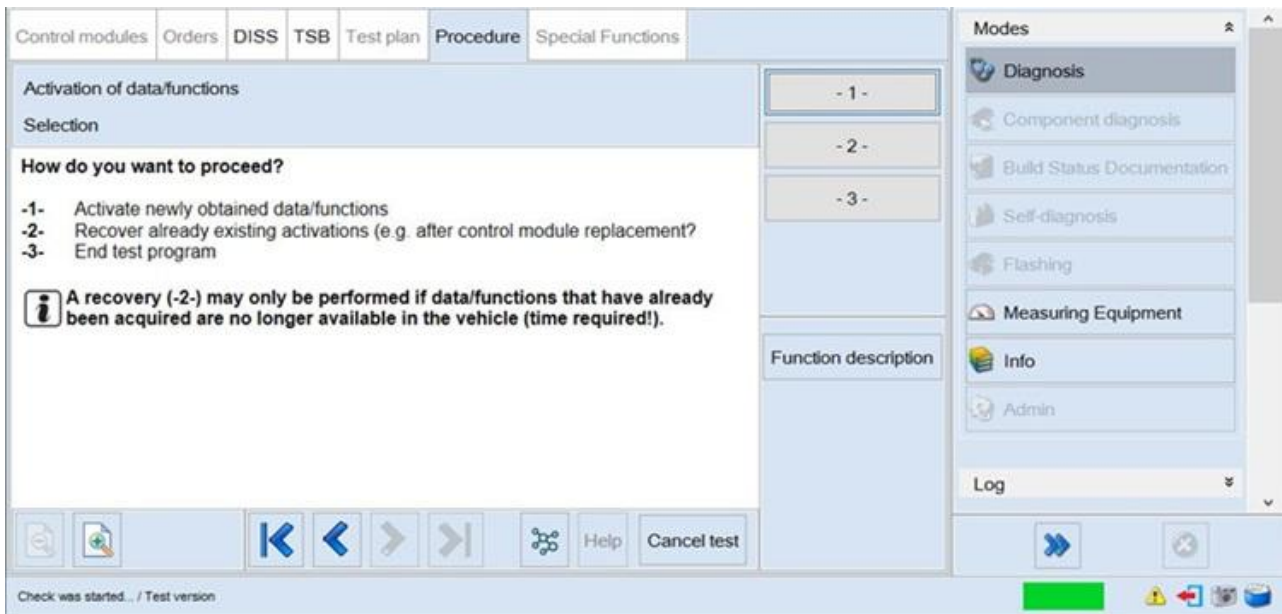
Figure 4. ODIS screen.

- Now select “-2- Restore already existing activations”.

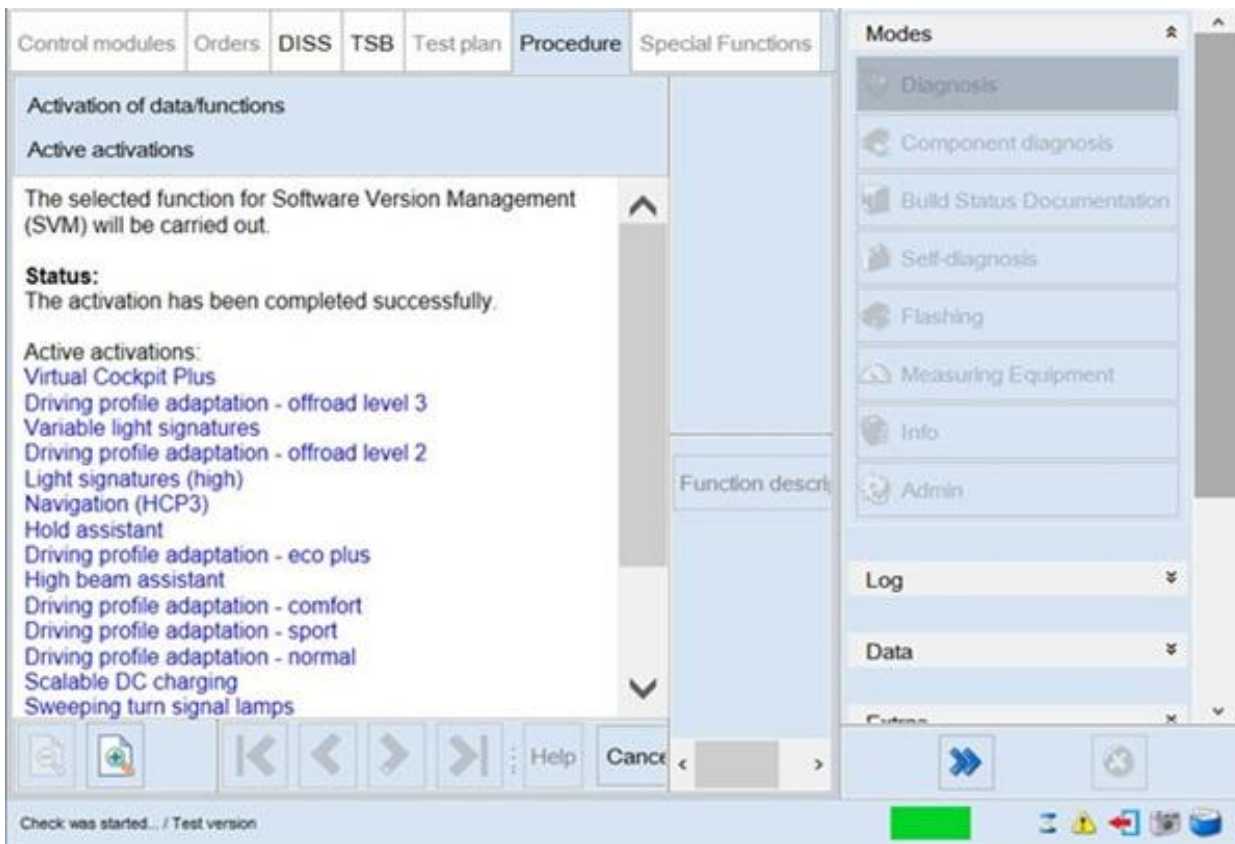
Figure 5. ODIS screen.

- You will then be shown at which diagnostic address(es) the existing activations can be restored.
- The successfully activated functions will then be listed.
