Condition

Model(s)	Year(s)	VIN Range	Vehicle Specific Equipment
A4, A4 allroad, S4, Q5, Q5 e quattro, Q5 Sportback, SQ5, and SQ5 Sportback	2024	All	Without PR Codes: FK0 9M0 KA0 7Y0 0019 – Data Bus OBD Interface with software: 0042 0043 3039
A5, A5 Cabriolet, A5 Sportback, S5, S5 Cabriolet, S5 Sportback, RS 5, RS 5 Sportback A6, A6 allroad, S6, RS 6 Avant, A7, S7, RS 7, A8, S8, e-tron GT, RS e-tron GT, Q7, SQ7, Q8, SQ8, RS Q8, Q8 e-tron, Q8 Sportback e-tron, SQ8 e-tron, and SQ8 Sportback e-tron	2024	All	0019 – Data Bus OBD Interface with software: 0025 0027 0042 0043 0051 3039

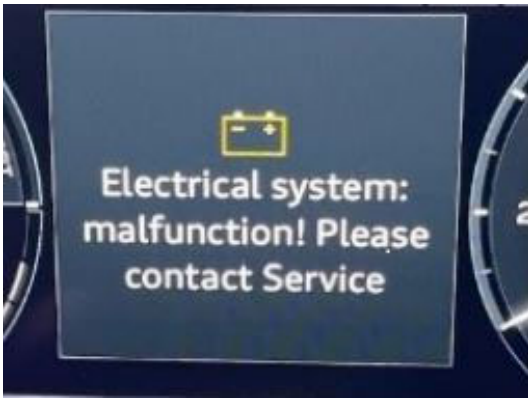
The customer complains that there is a yellow warning lamp in the instrument cluster (Figure 1) with a message about a battery management fault (12V system).

Figure 1. Yellow warning lamp.

- **P0A1F00:** Battery Energy Control Module Malfunction

Software issue in diagnostic interface control unit (DA0019).

Software update to SW 0052 for the diagnostic interface control unit (DA0019):

Please update the data bus diagnostic interface J533 (diagnostic address 0019) via SVM. To enter the SVM code, use “Flash” mode on the ODIS tester.
