Water enters the vehicle interior. The headliner and/or footwell is wet.

Water enters the dry area of the wind deflector storage compartment.

Modification(s) on panoramic sliding sunroof.

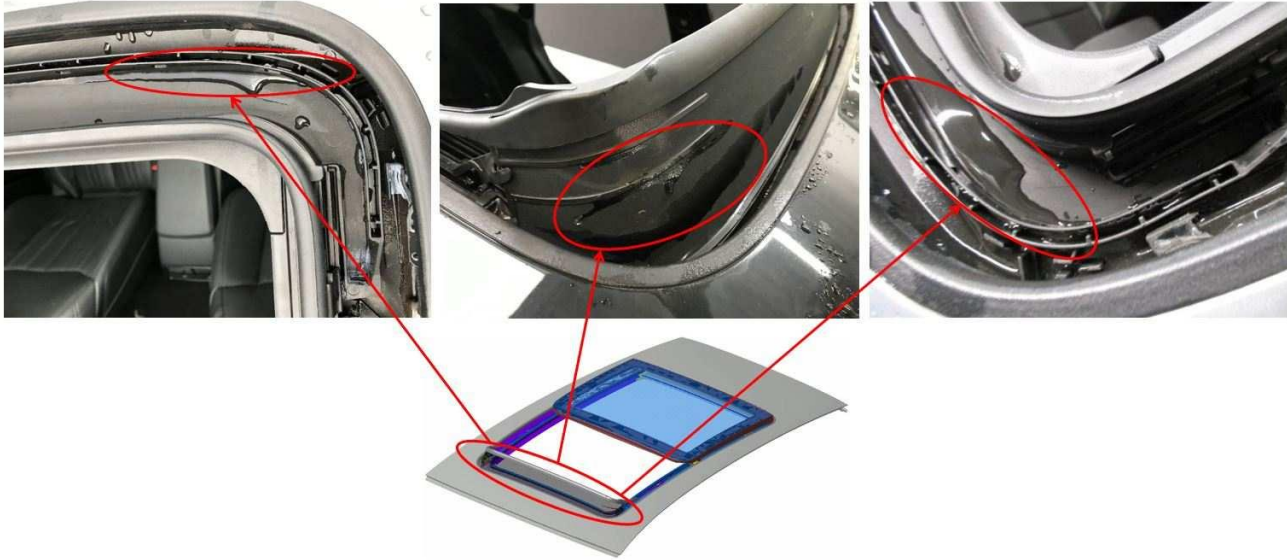
If there is standing water in the wind deflector area, as shown in Figure 1, work through the points in this TSB. Please note the production condition and compare the images with the components on the vehicles.

**Figure 1.** Examples of standing water in the wind deflector.

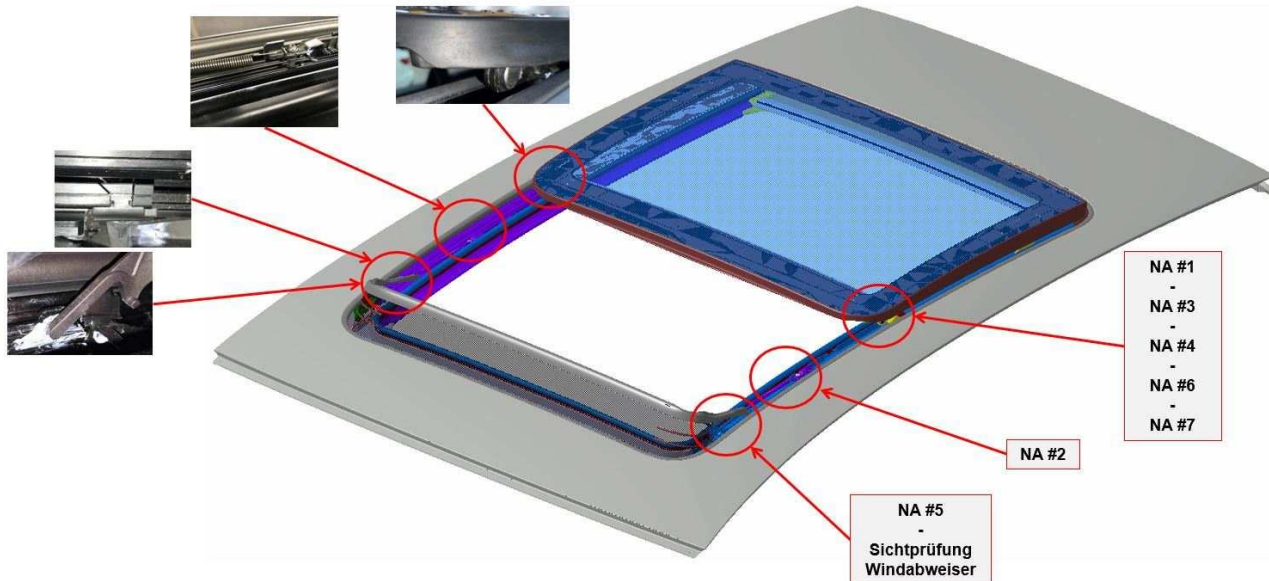
**Figure 2.** Modification areas.

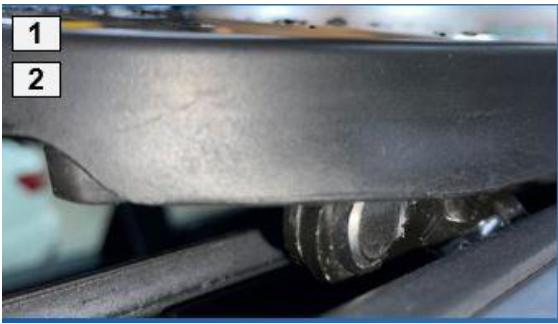
**Figure 3.**

1. "Short trim" glass panel **without** rubber buffers.
2. Mechanism **without** "flapper valve" (see Figure 3).

**Required modifications: no. 1, 2, 5**

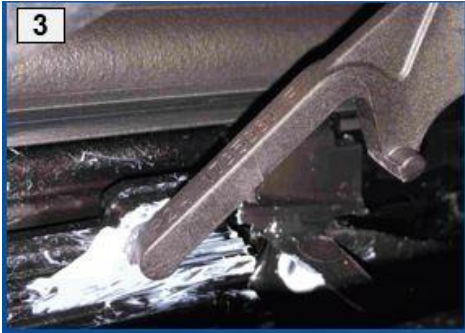
**Figure 4.**

3. Wind deflector tilt lever **without** "drip tab" (see Figure 4).

Replace wind deflector (if it does not have a water drip tab).

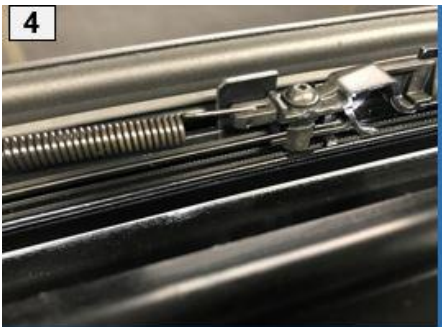
**Figure 5.**

4. Guide rail **without** "butyl barrier" (see Figure 5).

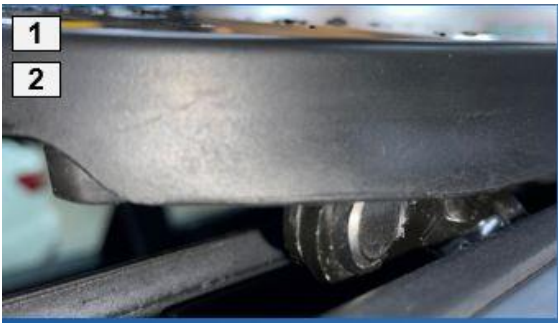
**Figure 6.**

1. "Short trim" glass panel **without** rubber buffers (see Figure 6).
2. Mechanism **without** "flapper valve" (see Figure 6).

**Required modifications: no. 1, 5**

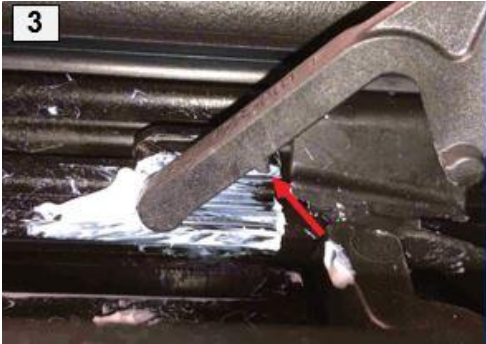
**Figure 7.**

3. Wind deflector tilt lever **with** "drip tab" (see Figure 7).

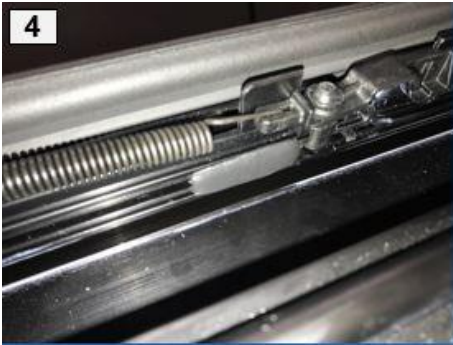
**Figure 8.**

4. Guide rail **with** "butyl barrier" (see Figure 8).

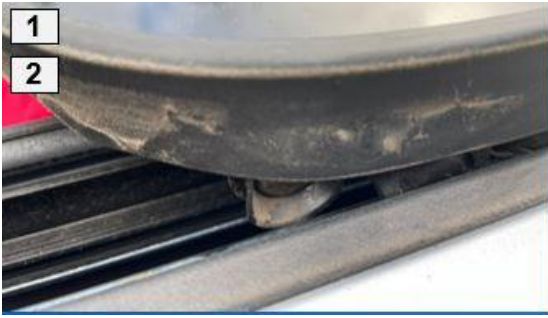
**Figure 9.**

1. "Short trim" glass panel **with** rubber buffers (see Figure 9).
2. Mechanism **with** "flapper valve" (see Figure 9).

**Required modifications: no. 3, 5**

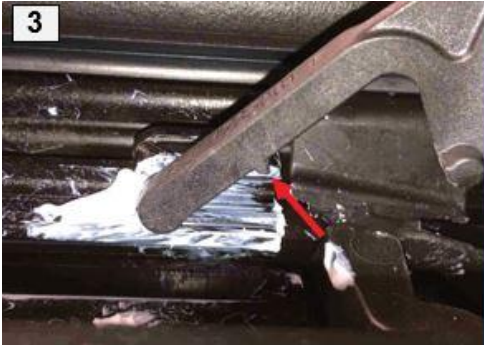
**Figure 10.**

3. Wind deflector tilt lever **with** "drip tab" (see Figure 10).

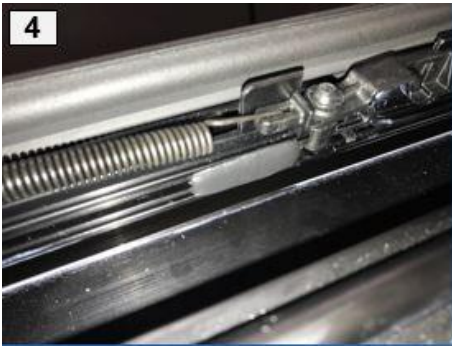
**Figure 11.**

4. Guide rail **with** "butyl barrier" (see Figure 11).

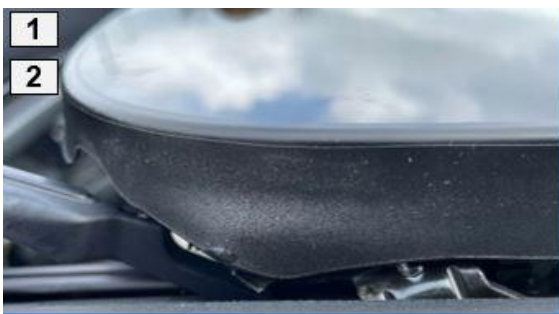
**Figure 12.**

1. "Long trim" glass panel **without** rubber buffers (see Figure 12).

2. Mechanism **without** "flapper valve" (see image 12).

**Required modifications: no. 4, 5**

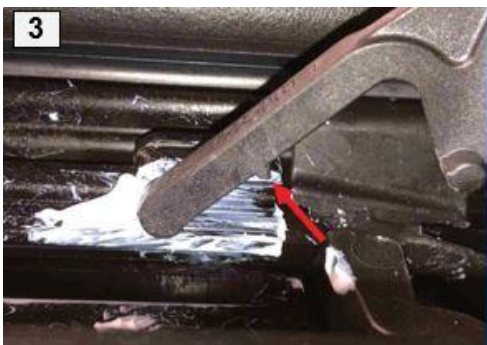
**Figure 13.**

3. Wind deflector tilt lever **with** "drip tab" (see Figure 13).

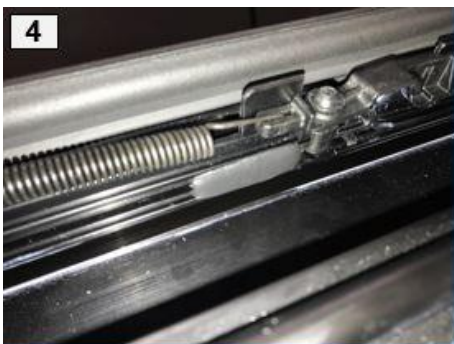
**Figure 14.**

4. Guide rail **with** "butyl barrier" (see Figure 14).

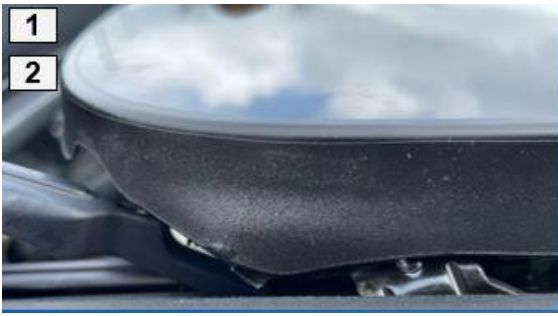
**Figure 15.**

1. "Long trim" glass panel **without** rubber buffer (see Figure 15).

2. Mechanism **without** "flapper valve" (see Figure 15).

**Required modifications: no. 4, 5**

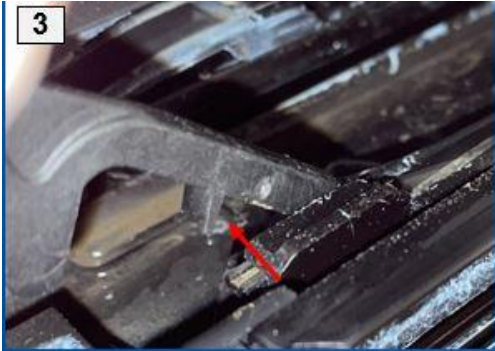
**Figure 16.**

3. Wind deflector tilt lever **with** "long drip tab" (see Figure 16).

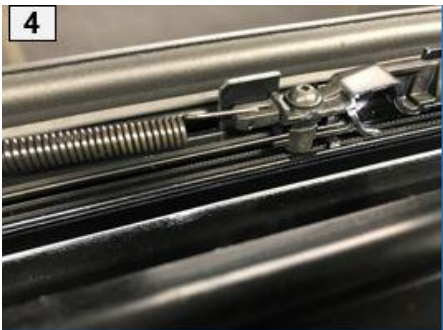
**Figure 17.**

4. Guide rail **without** "butyl barrier" (see Figure 17).

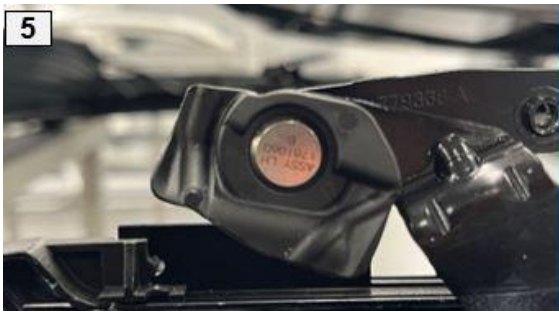
**Figure 18.**

5. Frame with new large "flapper valve" (see Figure 18).

**Required modifications: no. 6**

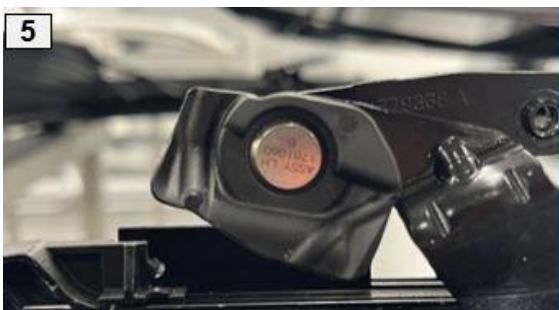
**Figure 19.**

5. Frame with new large "flapper valve" (see Figure 19).

**Required modifications: no. 7**
