Transaction No.: **2080201/3**

91 PSS Audi connect Q4 privacy mode activates itself

Release date: Apr 29, 2026

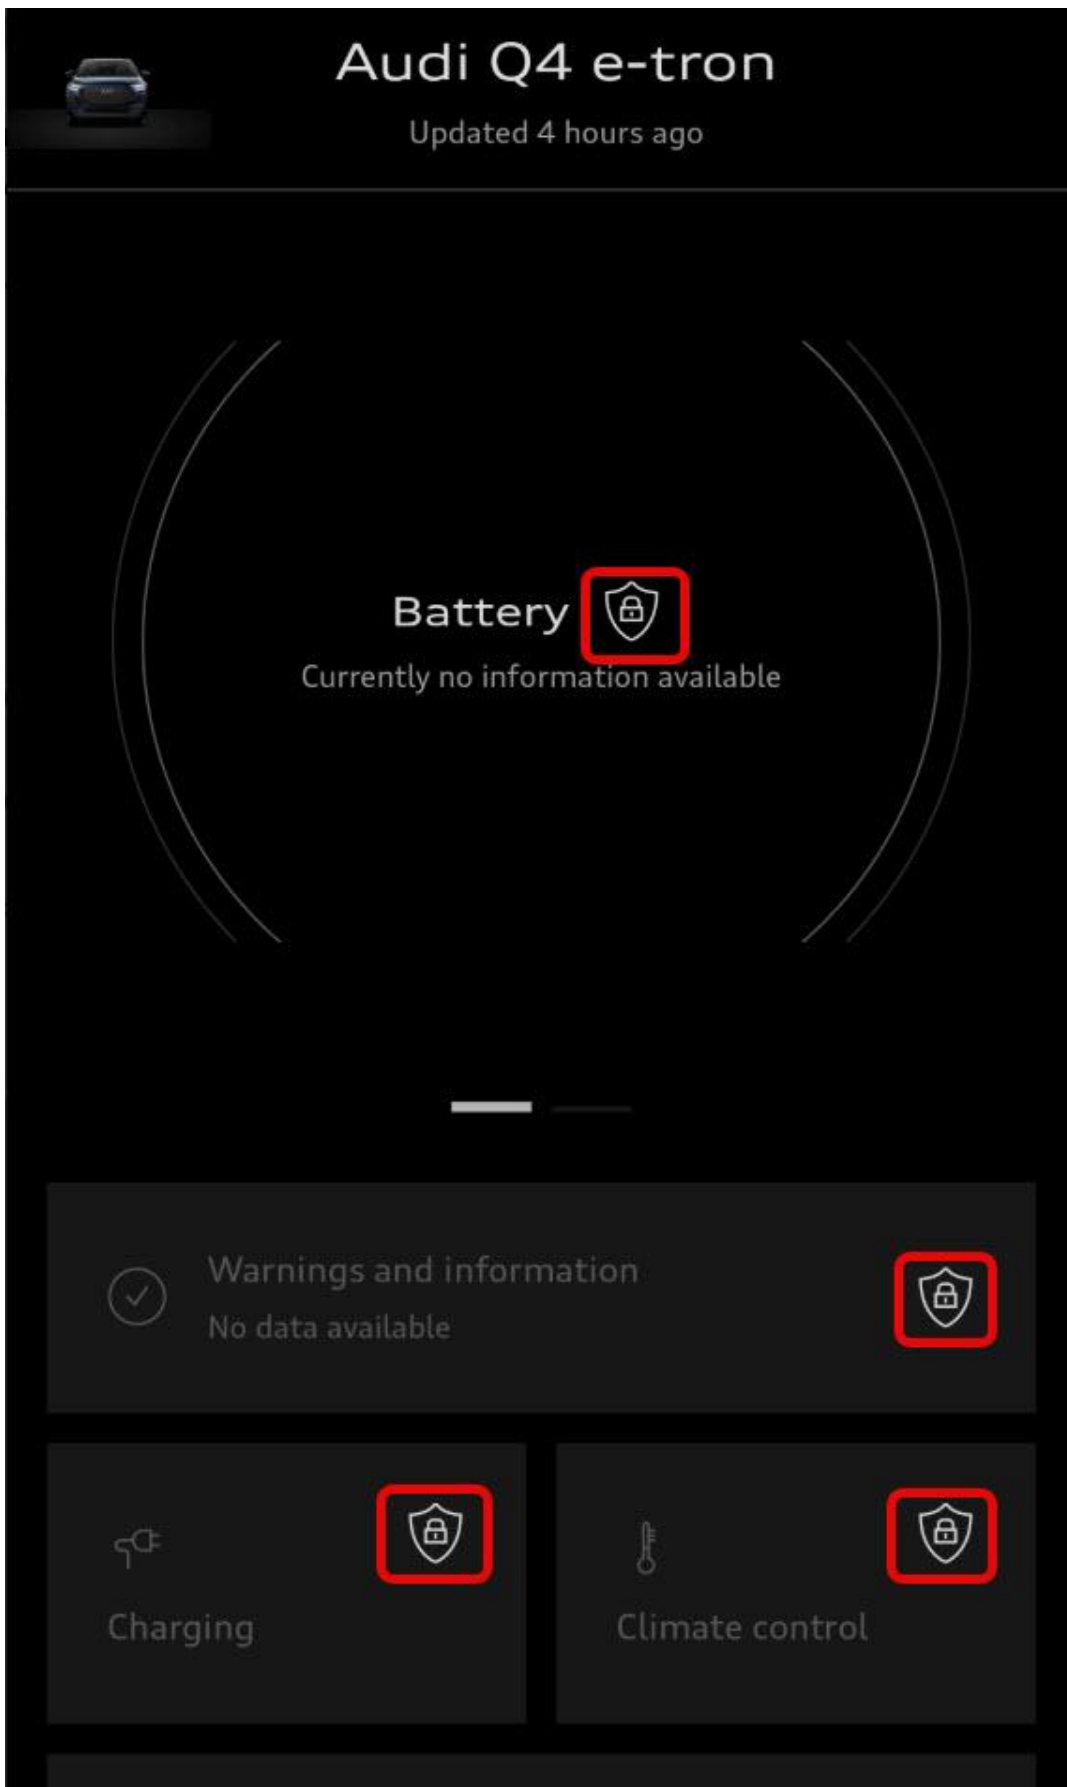
Privacy mode in the myAudi app **occasionally** activates itself.

Figure 1. The highlighted lock symbol in the example image indicates that privacy mode is active.

Software issue in control unit 1 for information electronics (diagnostic address 005F).

1. Explain to the customer that this matter is being reviewed, and you will be advised if any action is determined to be needed. A result should be available by the end of the 3rd quarter of 2026 (subject to change) and that no repairs are necessary at this point.
2. Do not replace any components for this condition since this will not resolve the customer's concern.
3. Create a PSS record in the PSS application through the Pending Service Solutions (PSS) link in Access Audi (under *Related Links >> Service*).
