Model(s)	Year(s)	VIN Range	Vehicle Specific Equipment
A6 Sportback e-tron, S6 Sportback e-tron	2025	All	0046 – Convenience system central module Software Version: 0195 – 0198 0201 – 0203 0206 0210 – 0213 0226 – 0227 0230
Q6 e-tron, Q6 Sportback e-tron, SQ6 e-tron, and SQ6 Sportback e-tron	2025	All	0046 – Convenience system central module Software version: 0195 – 0198 0201 – 0203 0205 – 0206 0210 – 0213 0226 – 0227 0230
Q5, Q5 Sportback, SQ5, and SQ5 Sportback	2025	All	0046 – Convenience system central module Software version: 0197 0201 – 0202 0206 0210 – 0213

The rear lid does not close and opens again.

All parts and service references provided in this TSB (**2080959**) are subject to change and/or removal.

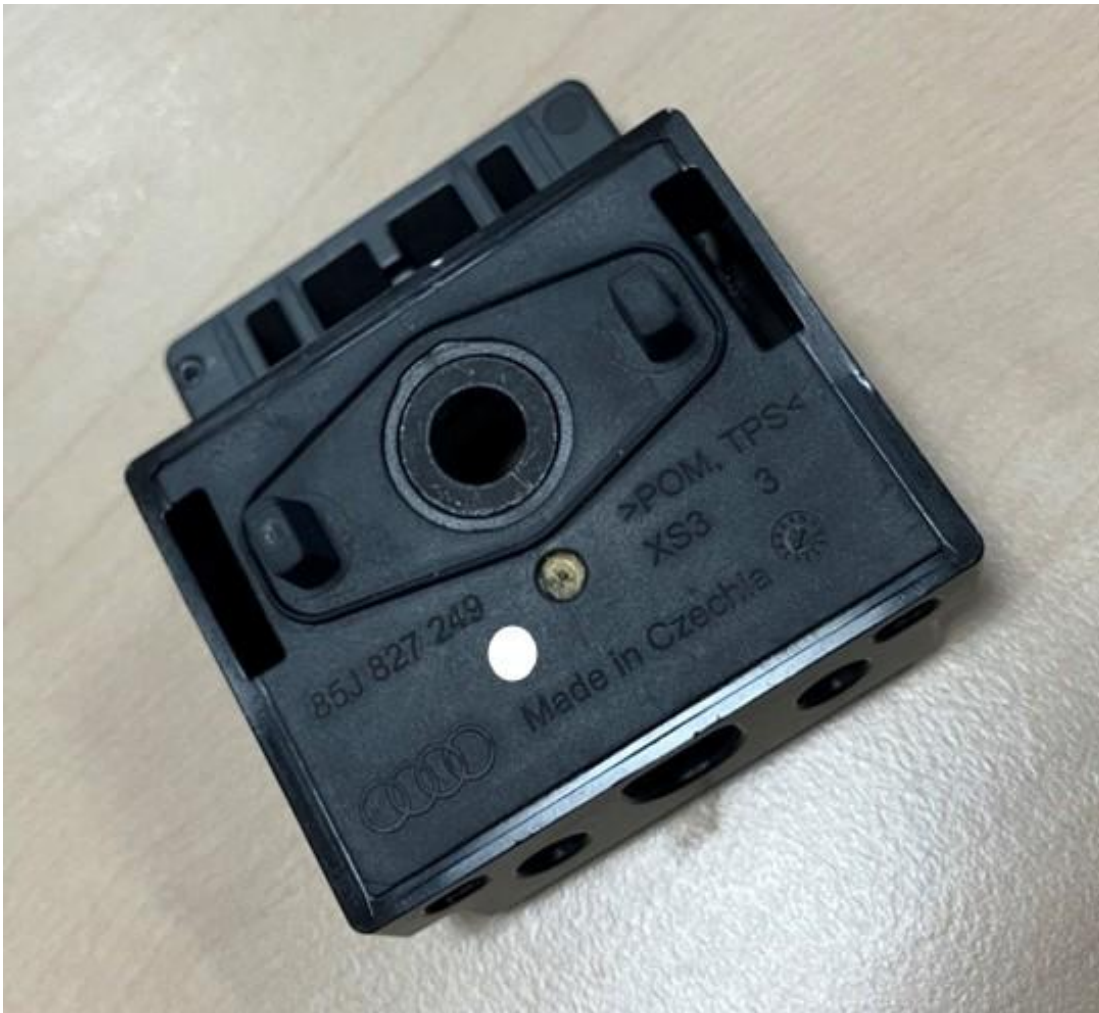
Make sure the new side bump stop (see Figure 1) with part number 85J 827 249 A is fitted on the vehicle. The spring preload is reduced on this part. If the old bump stop 85J 827 249 is fitted on the vehicle, replace it with the new bump stop with index A.

In autumn 2025, optimized buffers were already installed in vehicles that did not yet carry an index A. This buffer can be identified by a white dot on the back. These buffers can also remain fitted in the vehicle.

**Figure 1.** Example of an acoustic buffer with optimized spring without index A marked by a white dot.

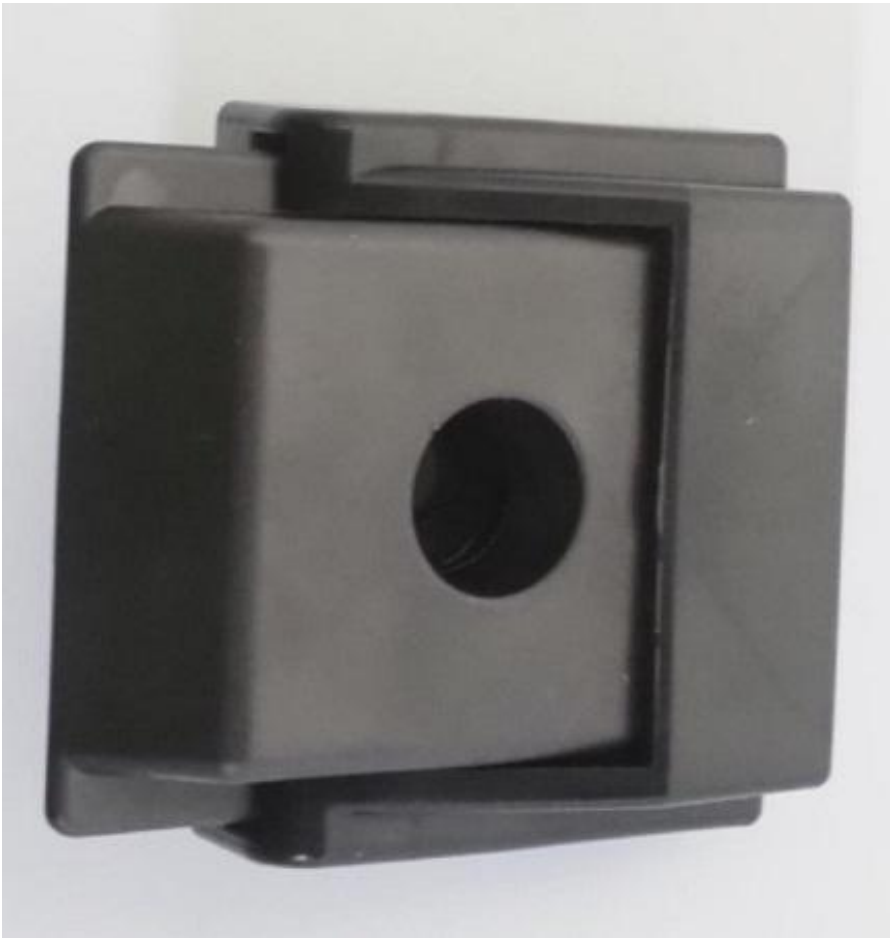
The control unit may detect excessive force at the bump stops.

**Figure 2.** Pre-tensioned bump stop.

- Remove the side bump stops (pre-tensioned spring buffers, see image 2). Using the Workshop Manual, spring force gauge VAS 895 035 and measurement film VAS 895 037, adjust the buffer forces of the rear lid bump stops to between 40 N and 60 N and then refit the bump stops. Alternatively, you can leave the side bump stop installed and set the buffer forces to the lower limit of 40 N. Please also observe the Special Technical Service Training video on the spring force gauge VAS 895 035 in the Audi Knowledge Tank (AKT). In addition, make sure that the striker is positioned correctly and enters the lock in the center. Incorrect positioning can also cause the rear lid to reverse direction. **NOTE:** If your vehicle is not equipped with side bump stops (see image 2), please start from the point: “**Adjusting buffer forces using spring force gauge VAS 895 035**”.
