Technical Service Bulletin

Transaction No.: **2081556/1**

91 Reversing camera - rear corner view cannot be activated via the MMI - Q4

Release date: Apr 6, 2026

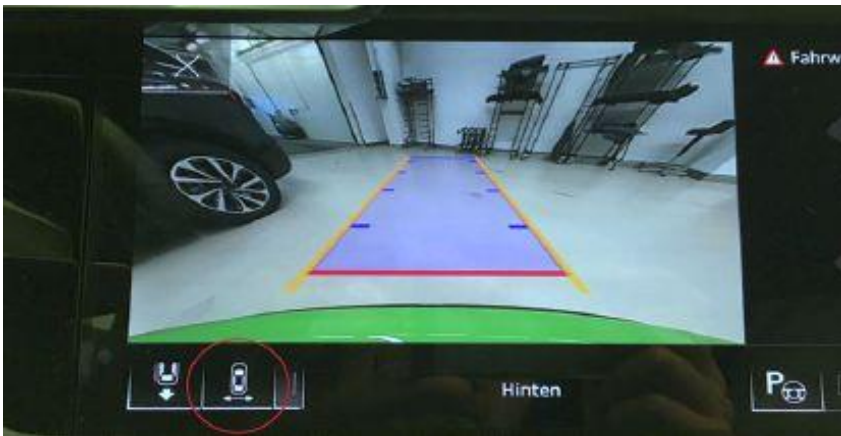
Figure 1. Reversing Camera MMI Selection.

The reversing camera view cannot be changed via the MMI. The rear corner view cannot be activated.

Software issue. The soft keys shown have no function and should not appear in the reversing camera view.

A software update has been prepared to repair this issue. This software update also contains updates for further control units and is being published as a combined software update.

This combined software update can be found in TSB 2080398, *00 Combined software update ID.S 5.4.3 for Audi Q4.*
