Model(s)	Year(s)	VIN Range	Vehicle Specific Equipment
Q6 Sportback e-tron, and SQ6 Sportback e-tron	2025	All	Not applicable
	2027	000000 – 000881

Technical Background

All parts and service references provided in this TSB (**2081609**) are subject to change and/or removal.

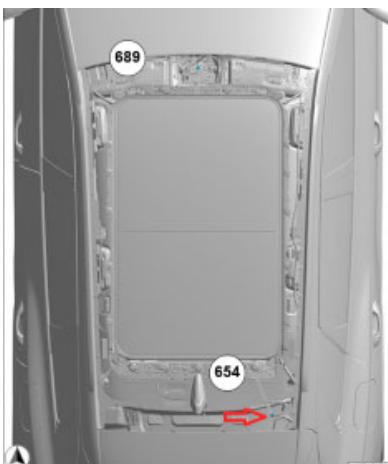
Figure 1. Earth point 654

In unfavorable circumstances, the expanding nut for the earth cable to the GPS aerial may not form a proper connection between the metal cross member of the D-pillar and the earth cable. This leads to rattling noises, or a restricted GPS signal or radio signal.

To clearly assign the complaint to this TSB, check earth point 654 with a borescope. The area is accessed via the opening on the right side of the luggage compartment between the roof trim and the body (see Figure 1).

This complaint applies if the two clips of the expanding nut are not securely in contact with the body.

In this case, please replace the expanding nut. The part number of the required expanding nut is **WHT.000.748**.

If the expanding nut makes secure contact, please perform Guided Fault Finding using the ODIS-S tester.
