## Condition

Model(s)	Year(s)	VIN Range	Vehicle Specific Equipment
Q6 Sportback e-tron, and SQ6 Sportback e-tron	2025	All	Not applicable
	2027	000000 – 000881

## Technical Background

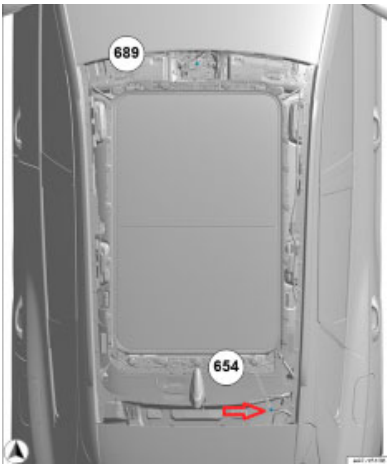
**Figure 1.** Earth point 654

In unfavorable circumstances, the expanding nut for the earth cable to the GPS aerial may not form a proper connection between the metal cross member of the D-pillar and the earth cable. This leads to rattling noises, or a restricted GPS signal or radio signal.

To clearly assign the complaint to this TSB, check earth point 654 with a borescope. The area is accessed via the opening on the right side of the luggage compartment between the roof trim and the body (see Figure 1).

This complaint applies if the two clips of the expanding nut are not securely in contact with the body.

In this case, please replace the expanding nut. The part number of the required expanding nut is **WHT.000.748**.
