Condition

Model(s)	Year(s)	VIN Range	Vehicle Specific Equipment
A8	2019 – 2026	All	Not applicable
S8	2020 – 2026		
A8 e quattro	2020 - 2021

Sloshing noises can be heard inside the vehicle.

Water has accumulated in the door sill.

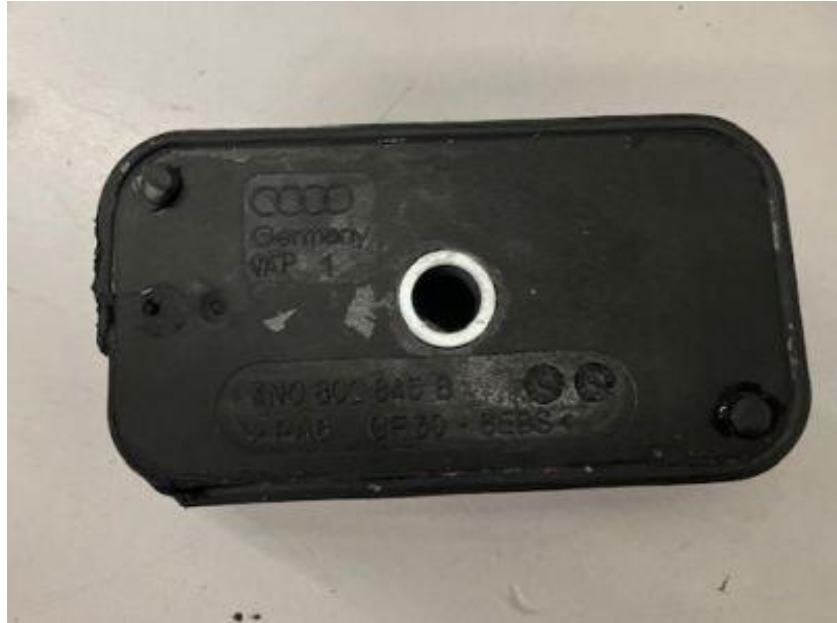
1. Jacking point: Please check whether the seal around is free of damage. This seal ensures that openings in the vehicle body are sealed correctly.

Figure 1. A damaged jacking point leads to water accumulating in the door sill.

Secure any clips which have not been attached and check that jacking points are leak tight.

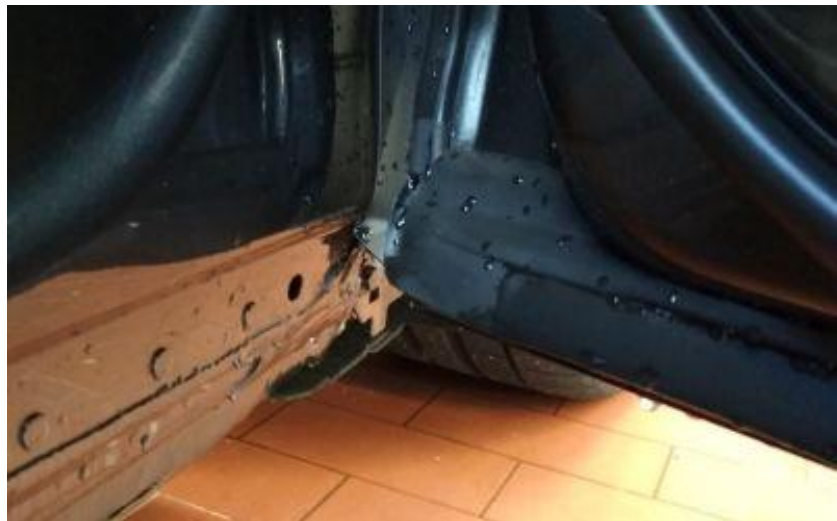
2. Water ingress via clips at side of door sill trim: The surface with which the seal for the clip makes contact may be occupied due to incorrect application of the PVC joint seal.

Figure 2. Hole for side clip on door sill trim (example).

Cut the PVC seal to enable a flat contact surface at the sealing surface of the clips and, if necessary, restore the paintwork structure to avoid damage through to the base substrate.

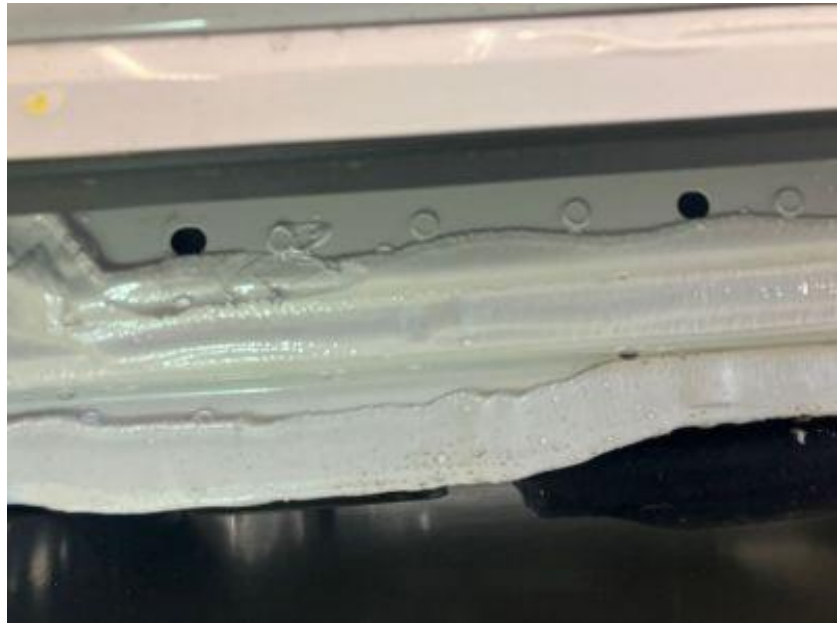
Figure 3. PVC joint seal too high.

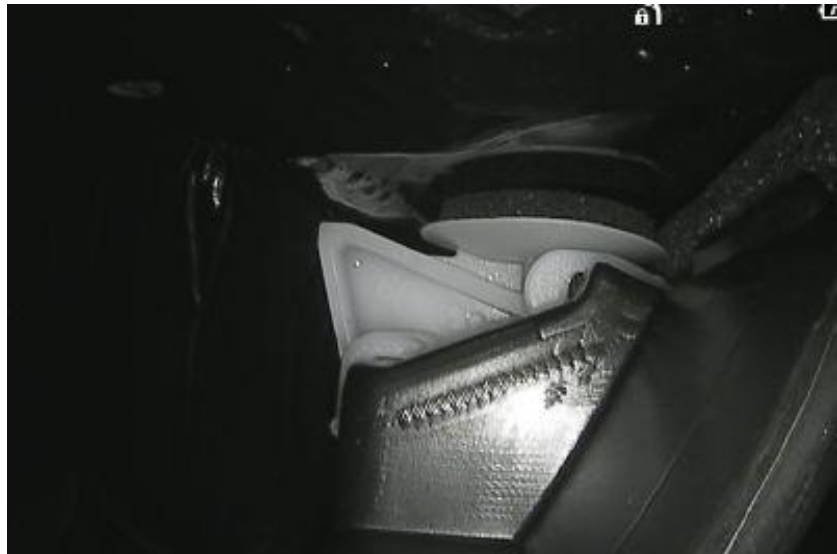
3. Water ingress via clips at bottom of door sill trim: There is a potential leak caused by a clip which is not fully engaged on the underside of the door sill.

Figure 4. Door sill clip on underside with seal.
