Technical Service Bulletin

Transaction No.: **2081781/1**

55 Water in luggage compartment - leak in rear lid bump stop

Model(s)	Year(s)	VIN Range	Vehicle Specific Equipment
Q4 e-tron, Q4 Sportback e-tron, Q5, Q5 Sportback, SQ5, and SQ5 Sportback	2025 – 2026	All	Not applicable

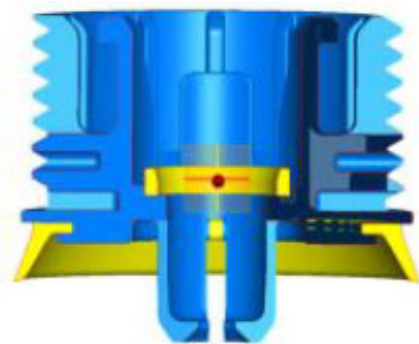
There is a leak in the rear lid bump stop which has caused water to collect in the luggage compartment. This may mean that the electrically operated rear lid stops working.

The bump stop 83H827499 is secured with a spreader rivet in a square hole. Deviations in the installation process may result in the required contact pressure not being attained by the seal around the bump stop.

Figure 1. Cross-section of bump stop 83H.827.499.

- Remove both bump stops 83H827499 and clean the contact surfaces. Also make sure that the bonding surface is free of grease.
- Then install the new bump stop 83H827499.A by fitting the spreader rivet correctly and attach the additional double-sided adhesive tape.
- Remove the luggage compartment side trim panels and luggage compartment floor panels to expose the body. Dry the affected areas in the luggage compartment and the panels.
- Then install the panels that were removed previously.

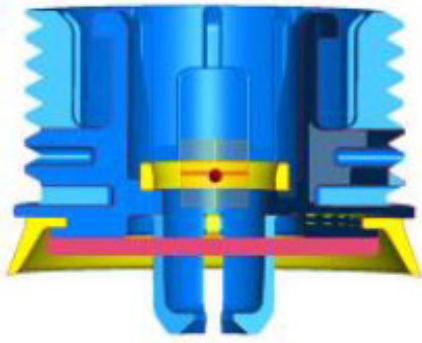
Process optimization and component optimization (additional double-sided adhesive tape) were implemented at the factory in week 43 / 2025. The optimization was incorporated into bump stop 83H827499A.

Figure 2. Cross-section of buffer stop 83H.827.499.A with double-sided adhesive tape.
