## Condition

Model(s)	Year(s)	VIN Range	Vehicle Specific Equipment
A5, S5 (FU), Q5, Q5 Sportback, SQ5, SQ5 Sportback (GU), A6 Sportback e-tron, S6 Sportback e-tron, Q6 e-tron, Q6 Sportback e-tron, SQ6 e-tron, SQ6 Sportback e-tron	2025	All	002C - Rear presence detection With Software: 0016 With PR Code: 5P2
A6 (FN)	2026

## Technical Background

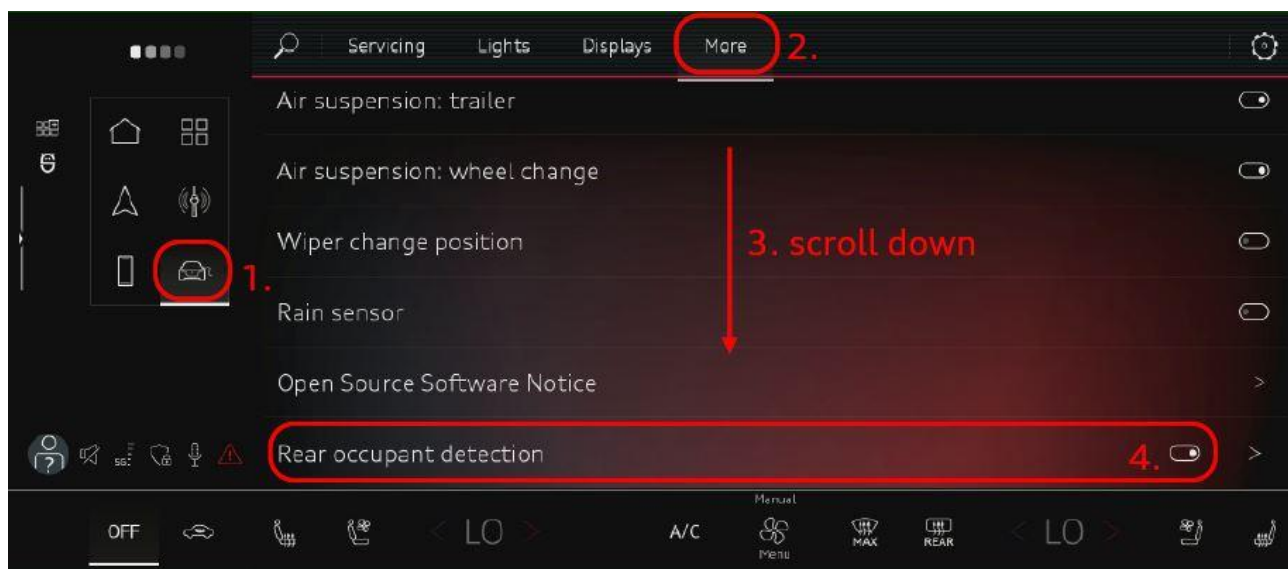
**Figure 1.** In the MMI, navigate from the main menu to the vehicle menu, then select “More”, and toggle “Rear occupant detection” to deactivate.

To avoid issues until the update is available, the *rear occupant detection* should be deactivated permanently on the MMI. To do so, follow these prompts:

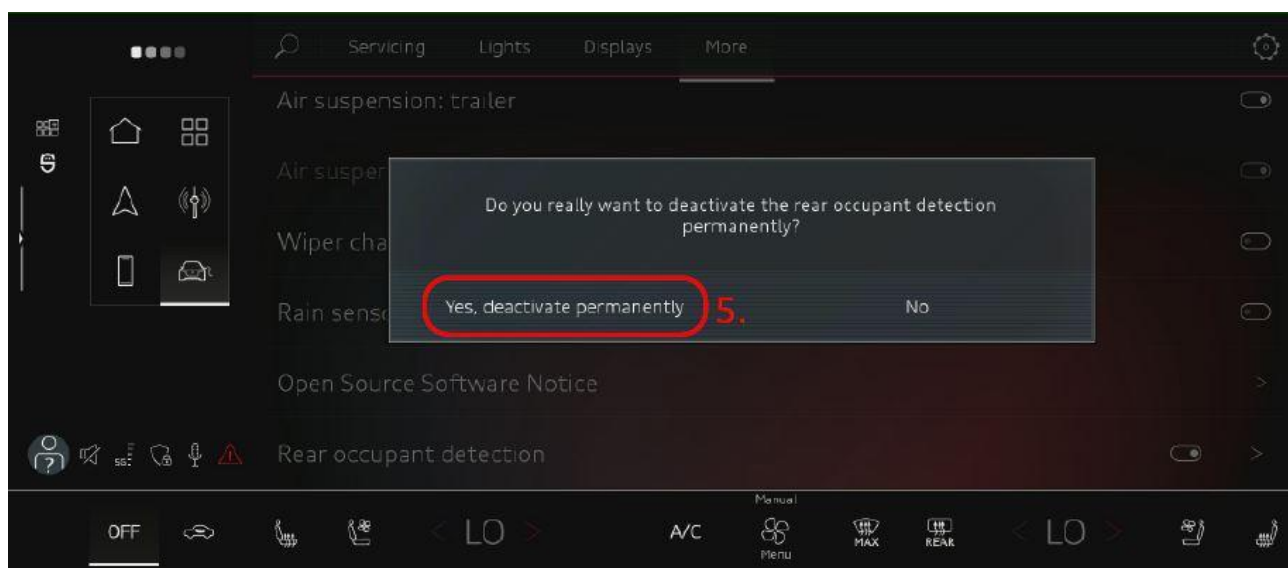
**Figure 2.** Select “Yes deactivate permanently” to save the choice.

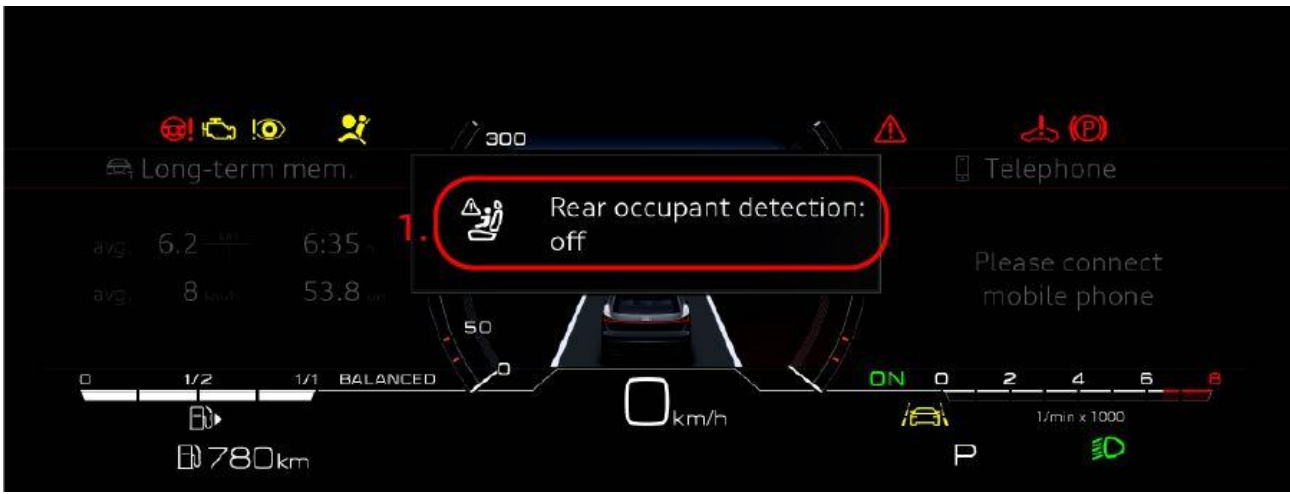
Due to the deactivation, the message “Rear occupant detection: off” appears in the Audi virtual cockpit for a few seconds when the ignition is switched on.

**Figure 3.** The message above will appear for a few seconds after the ignition is turned on once the rear occupant detection has been turned off.

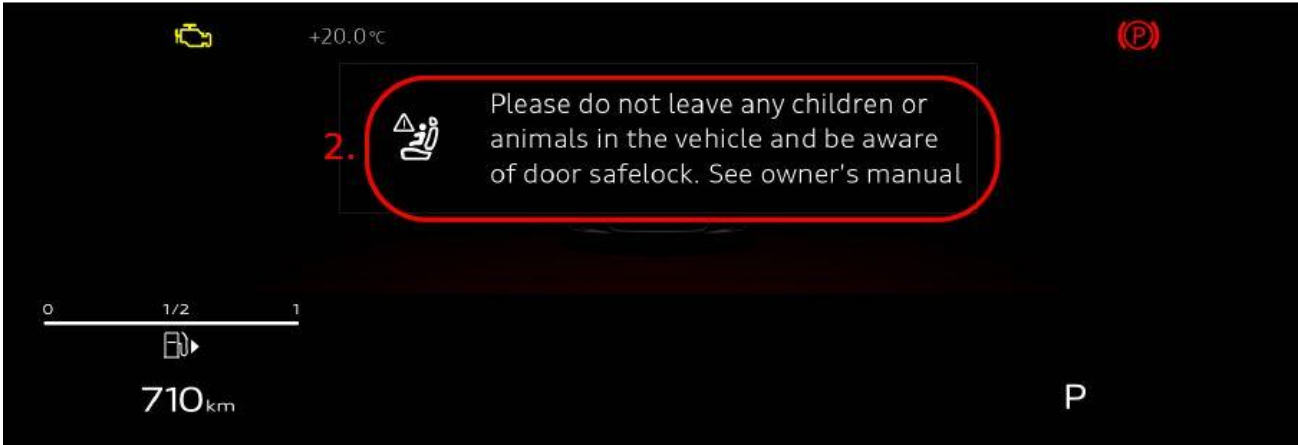
Despite deactivation, the message **“Please do not leave any children or animals in the vehicle”** may be displayed in the Audi virtual cockpit when the driver leaves the vehicle. This cannot be deactivated.

**Figure 4.** The message above will appear for a few seconds when the driver leaves the vehicle once the rear occupant detection has been turned off.
