**Vehicle-specific service**

Transaction No.: **2081841/1**

91 PSS Apple CarPlay/Android Auto remains black after using MMI (PPE/PPC)

Release date: Apr 28, 2026

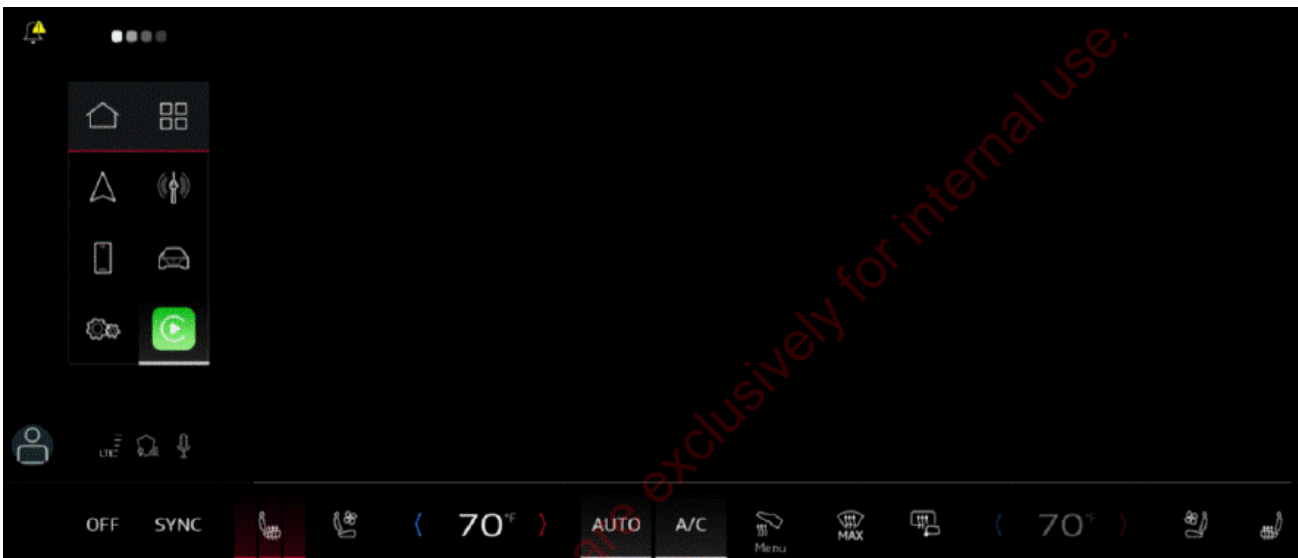
When using Apple CarPlay/Android Auto, the customer complains that Apple CarPlay/Android Auto remains black after operating a native menu (changing the drive mode, operating the air conditioning, or similar...).

If the CarPlay/Android Auto button is pressed again or Siri/Google Assistant is used, the image reappears. Media playback continues without any interruptions. The display in the instrument cluster also functions as normal.

The issue cannot be reproduced on consecutive attempts; it is necessary to wait at least 5 minutes.

1. Explain to the customer that a solution is expected to be available by the end of the 2nd quarter of 2026 (subject to change) and that no repairs are necessary at this point.
2. Do not replace any components for this condition since this will not resolve the customer's concern.
3. Create a PSS record in the PSS application through the Pending Service Solutions (PSS) link in Audi Now; *Service | AU-US > Pending Service Solutions (PSS)*.

As a workaround, If the CarPlay/Android Auto button is pressed again or Siri/Google Assistant is used, the image reappears.
