Y1A, Y1B, Y1C- High-Voltage (HV) Battery Measurements during HV Battery Repair

Vehicles Affected

Models	Model Year	Model Type	VIN Range	Vehicle-Specific Equipment
Taycan	All	Y1A, Y1B, Y1C	All	N/A

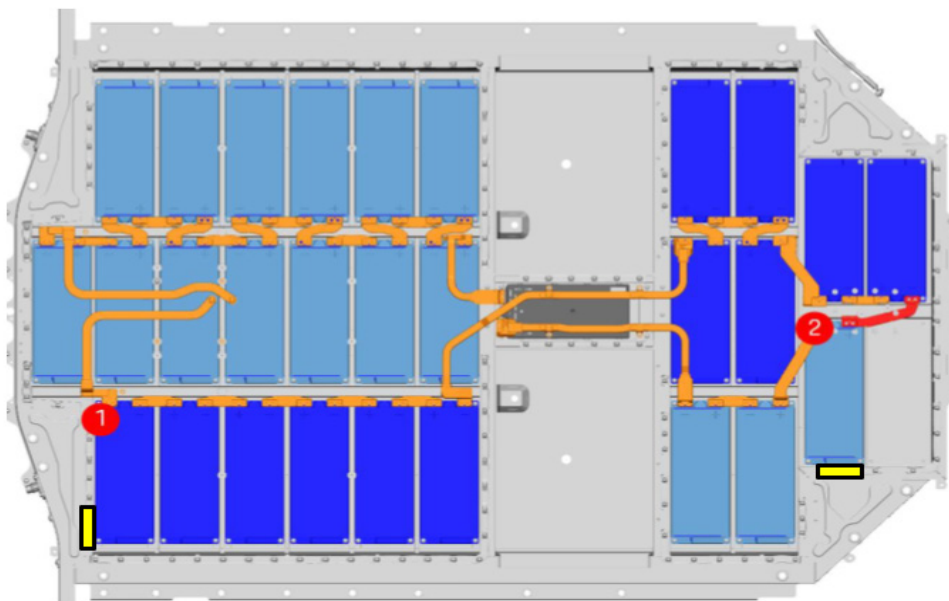
Figure 1 - 28-module HV Battery measurement points

DST Procedure for 28-module Taycan Battery Pack (Figure 1)

- Only two DSTs are to be performed on a 28-module battery pack during repair.
- The busbar indicated in red must be removed prior to measurements at either point.

- Perform an IR test at points 1 and 2 before the DST at those points.
- Perform a DST only at points 1 and 2 shown below for each repair scope.
- The yellow boxes in *Figure 1* designate the sections of frame where a lid screw can be hand-started to ground the dielectric strength tester.

- If the final IR test at measurement point 1 fails, remove busbars and CMC connections from each module shaded in dark blue for further IR testing as described in the following *Updated IR Measurement Procedure* sections.

- If the final IR test at measurement point 2 fails, remove busbars and CMC connections from each module shaded in light blue module for further IR testing as described in the following *Updated IR Measurement Procedure* sections.

- EXAMPLE: Point 1 passes DST and point 2 fails.
 - Perform IR tests on each light blue module in the failing section (In this example, section 2). No additional work is required for the passing modules in section 1.

- Also perform IR tests at points 1 and 2 after a DST, with the negative probe in contact with a clean spot on the silver frame surface designated by the yellow boxes.

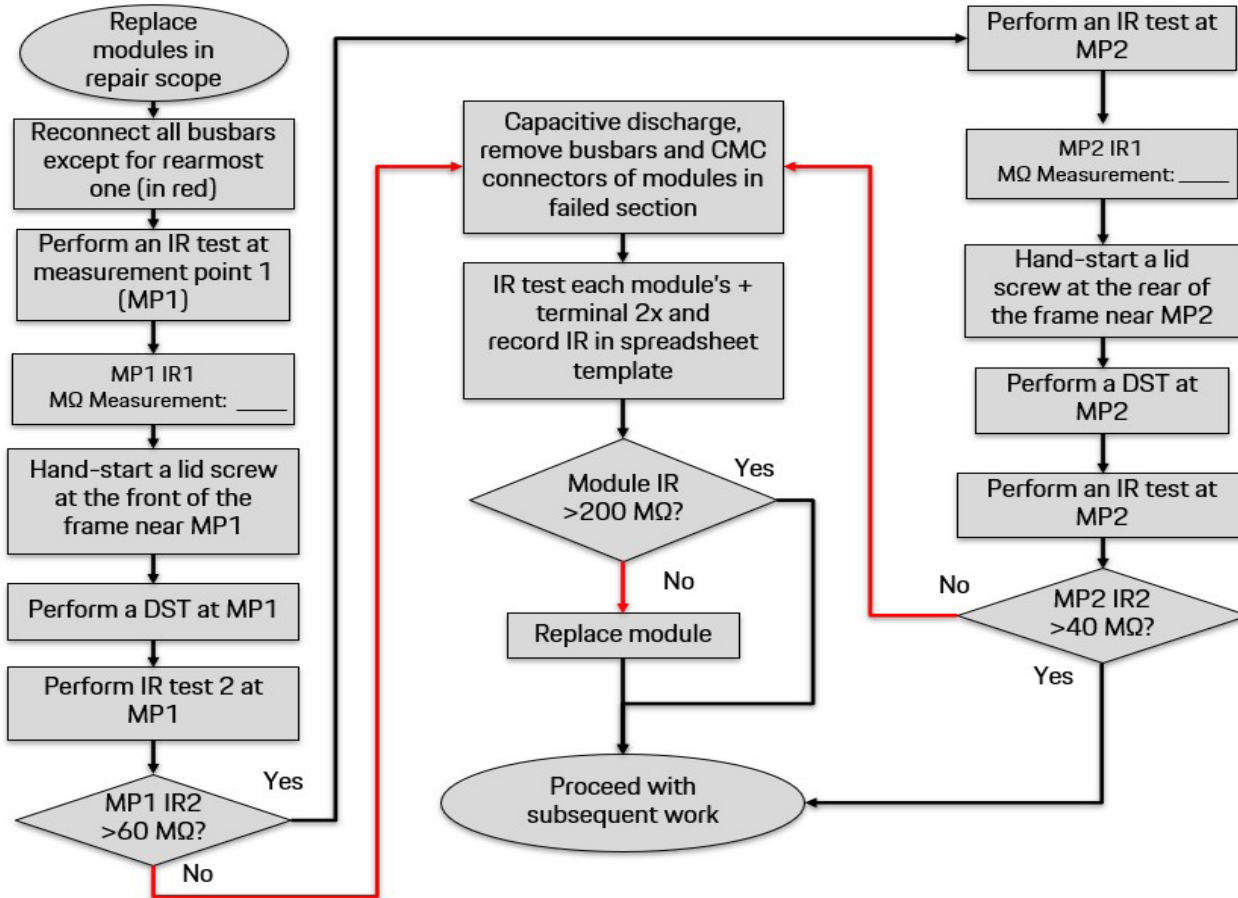
Figure 2 - 28-module Flowchart

Flowcharts of this process for each battery variant are available in figures to follow. The end step "Proceed with subsequent work" can refer to the next measurement point or completion of the repair depending on scenario.

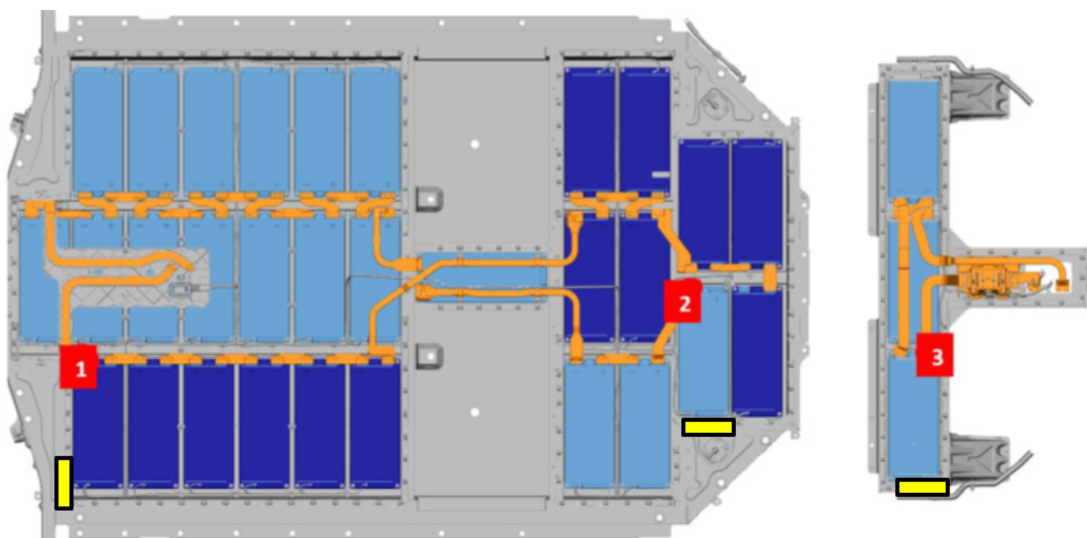
Figure 3 - 33-module HV Battery measurement points

DST Procedure for 33-module Taycan Battery Pack (Figure 3)

- Only a total of three or four DST's are to be performed on the 33-module battery pack during repair, depending on scope.
 - ▷ Perform a DST only at points 1, 2, and 3 for any repair scope involving the lower-level modules.

- The yellow boxes in *Figure 3* designate the section of frame where a lid screw can be hand-started to ground the dielectric strength tester. If performing a DST on the mid-pack fuse, use the location on the upper "T" section to ground the negative clamp.

- If the final IR test at measurement point 1 fails, remove busbars and CMC connections from each module shaded in dark blue for further IR testing as described in the following *Updated IR Measurement Procedure* sections.

- If the final IR test at measurement point 2 fails, remove busbars and CMC connections from each module shaded in light blue for further IR testing as described in the following *Updated IR Measurement Procedure* sections.

- If the final IR test at measurement point 3 fails, remove busbars and CMC connections from each module in the upper "T" section for further IR testing as described in the following *Updated IR Measurement Procedure* sections.

- EXAMPLE: It is possible for battery to have point 1 pass, point 2 pass, and point 3 fail the DST. It would then only be required to perform further IR tests on each module in the upper "T" section. No additional work would be required for the passing lower sections.

- Perform IR tests at points 1, 2, and 3 after a DST, with the negative probe in contact with a clean spot on the silver frame surface designated by the yellow boxes.
