Symptom - Oil Leakages on Double Clutch Transmission (PDK): Observe Specified Work Procedure (SY 13/25)

Model Year: **As of 2024**

Model Line: **Panamera (YAA/YAB)**

Concerns: **Double-clutch transmission (PDK)**

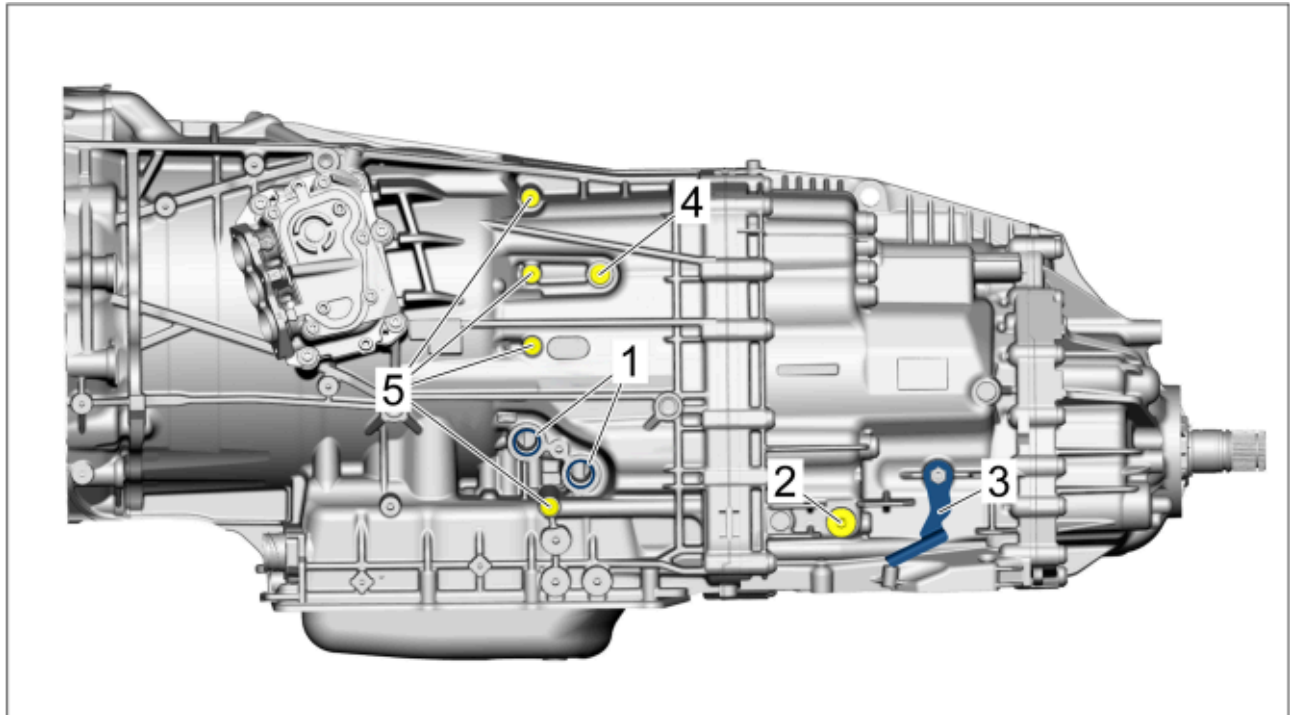
Position	Leak area	Possible cause(s)	Repair measure
<p>⇒ Left side of transmission -1-</p>	<p>ATF cooler connections</p>	<p>Sealing ring damaged:</p>

⇒ Left side of transmission -2-	Filler screw	Screw loose	Check that it is installed securely.
		Sealing ring damaged	Check that it is installed securely. Replace filling screw if necessary. For work procedure, see: ⇒ <i>Technical Information</i> 'Replacing screw plug'
⇒ Left side of transmission -3-	Parking lock	Sealing ring damaged	Replace parking lock sealing ring. For work procedure, see: ⇒ <i>Technical Information</i> 'Replacing parking lock sealing ring'
⇒ Left side of transmission -4-	Screw plug	Screw loose	Check that it is installed securely.
		Sealing ring damaged	Check that it is installed securely. Replace screw plug if necessary. For work procedure, see: ⇒ <i>Technical Information</i> 'Replacing screw plug'
⇒ Left side of transmission -5-	Screw plug	Screw loose	Check that it is installed securely. Replace screw plug if necessary.
		Sealing ring damaged	For work procedure, see: ⇒ <i>Technical Information</i> 'Replace screw plug'

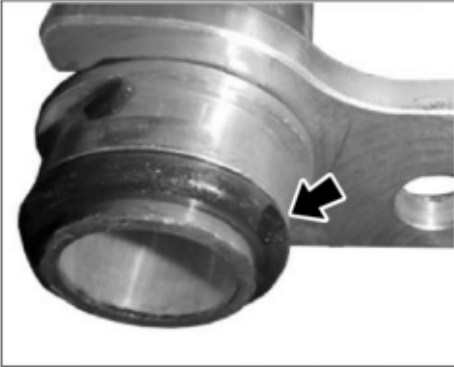
<p>ATF cooler sealing ring</p>	<p>Replace sealing ring on ATF cooling line. For work procedure, see: ⇒ <i>Technical Information</i> 'Replacing sealing ring on ATF cooling line'</p>
		<p>Line corroded or crimping damaged:</p>

- Work Procedure: 1 Replace sealing ring on ATF cooling line.
 For work procedure, see:
 ⇒ *Workshop Manual '386219 Removing and installing line for ATF cooling'*
or
 ⇒ *Workshop Manual '386219 Remove and install line for ATF cooling (hybrid)'*
- 2 Check and top up ATF.
 ⇒ *Workshop Manual '370235 Checking and topping up ATF'*

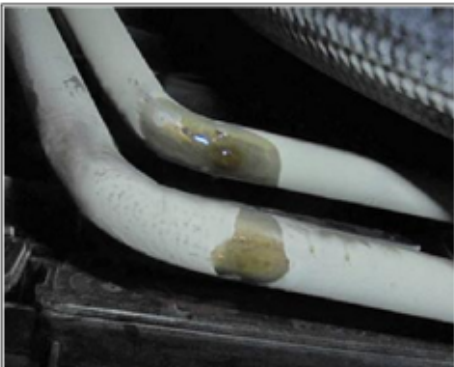
<p>ATF cooling line - corroded</p>	<p>Replace ATF cooling line. For work procedure, see: ⇒ <i>Technical Information</i> 'Replacing ATF cooling line'</p>

Work Procedure: 1 Replace ATF cooling line.
⇒ *Workshop Manual '386219 Removing and installing line for ATF cooling (rear section)'*

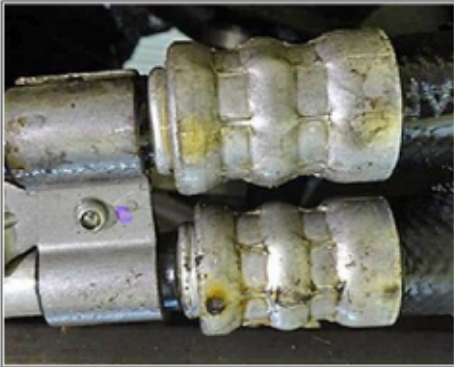
<p>ATF cooling line - crimping damaged</p>

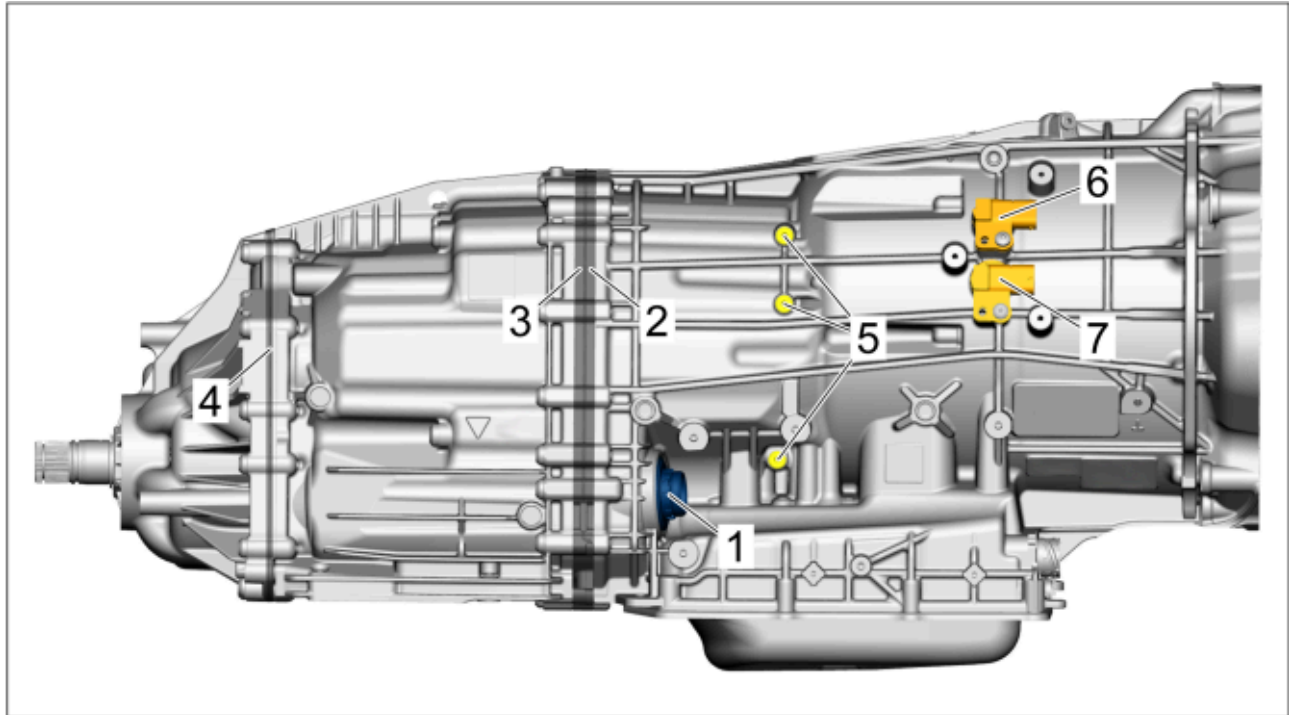
Position	Oil leakage	Possible cause(s)	Repair measure
<p>⇒ Right side of transmission -1-</p>	<p>Front output shaft</p>	<p>Sealing ring damaged:</p>

⇒ Right side of transmission -4-	Transmission housing	Screw loose	Check that it is installed securely.
		Seal damaged	Replace double clutch transmission. For work procedure, see: ⇒ <i>Technical Information</i> 'Replacing double clutch transmission'
⇒ Right side of transmission -5-	Screw plug	Screw loose	Check that it is installed securely. Replace screw plug if necessary. For work procedure, see: ⇒ <i>Technical Information</i> 'Replacing screw plug'
		Sealing ring damaged	
⇒ Right side of transmission -6-	Connecting element NTC sensor	Screw loose	Check screw connection. If necessary, replace the NTC sensor connection element. For work procedure, see: ⇒ <i>Technical Information</i> 'Replacing connecting elements'
		Connecting element damaged	
⇒ Right side of transmission -7-	Connecting element RLS sensor	Screw loose	Check screw connection. If necessary, replace connecting element for RLS sensor. For work procedure, see: ⇒ <i>Technical Information</i> 'Replacing connecting elements'

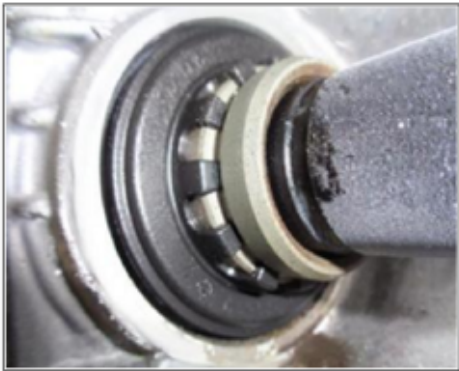
<p>Output shaft sealing ring</p>	<p>Replace sealing ring for front output shaft. For work procedure, see: ⇒ Technical Information 'Replacing sealing ring for front output shaft'</p>
		<p>O-rings damaged:</p>

- Work Procedure: 1 Replace sealing ring for front output shaft.
⇒ *Workshop Manual '387055 Replace sealing ring for front output shaft'*
- 2 Check and top up ATF.
⇒ *Workshop Manual '370235 Check and top up ATF.'*

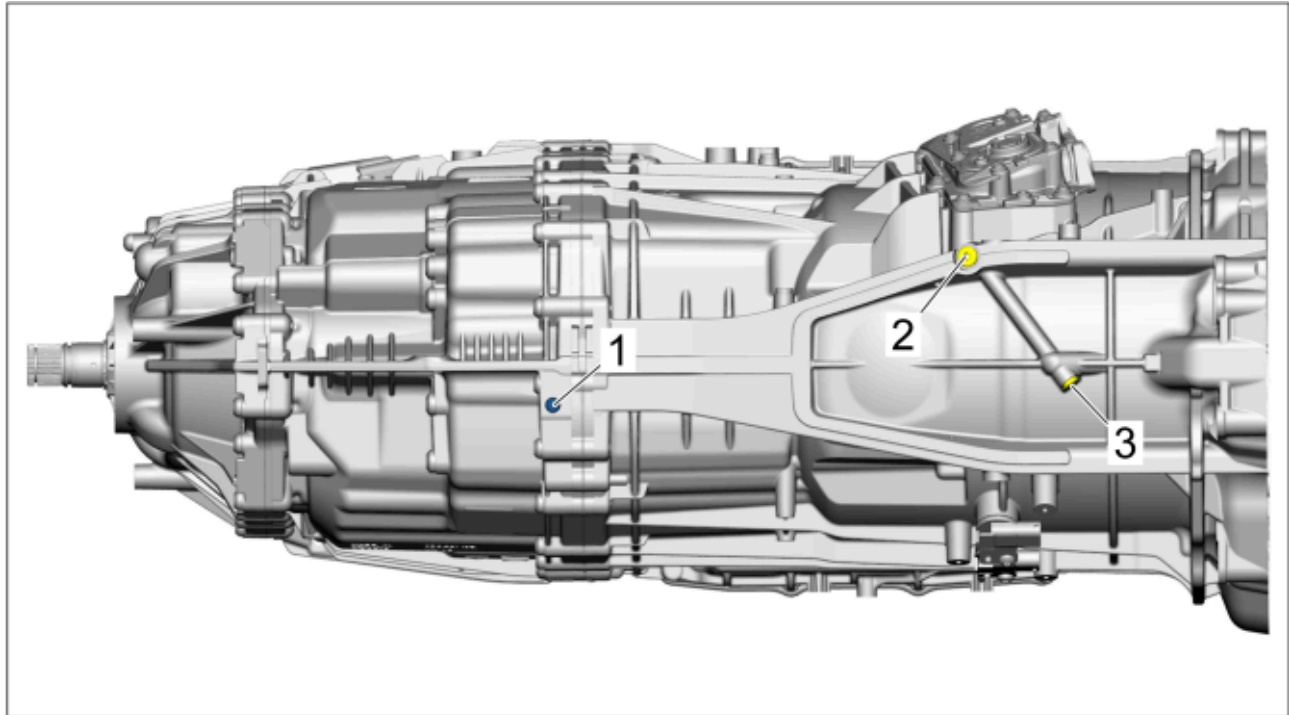
Position	Oil leakage	Cause	Repair measure
⇒ Upper transmission side -1-	Hydraulic space bleeder	Oil over-filled	Check and top up ATF. For work procedure, see: ⇒ <i>Technical Information 'Checking and topping up ATF'</i>
		Insufficient defoamer	Replace ATF. For work procedure, see: ⇒ <i>Technical Information 'Replacing ATF'</i>
		Breather defective	Replace hydraulic chamber breather. For work procedure, see: ⇒ <i>Technical Information 'Replacing hydraulic chamber breather'</i>
⇒ Upper transmission side -2-	Screw plug	Screw loose	Check that it is installed securely. Replace screw plug if necessary.
		Sealing ring damaged	
⇒ Upper transmission side -3-	Screw plug	Screw loose	Check that it is installed securely. Replace screw plug if necessary.
		Sealing ring damaged

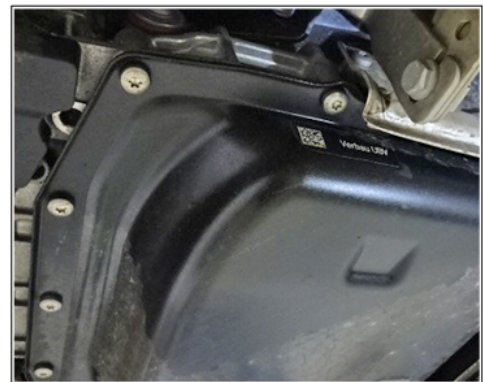
ATF oil pan

If the oil leakage has spread so much that the oil pan is also oily, as shown, proceed as follows in case there is a complaint:

- Ensure that the accessible oil pan screws are tightened to the specified torque; tighten them, if necessary.
- Before carrying out any further work, the entire transmission must be thoroughly cleaned in the areas of oil leakages/oil contamination and sprayed with SpotCheck.
- Clean the transmission oil pan area absolutely thoroughly. An oil pan seal leak can lead to misinterpretation. Thereafter, perform a test drive.
- **After the test drive, review the transmission for oil leakages below.**

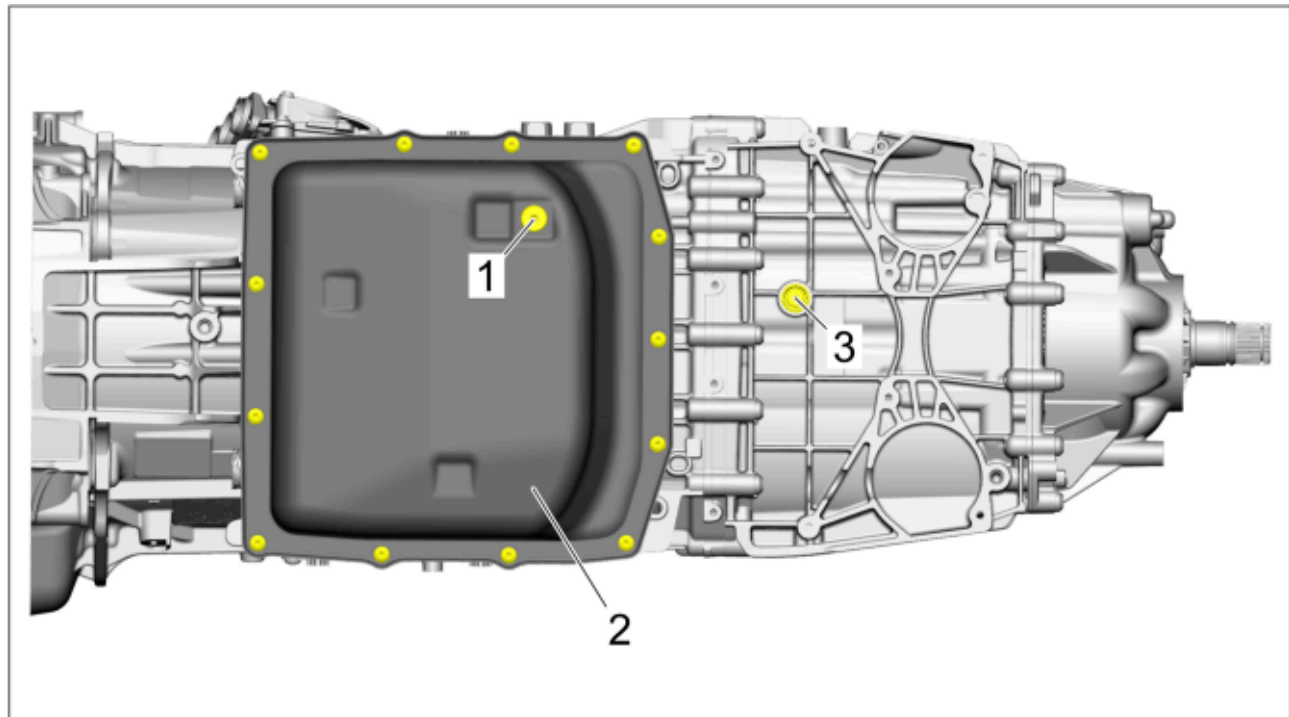
Position	Oil leakage	Cause	Repair measure
⇒ Lower side of transmission -1-	Oil drain plug	Screw loose	Check that it is installed securely. Replace oil drain screw if necessary. For work procedure, see: ⇒ <i>Technical Information 'Replacing ATF pan'</i>
		Sealing ring damaged	
⇒ Lower side of transmission -2-	ATF pan	Screws loose	Check that it is installed securely. Replace screws on the ATF pan if necessary. Replace ATF pan. For work procedure, see: ⇒ <i>Technical Information 'Replacing ATF pan'</i>
		Seal damaged	
⇒ Lower side of transmission -3-	Oil inspection plug	Screw loose	Check that it is installed securely. If necessary, replace lifting tube and oil inspection plug. For work procedure, see: ⇒ <i>Technical Information 'Replacing lifting tube and oil inspection plug'</i>
		Lifting tube loose

- Work Procedure:
- 1 Replace oil drain plug.
For work procedure, see: ⇒ *Workshop Manual '370255 Replacing ATF'*
 - 2 Replace lifting tube and tighten to **Tightening torque 27 Nm (19.9 ftlb.)**.
 - 3 Replace oil inspection plug.
For work procedure, see: ⇒ *Workshop Manual '370235 Checking and topping up ATF'*

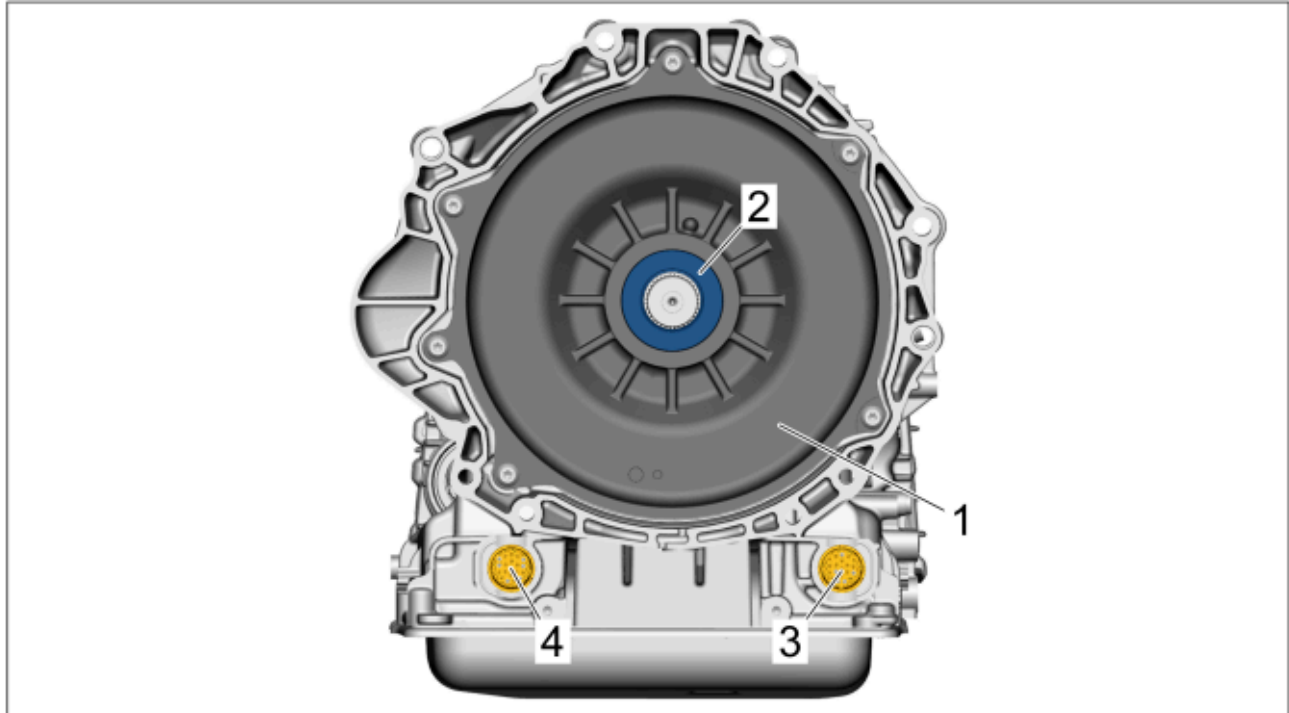
Position	Oil leakage	Cause	Repair measure
⇒ Front side of transmission -1-	Clutch bell-housing, clutch cover	Apparent assembly grease leak	No action required.
		Grease leak on dual-mass flywheel	Assess dual-mass flywheel. For work procedure, see: ⇒ <i>Technical Information 'Assessment of dual-mass flywheel (DMF) on vehicles with PDK (11/14)'</i>
		Engine leaking	Find oil leakages and fix them.
		Clutch cover O-ring damaged	Replace double clutch transmission. For work procedure, see: ⇒ <i>Technical Information 'Replacing double clutch transmission'</i>
⇒ Front side of transmission -2-	Clutch cover	Radial shaft seal on clutch cover damaged	Replace the radial shaft seal. For work procedure, see: ⇒ <i>Technical Information 'Replacing radial shaft sealing ring'</i>

⇒ Front side of transmission -3-	Central connector on the left	Connector leaking	Replace wire harness in transmission. For work procedure, see: ⇒ <i>Technical Information 'Replacing wire harness in transmission'</i>
⇒ Front side of transmission -4-	Central connector on the right	Connector leaking	Replace wire harness in transmission (clutch).

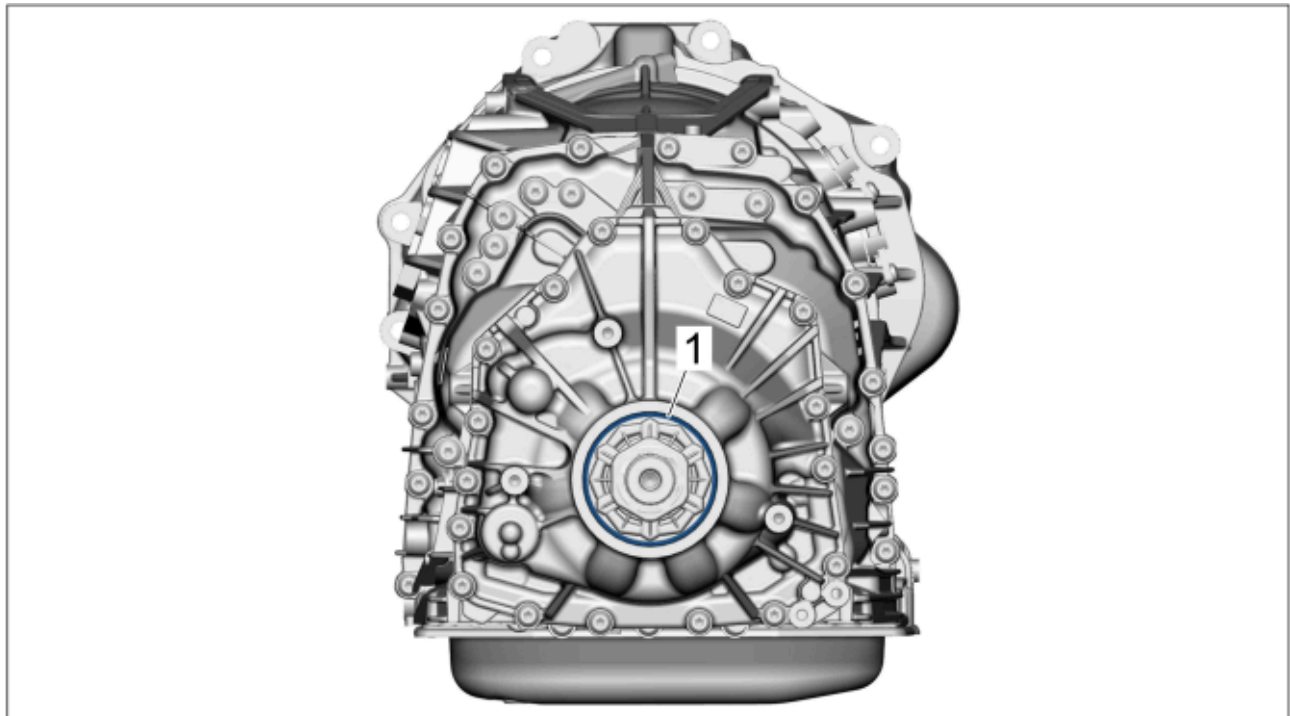
Position	Oil leakage	Cause	Repair measure
⇒ Rear side of transmission -1-	Rear-axle shaft	Shaft sealing ring damaged	Replace rear axle shaft sealing ring. For work procedure, see: ⇒ <i>Technical Information 'Replacing rear axle shaft sealing ring'</i>

- Work Procedure: 1 Replace sealing ring for cardan flange.
For work procedure, see: ⇒ *Workshop Manual '387055 Replacing sealing ring for output shaft'*
- 2 Check and top up ATF.
⇒ *Workshop Manual '370235 Checking and topping up ATF'*
