992/971/Y1A - PCM Login Failure "Account Could Not be Activated"

Vehicles Affected

Models	Model Year	Model Type	VIN Range	Vehicle-Specific Equipment
911	2022	N/A	N/A	
Panamera	2022	N/A	N/A	
Taycan	2022	N/A	N/A

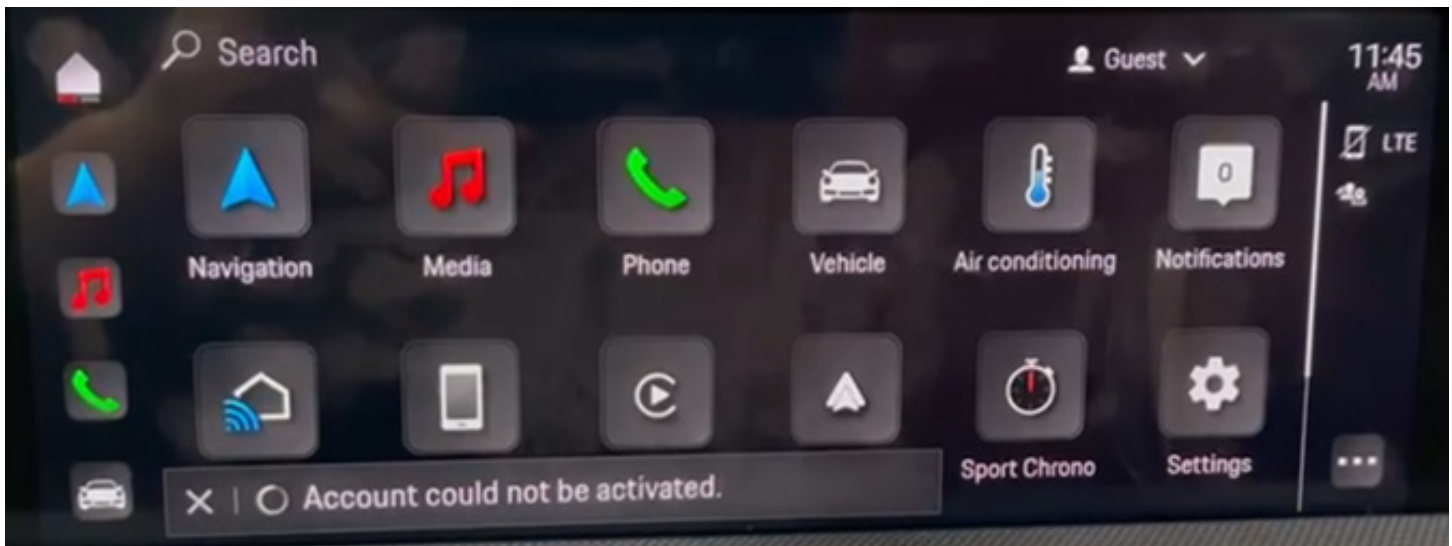
Figure 1

Customer complains when selecting the Main user account, login is not possible. When selecting the account, they receive the error prompt "Account could not be activated" or "No access authorization".

This ATI is only applicable to user login failures of MY22 vehicles that give the error prompts from Figures 1 & 2.

The solution for this issue is to perform Automatic Coding of the Gateway Control Unit (as of Tester version 43.800.040).

1. Create a Pre-VAL.
2. Verify there are no fault codes associated with the PCM, External Communication CU (ConBox), or Gateway CU.
3. Verify the Gateway CU software level is 0613.
 - a. If not, perform TI 71/22 (WND4 Re-Programming Gateway Control Unit)
4. Perform automatic coding of the Gateway CU.
5. Perform a 10-minute bus sleep.
6. Verify account login is operational.
 - a. If account login is not operational, perform a PCM reset and repeat steps 4-6.
