**Bluetooth Connection to Mobile Phone is Cancelled or Error Message “Emergency Call Faulty” on Instrument Cluster (90/25)**

Model Year: **As of 2022 up to 2024**

Model Line: **Panamera (97A / 97B / 97C)**

Concerns: **External communication control unit**

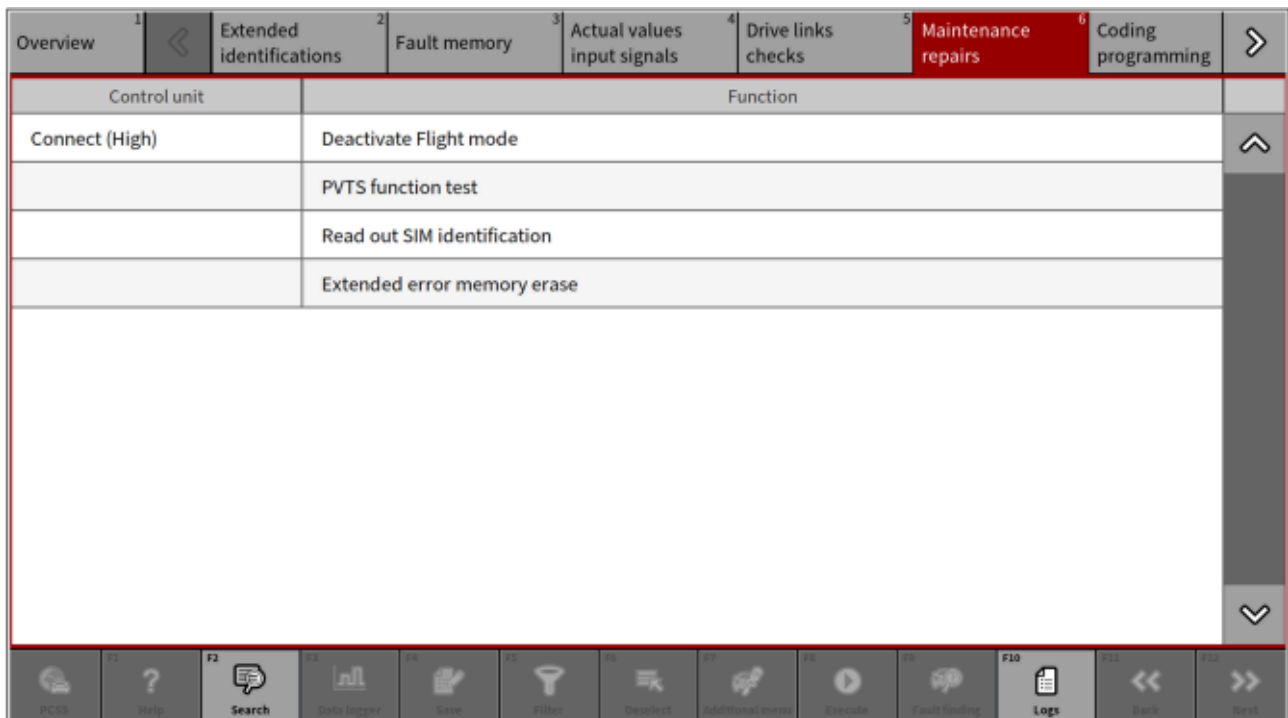
*Delete extended fault memory*

- 7.1 Select the **"Delete extended fault memory"** function, then press **[F12]** ("Next") to confirm and perform the function with menu guidance.
- 8 Unless already done, start the integration test by pressing **[F3]** in the Porsche Tester.
