E326: EPA17-24 and CARB24 PACCAR MX Fuel Injector Connector Upgrade

E326

3/11/2025

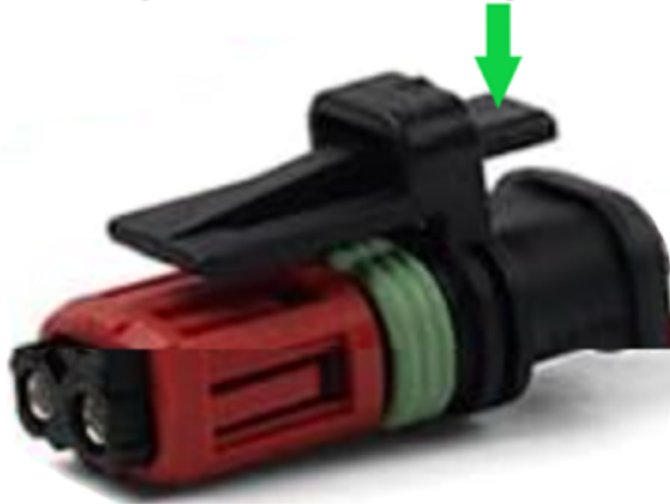
Injector Connector Locking Tab

When performing upgrades that require disconnecting the injectors or removing the valve train casing, it's possible that the locking tabs on the injector connector shell (part number 1439888PE) could break.

To increase uptime and serviceability, dealers should stock the injector connector shells (1439888PE). Upgrades to broken connector shells should occur rather than replacement of the valve train casing assembly.

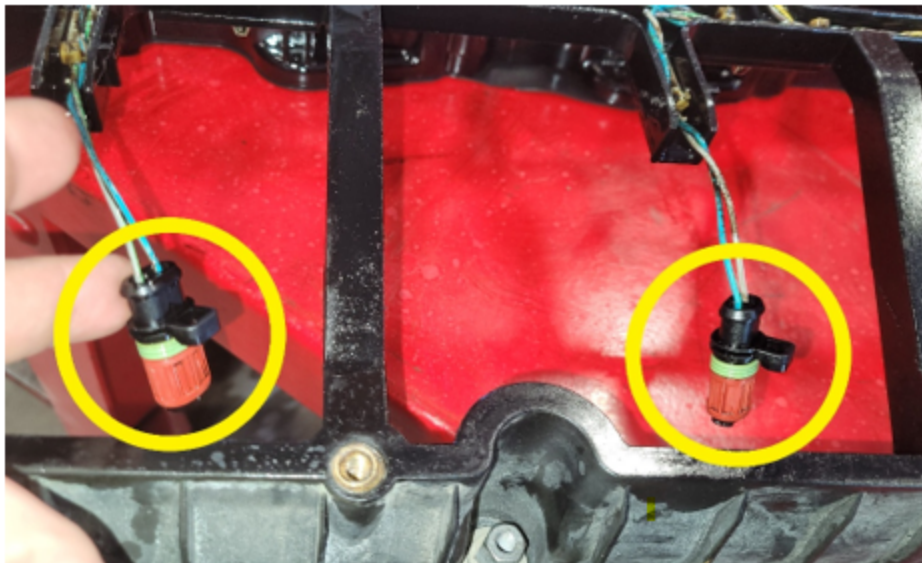
During repairs which involve disconnecting the injectors or removing the valve train casing, the injector connector shells (1439888PE) locking tabs may be broken. Since the injector connector shells were not

Broken Injector Connectors in Valve Train Casing Assembly

Injector connector shell locking tabs may break when disconnected, resulting in valve train casing assembly replacement.

To prevent downtime, dealers should stock the injector connector shells (1439888PE). Replacement of broken connector shells should occur rather than replacement of the valve train casing assembly.

Injector connector shell replacement procedures can be found in RMI by searching “valve train casing”, then select Parts > Valve train casing > Jobs > replace 1 (one) connector 2-pin (Basic assembly).

When connector shells are replaced according to RMI, a pin extraction tool is required to complete the repair. This tool is part number 539972-1, available through PACCAR Parts.
