Item: TB261.1

Description: Camshaft Wear

Model Affected: Tiger 1200 Alpine Edition, Tiger 1200 Desert Edition, Tiger 1200 GT, Tiger 1200 GT Pro, Tiger 1200 GT Explorer, Tiger 1200 Rally Pro, Tiger 1200 Rally Black Edition, Tiger 1200 Rally Explorer

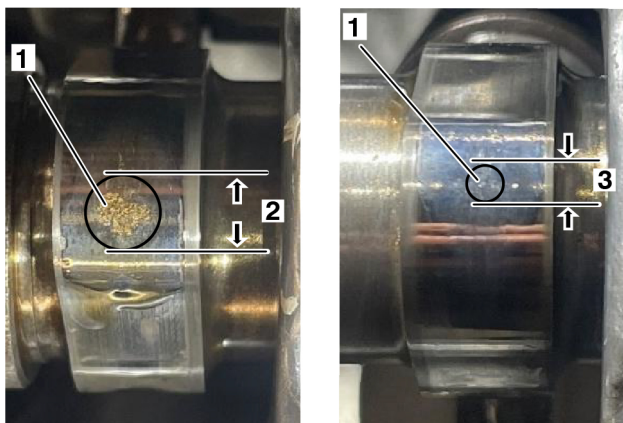
- The pitting area on the tip of the camshaft lobe is greater than 3.5 mm in diameter.
- If there are signs of porosity (casting void) no matter the size of the pitting diameter.
- Visual pitting of any size with a noticeability reduction of engine performance.
- Visual pitting of any size with a change of engine/cylinder head noise.

1. Pitting
2. 3.5 mm Diameter or greater
3. Less than 3.5 mm Diameter

Dealers are to renew the camshafts if one or more of the following conditions are met:
