<b>REFERENCE:</b>	<b>TSB:</b> 08-190-26 <b>GROUP:</b> 08 - Electrical	<b>Date:</b>	April 30, 2026	<b>REVISION:</b>	—
<b>VEHICLES AFFECTED:</b>	<b>2026 (WS) Jeep Wagoneer / Grand Wagoneer</b> This bulletin applies to vehicles built on or after February 10, 2026 (MDH 0210XX) and built on or before February 21, 2026 (MDH 0221XX) equipped with a Floor Console W/Cupholder (Sales Code CUQ).	<b>MARKET APPLICABILITY:</b>		<input checked="" type="checkbox"/> NA <input type="checkbox"/> MEA <input type="checkbox"/> SA <input type="checkbox"/> IAP <input type="checkbox"/> EE <input type="checkbox"/> CH <b>NOTE:</b> This bulletin applies to the North America markets.	
<b>CUSTOMER SYMPTOM:</b>	<b>Customers may experience one or more of the following:</b> <ul style="list-style-type: none"> <li>• The odometer is flashing.</li> <li>• The heated seats not showing on rear screen <a href="#">Fig. 1</a>.</li> </ul>

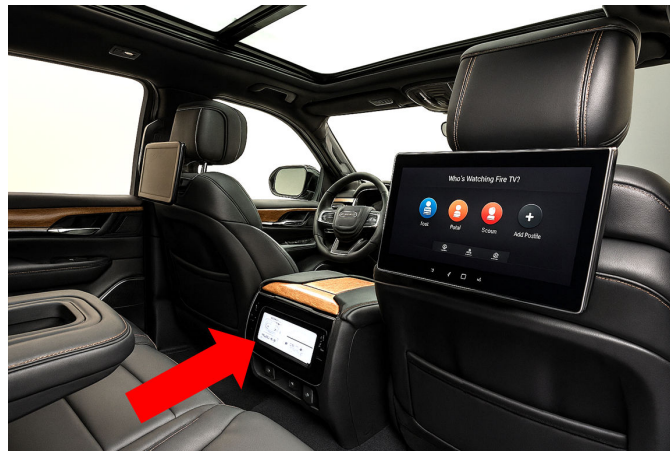
**Fig. 1**  
Rear Screen

<b>CAUSE:</b>	DSM not Proxied

This bulletin involves performing a restore vehicle configuration and Proxi configuration alignment.

1. Using the wiTECH, perform a Restore Vehicle Configuration. This routine is available under the 'Guided Diagnostics' tab found on the home, 'Vehicle View' page of wiTECH.
2. Perform a Proxi Configuration Alignment routine. This routine is available under the 'Guided Diagnostics' tab found on the home, 'Vehicle View' page of wiTECH.
3. Clear any DTCs that may have been set.
