Technical Service Bulletin (TSB)
Global Telematics Box Module (TBM) Firmware
Over The Air (FOTA) Update From R5R1 To R5T

REFERENCE:	TSB: 08-193-26 GROUP: 08 - Electrical	Date:	April 30, 2026	REVISION:	—
VEHICLES AFFECTED:	2026 (KM) Jeep Cherokee/Wagoneer S This bulletin applies to vehicles built on or before March 07, 2026 (MDH 0307XX) equipped with Global Telematics Box Module (TBM) (Sales Code RDG).			MARKET APPLICABILITY: <input checked="" type="checkbox"/> NA <input type="checkbox"/> MEA <input type="checkbox"/> SA <input type="checkbox"/> IAP <input type="checkbox"/> EE <input type="checkbox"/> CH NOTE: This bulletin applies to the North America market.	
CUSTOMER SYMPTOM:	Customers must experience a Malfunction Indicator Lamp (MIL) illumination and the vehicle must exhibit/set one or more of the following Diagnostic Trouble Codes (DTCs): <ul style="list-style-type: none"> ● B1560-11 - Cellular Antenna 1-Circuit Short To Ground. ● B1560-13 - Cellular Antenna 1-Circuit Open. ● B1561-11 - Cellular Antenna 2 Short To Ground. ● B1561-13 - Cellular Antenna 2-Circuit Open. ● B1562-14 - GPS Antenna-Circuit Short To Ground Or Open. ● B22A9-96 - ECU Internal Performance - Component Int

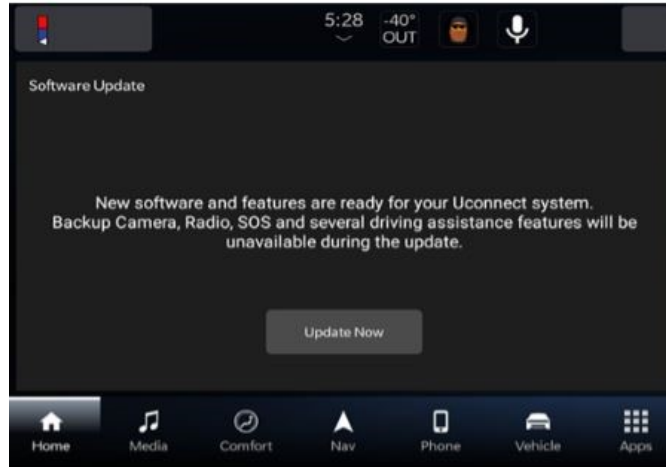
Fig. 1

Software Acceptance Screen

1. The vehicle needs to be in 'Park'. The ignition needs to be in the off position.
2. If the customer selects "Update Now" [Fig.1](#) they can shut off the vehicle and leave. The update will be completed automatically.

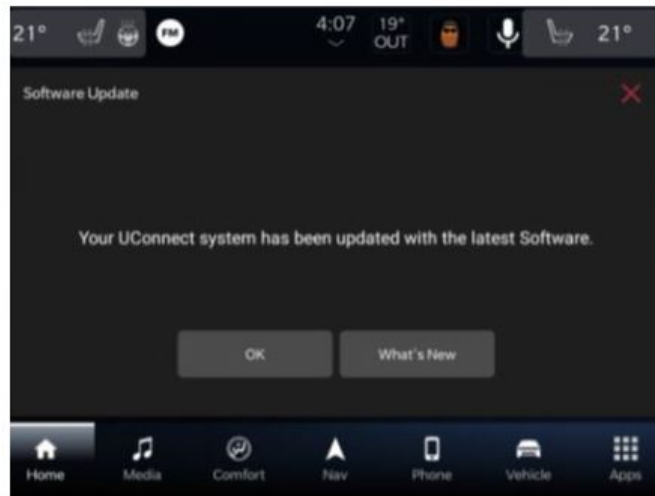
Fig. 2

Software Update Confirmation Screen

3. Upon completion of update, the radio will display a confirmation message [Fig. 2](#).
