Technical Service Bulletin (TSB)
Global Telematics Box Module (TBM)
Firmware Over The Air (FOTA) Update

REFERENCE:	TSB: 08-199-26 GROUP: 08 - Electrical	Date:	May 2, 2026	REVISION:	-
VEHICLES AFFECTED:	2026 (WS) Jeep Wagoneer / Grand Wagoneer This bulletin applies to vehicles built on or before January 22, 2026 (MDH 0122XX) equipped with Global Telematics Box Module (Sales Code RDG) .			MARKET APPLICABILITY: <input checked="" type="checkbox"/> NA <input type="checkbox"/> MEA <input type="checkbox"/> SA <input type="checkbox"/> IAP <input type="checkbox"/> EE <input type="checkbox"/> CH NOTE: This bulletin applies to the North America market.	
CUSTOMER SYMPTOM:	Customers must experience a Malfunction Indicator Lamp (MIL) illumination and the vehicle must exhibit/set one or more of the following Diagnostic Trouble Codes (DTCs): <ul style="list-style-type: none"> • B22A9-96 ECU Internal Performance-Component Internal Failure. • B1560-11 Cellular Antenna 1 - Short To Ground. • B1560-13 Cellular Antenna 1 - Circuit Open. • B1561-11 Cellular Antenna 2 - Short To Ground. • B1561-13 Cellular Antenna 2 - Circuit Open. • B1562-14 GPS Antenna Short To Ground Or Open. Customers may also exper

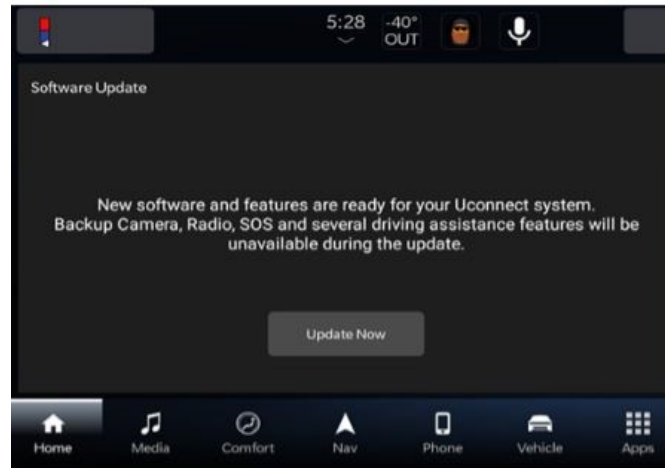
**Fig. 1**

Software Acceptance Screen
