STAR ONLINE PUBLICATION

Case Number: S2623000030

Symptom/Vehicle Issue: Water Under Hood From 6 Pack Hood.

Models Affected: 2026 Dodge Charger (LB) with 6 Pack MGB Hood

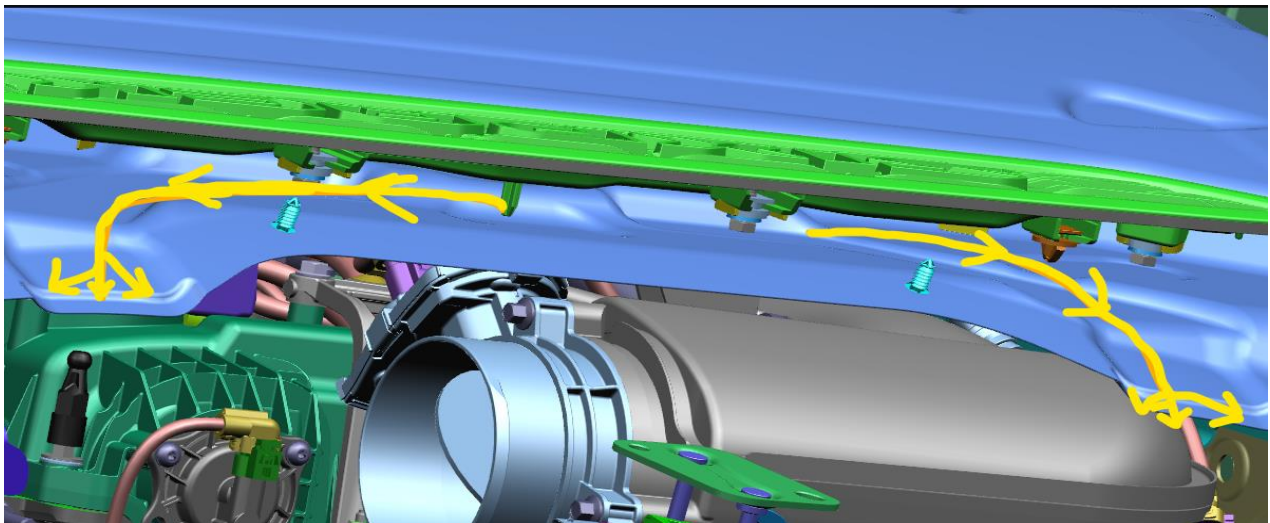
Water Management Flow From Hood

Discussion: Customer might complain about water leaking under the hood via the Hood bezel. The intended engineering water management direction for the water flow is through the hood bezel, onto the hood inner, and then toward the beauty cover. There are 2 drain holes on the bezel and both direct water onto the hood inner acoustics and then toward the beauty cover. Attached image shows the direction of flow.

If the water flows as described above, no repairs are required.
